# St Benedict Church, Gyffin

RIBA Stage 03 - Design Report and Statement of Significance

# Gyffin, St Benedict

## Detailed Comment

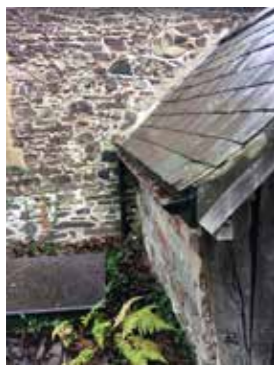
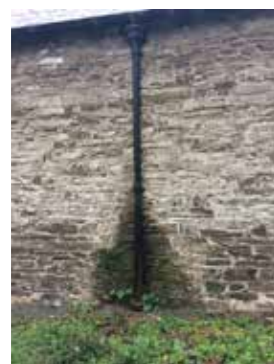
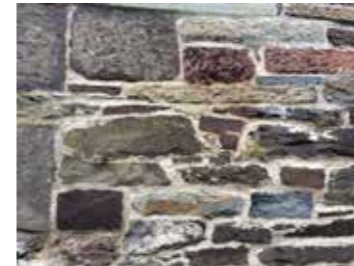
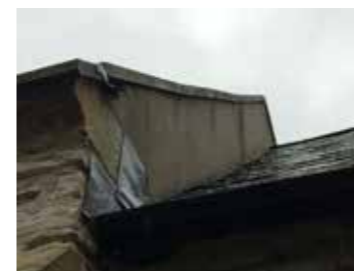
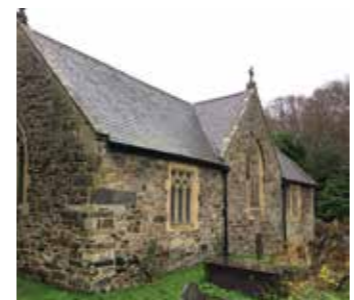
A  
B  
C  
D  
E

Most of gutters are in good condition. Some cast iron sections, particularly down pipes have lost their protective coating resulting in corrosion and holes/fractures. The downpipe on the north elevation has a hole causing water to spray onto the northern elevation of the Nave. It was difficult to establish if the gutters were blocked as the downpipes run directly into the ground and are well aligned. The cast iron gutter to the northern side of the Nave appeared blocked. Given the proximity of the trees it is possible that others are also blocked.

06	We would recommend monitoring the temperature and humidity levels with the church is monitored. This can be done by fitting battery operated humidity and temperature sensors which will record the findings every hour. This information will be critical in the long term conservation of the painted ceiling. The recordings will inform the specialist conservator if there have been any environmental changes which have contributed to any accelerated deterioration.	£250.00
07	Replace section of cast iron downpipe to northern elevation of Nave.	£250.00
08	Remove plaster to all walls. Allow sufficient time for drying out before replastering using a lime based plaster. Redecorate in an appropriate breathable paint.	£1,000.00
09	None. Rectification of dampness covered elsewhere, (Repointing walls, re-plastering and rain water goods).	£0.00
10	Prepare and redecorate all cast iron rainwater goods.	£1,000.00

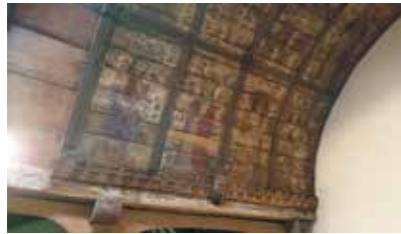
The ceiling is generally in good condition.

The medieval boarded wagon roof is set below the main roof line with a void above. We understand that the area above the boards were cleaned and consolidated during the works in 1991. A specialist report, prepared in 1991 includes a series of photographs of the figures. The condition assessment of this medieval ceiling should be undertaken by a specialist paint conservator who can

Item	Element	Indicative Cost (£)
01	As the painted ceiling has not been inspected by a specialist since 1991, we would recommend that a report on the current condition is undertaken.	£500.00
02	It is worth considering replacing the lower sections of the cast iron downpipes and introduce a 'shoe' and ground gully. This would allow ease of maintenance and will better inform if there are any blockages.	£750.00
03	Monitor condition of stonework.	£250.00
TOTAL		£1,500.00
Category E –Possible New Interventions.

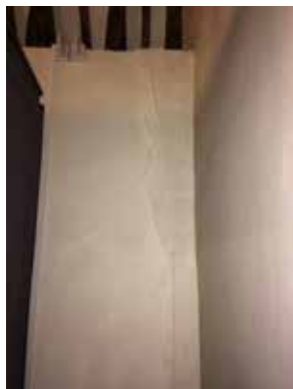
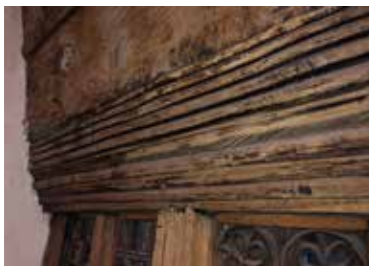
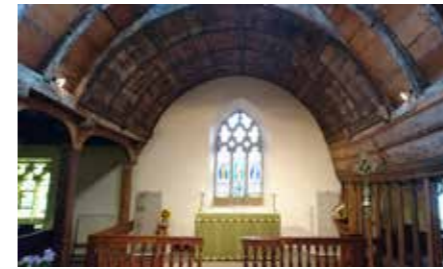
On the south elevation there is an area of dampness, blistering plaster and flaking paintwork. This may be a result of a non-breathable paint and plaster skim applied to the surface of the wall and the quality of the external pointing or the void above.

10	Following the external repointing, covered elsewhere, the condition of the wall should be reassessed to see if this moisture levels have reduced thus avoiding the need to undertake immediate action internally. Should the dampness remain, we would recommend removing the non-breathable paint and plaster and replaster using a lime based plaster and a breathable (ideally limewash) coat.	£0.00
TOTAL		£4,250.00
Category D –Works to improve aesthetic presentation.

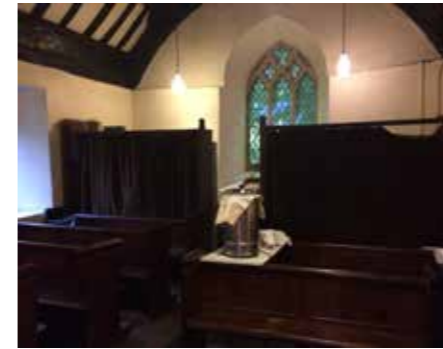
The timber parclose screen is in fair and stable condition. A section of the reed moulding has split however this is visible in the 1948 RCAHMW photographic record and does not appear to have widened.

The 'wall plate' of the timber screen dividing the Chancel and North transept and the feet of the rafters bearing onto the screen has decayed and lost a large amount of its width. This appears historic as there are existing 'packers' insitu supporting the rafters. Despite the loss, the timber appears dry and retains its integrity
