STRUCTURAL REPORT

Client: Church of St Mary, Betws-y-Coed, PCC

Project: Structural Inspection of the Tower

REPORT OF A STRUCTURAL INSPECTION OF THE TOWER AT THE CHURCH OF ST MARY, BETWS-Y-COED, CONWY, WALES

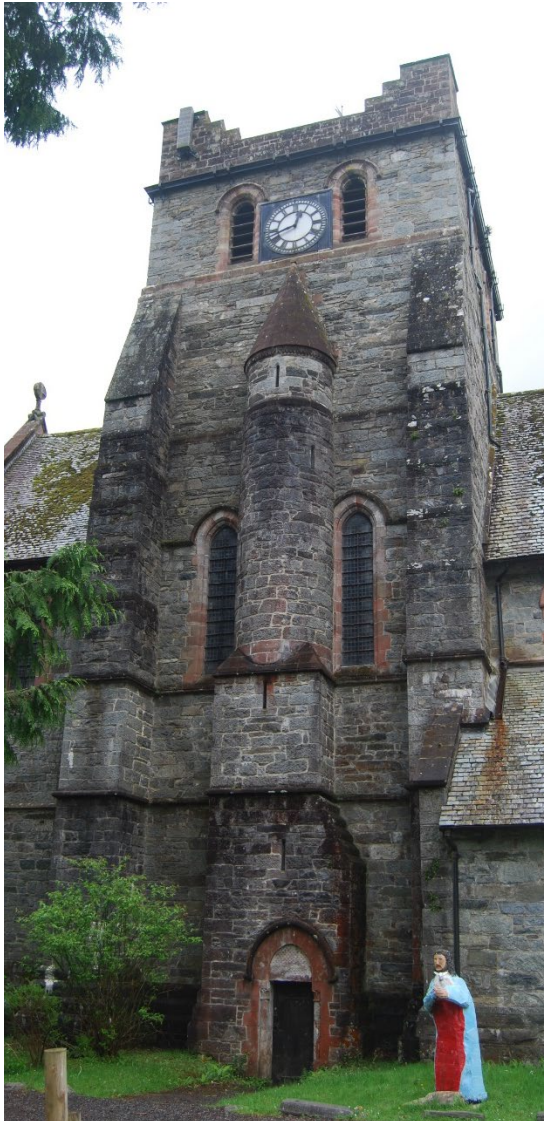
2.01 North Elevation Wall:

In the centre of this elevation is a semi-circular projection which houses the spiral staircase giving access to the first intermediate chamber of the tower. To each side of this, in the north east and north west corners, are two substantial orthogonal buttresses which extend northwards. All three projections extend up to sill level of the belfry louvre window openings. At the top of the tower, in the north east corner, is a small telephone mast and just below this is a continuous gutter which catches rainwater from the tower roof. The masonry appears to be in generally fair condition, consistent with its age, with no evidence of any significant cracking, recent or ongoing movement or other structural distress.

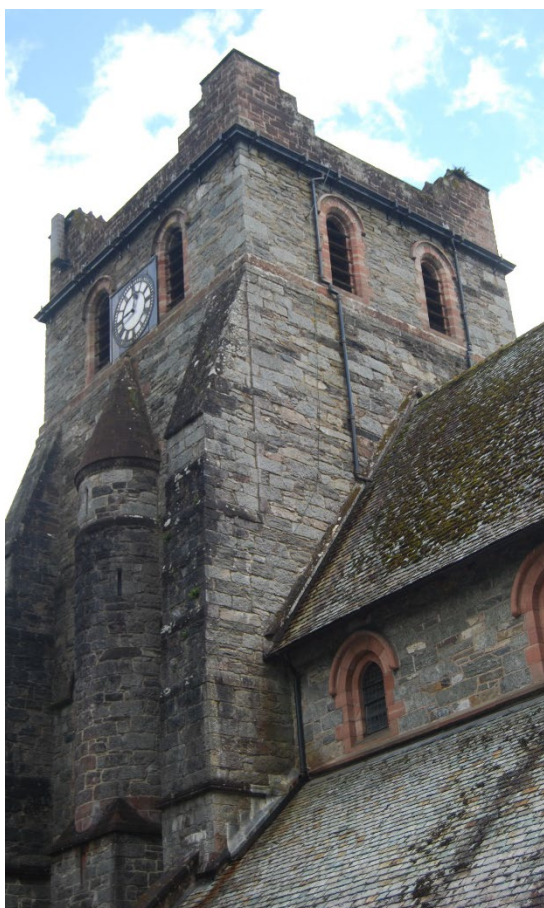
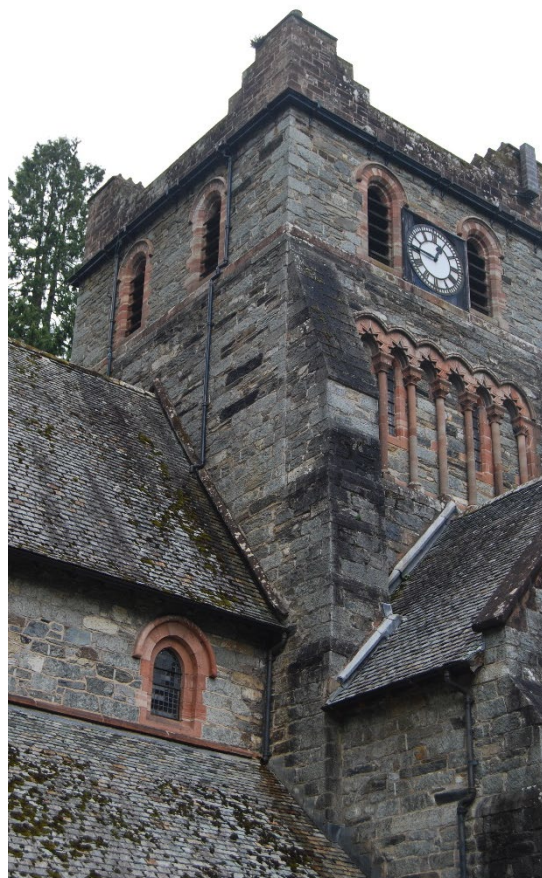
2.02 West Elevation Wall

Just below parapet level, there is a continuous gutter, similar to that on the north elevation, which catches rainwater from the tower roof. This discharges via two downpipes to the north and south sides of the belfry louvre window opening onto the roof of the nave. The masonry appears to be in generally fair condition, consistent with its age, with no evidence of any significant cracking, recent or ongoing movement or other structural distress.

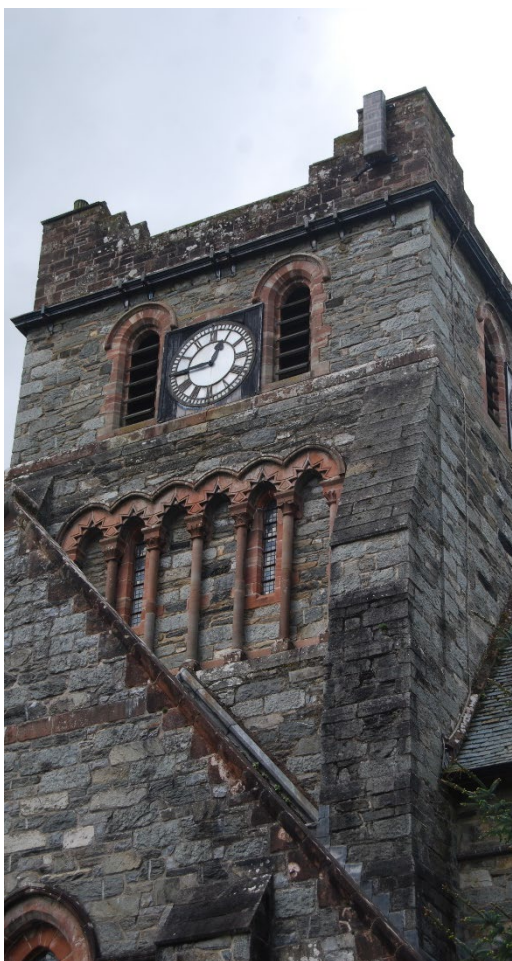
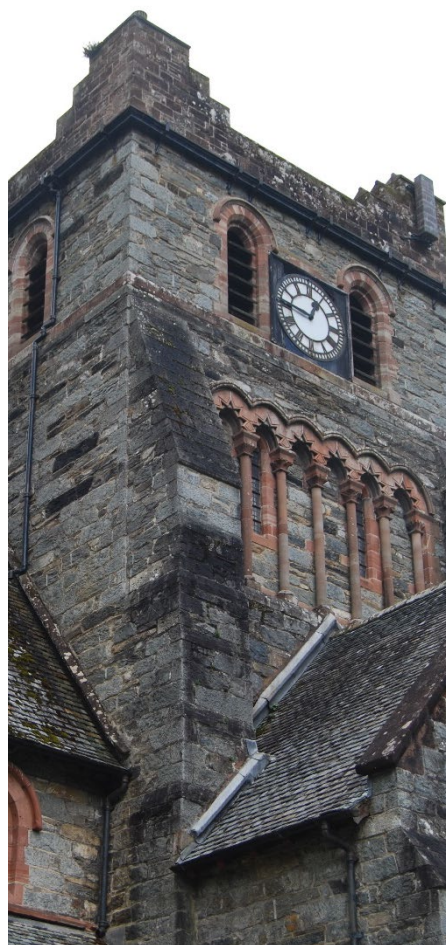
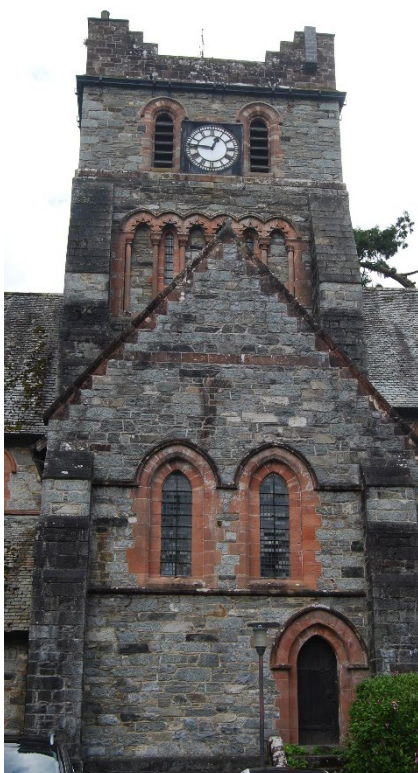
2.03 South Elevation Wall

In the south east and south west corners are two substantial orthogonal buttresses which extend southwards and up to sill level of the belfry louvre window openings. At the top of the tower, in the south east corner, is a small telephone mast and just below this is a continuous gutter, similar to that on the north elevation, which catches rainwater from the tower roof. The masonry appears to be in generally fair condition, consistent with its age, with no evidence of any significant cracking, recent or ongoing movement or other structural distress.

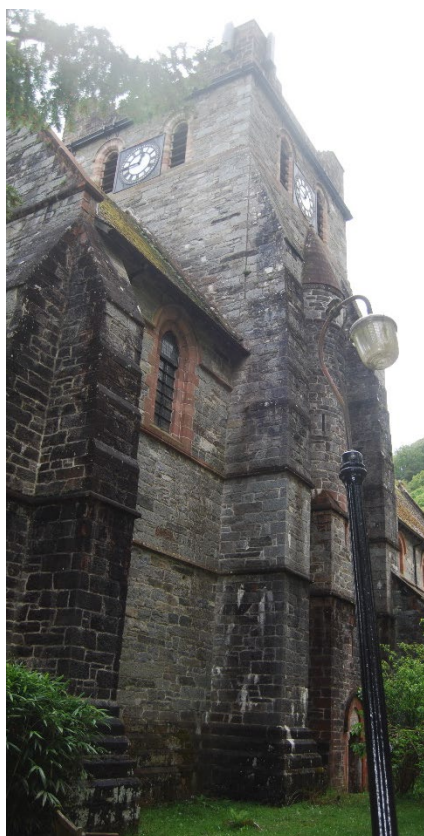
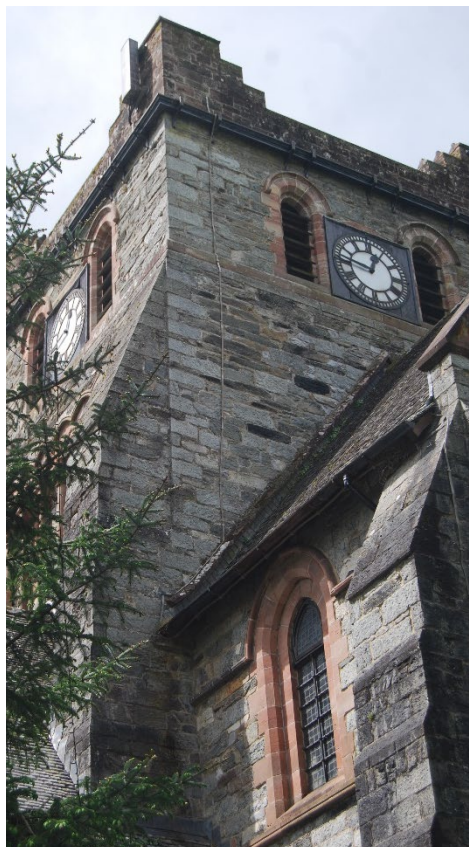
2.04 East Elevation Wall

Just below parapet level, there is a continuous gutter, similar to that on the north elevation, which catches rainwater from the tower roof. The masonry appears to be in generally fair condition, consistent with its age, with no evidence of any significant cracking, recent or ongoing movement or other structural distress.

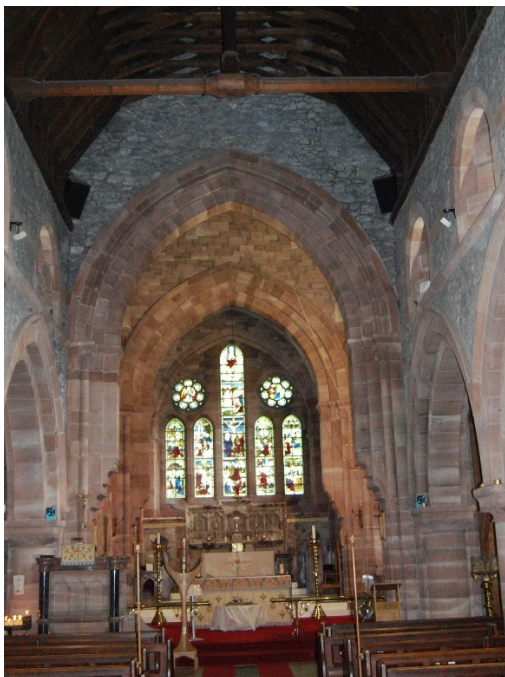
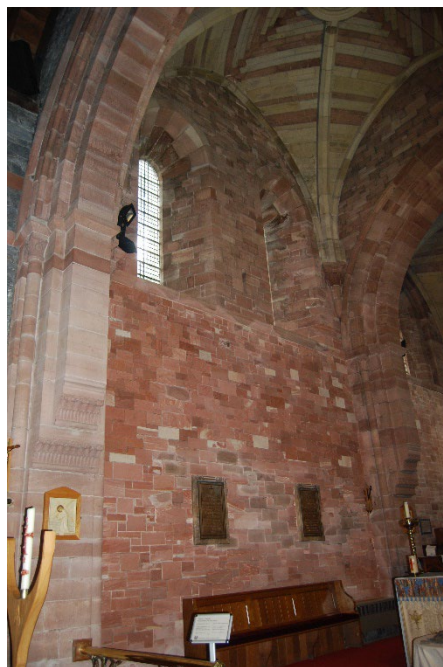
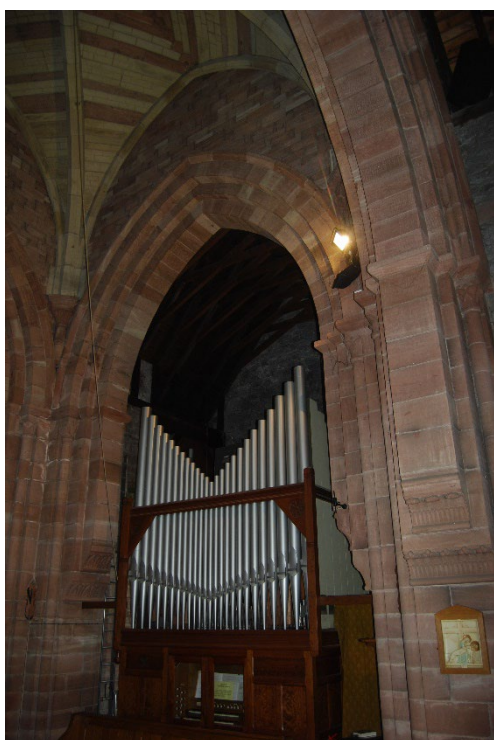
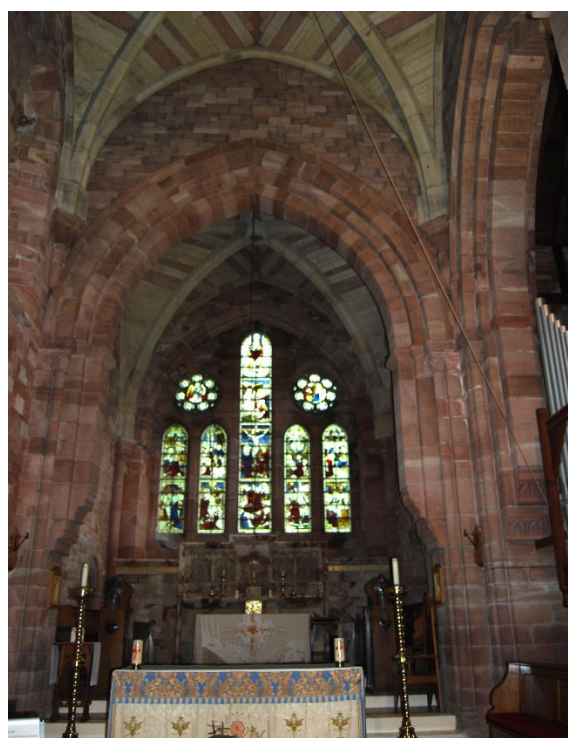
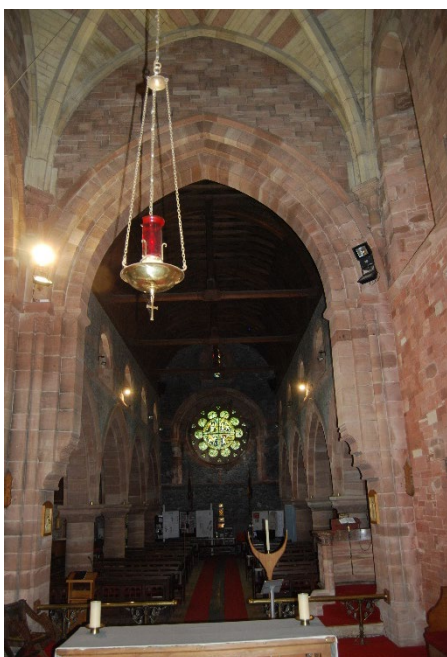
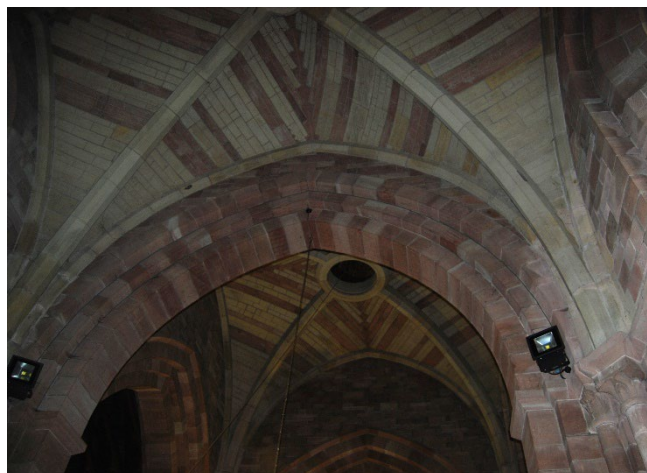
3.01 Ground Floor Level:

The walls at this level are of exposed stone masonry construction. There are almost full internal height archways in each elevation which take up almost the whole of the internal elevation widths, such that the tower is supported effectively by four substantial stone columns. The masonry appears to be in generally fair condition, consistent with its age, with no evidence of any significant cracking, recent or ongoing movement or other structural distress.

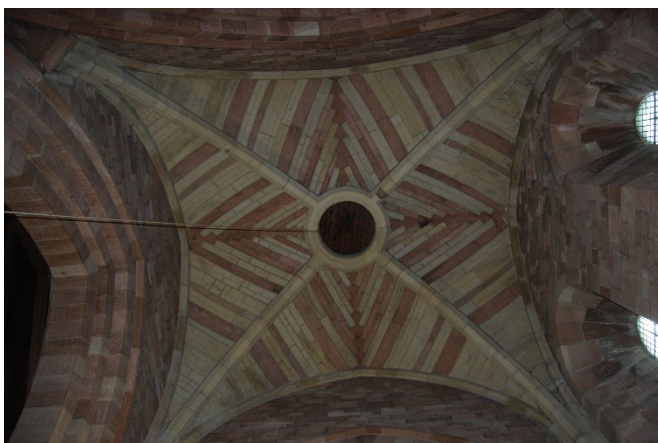
There is a vaulted stone ceiling to the ground floor chamber. This has a circular trapdoor in the centre to allow equipment to be hoisted up to the first intermediate chamber. Measurements from above showed that the trapdoor is approximately 1130mm clear diameter. Again, the masonry appears to be in generally fair condition, consistent with its age, with no evidence of any significant cracking, recent or ongoing movement or other structural distress.

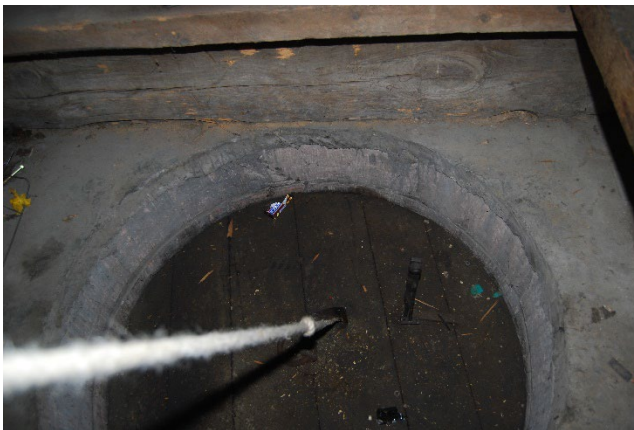
The trapdoor noted in the vaulted ceiling to the ground floor chamber is positioned below the clock case, severely limiting access.

- 5.07 The circular trapdoor in the floor of the clock chamber is immediately below the clock case, restricting access. It will therefore be necessary to temporarily remove the clock to allow for installation of the new bells and bell frame. It will also be necessary to modify the drive linkages from the clock to the clock faces when the new bells and bell frame are installed.

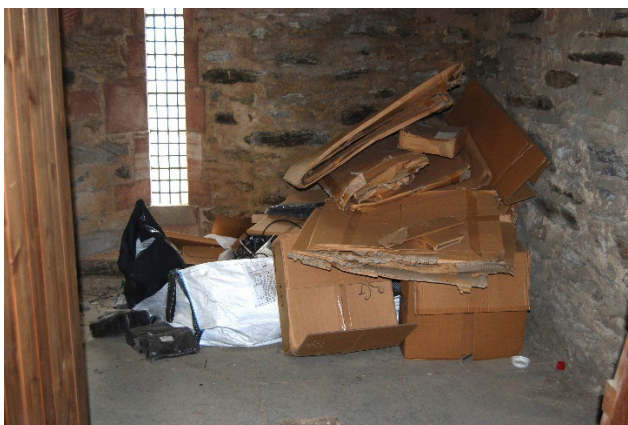
A pile of rubbish, possibly packaging from the mobile telephone equipment, has been left on the floor in the south west corner of the chamber.

- 5.08 A pile of rubbish was noted on the floor in the south west corner of the clock chamber. This could be a fire hazard and it is recommended that it is removed as soon as possible.

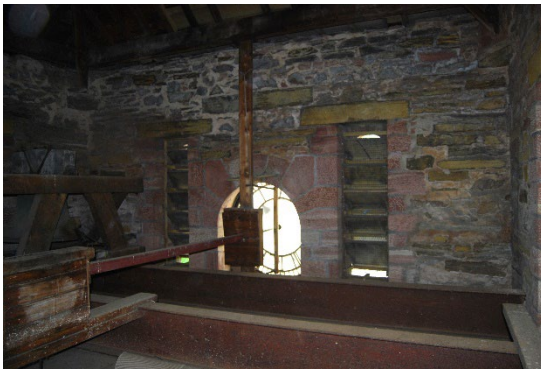
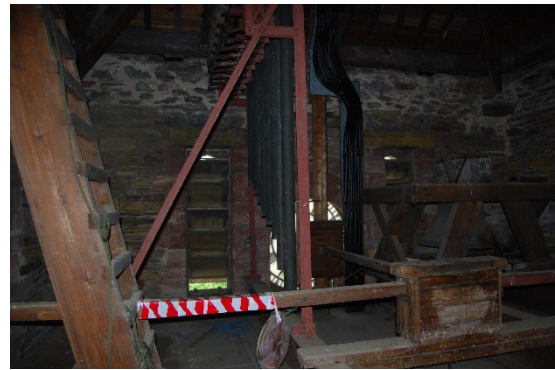
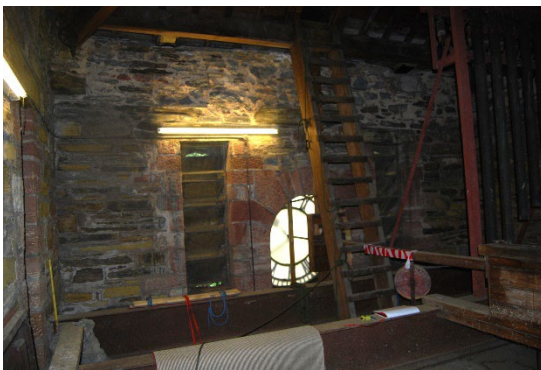
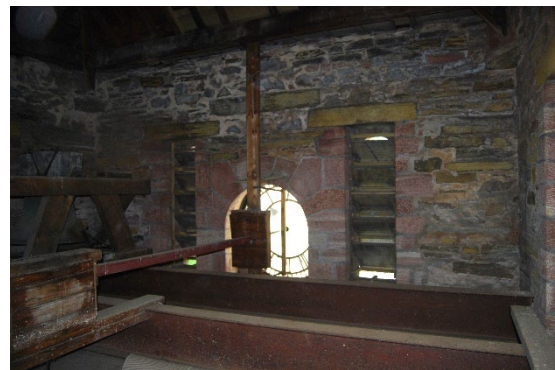
3.03 Second Intermediate Chamber (Belfry):

The walls at this level are of exposed stone masonry construction which has not been as heavily repointed as the clock chamber. The masonry appears to be in generally fair condition, consistent with its age, with no evidence of any significant cracking, recent or ongoing movement or other structural distress.

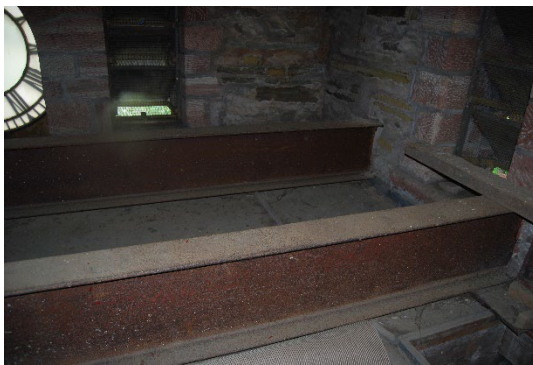
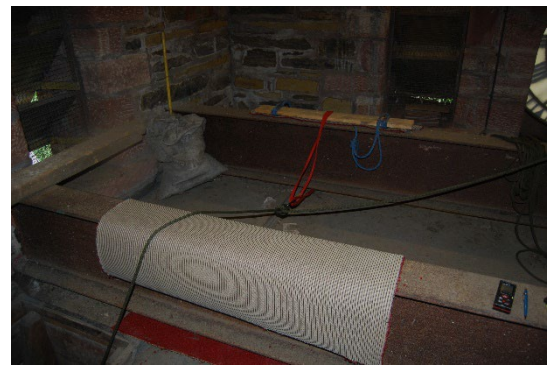
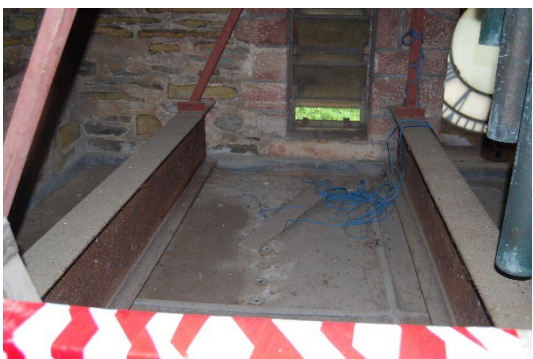
There are 4 no. steel I-section beams installed just above floor level. These run east west and are built into the east and west elevation walls of the tower. It is possible that these beams were installed originally to support a ring of bells.

- 5.03 At present, there are four steel I-section beams just above belfry floor level, running east west and built into the east and west elevation walls. The beams are imperial section, 18" x 7" and are positioned such that their soffits are just below louvre window sill level. This is at a level where the tower masonry is relatively weak due to the presence of louvre window openings in all the elevations and clock face openings in all the elevations except the west elevation wall.

In view of this, it is recommended that the existing steel beams and the belfry floor boards are removed so that a new grillage of steel foundation beams can be installed at a lower level in the tower, where the masonry is stronger. It should be possible, if desired, to retain the existing timber belfry floor support beams and install the upper, secondary, steel foundation beams running east west between them such that the tops of the beams are at, or just above, existing belfry floor level. The lower, primary, steel foundation beams can be installed running north south to support the secondary foundation beams. There are a number of competent bellhanging companies in the UK who will be able to design an appropriate twelve bell frame, together with suitable supporting beams.

- 5.04 It is of paramount importance that no differential movement is allowed to occur between the ends of the new steel bell frame foundation beams and the walls into which they are built. It is therefore recommended that the foundation beam ends are built into pockets formed in the walls of the tower and surrounded with good quality, well compacted, ordinary Portland cement concrete mixed with just enough water to make it workable. Under no circumstances should lime based concrete or lime mortared
