# JOHN TAYLOR & CO.,

Our Ref: CB/cb/488/11

23rd September 2022

### **CHURCH OF ST TEGAI, LLANDEGAI – The Bells**

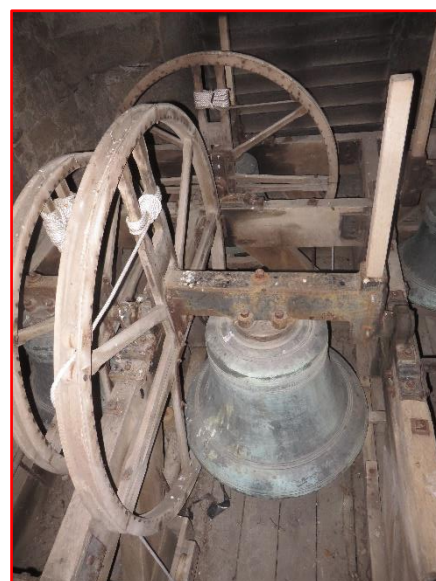
GENERAL VIEW OF THE TENOR BELL SHOWING  
MANY OF THE FITTINGS DESCRIBED

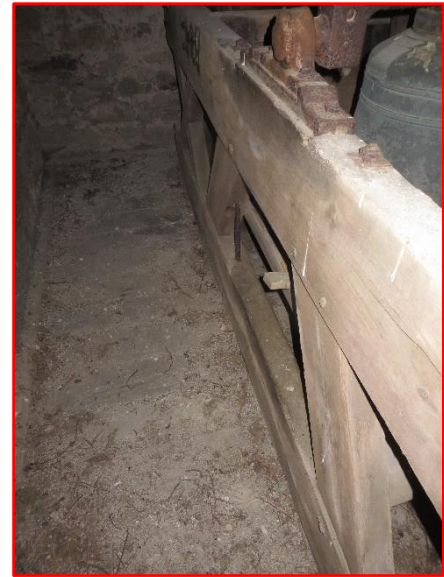
The wood of the bell frame has minor splits and small areas of insect attack in places but is generally in good condition. The iron fixings have surface corrosion but are not badly degraded. Although I did not systematically check the frame fixings the sample nuts that I tested were not rusted-up and could be turned.

To summarise on the bell frame, it is in reasonable condition but requires general maintenance work. If this is done it should provide many more years of service.

OUTSIDE OF TREBLE FRAME SIDE SHOWING INCLINED BRACES, HEAD, CILL AND X-BRACE ACROSS END OF SECOND PIT

Thoroughly clean down the headstocks, bearing housings, wheel reinforcing bars, tie rods, clamps, bracing angles and any other iron fittings, to remove all dirt, rust, and loose areas of paint. Treat any badly corroded areas with a fluid rust inhibitor. Paint all accessible parts of the frame and all metal fittings with a primer/undercoat and gloss topcoat.
