NAVE, PORCH, TOWER & PASSAGE: GROUND FLOOR PLAN

Notes and photographs taken from site visit in May 2023.

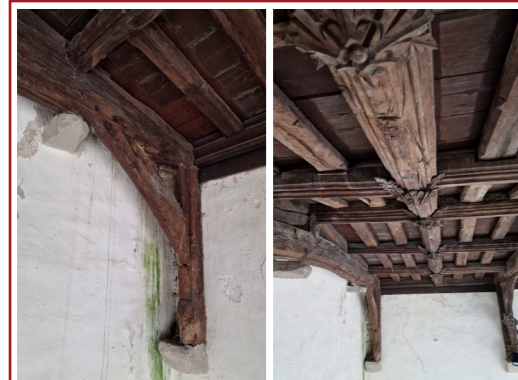
Nave: North-west corner - timbers and plaster
Noted additional decoration to these timbers is in contrast to others, appears older / all connected with traditional oak pegs (subsequent repairs not so apparent). No significant signs of water ingress or staining. Signs of wood boring insect, and timbers rotten in areas, but need to establish if this is historic insect / rot. No major staining or dampness to plaster, and no major loose parts or detachment in this corner. (Action required to investigate the timbers and liaise with an archaeologist).

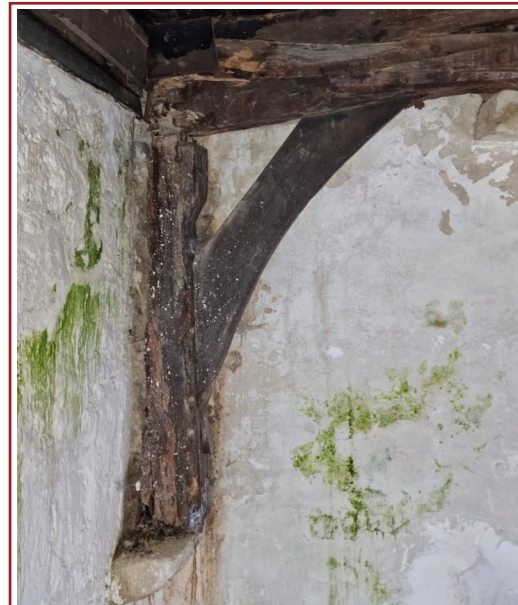
Nave: South-west corner - timbers and plaster
Signs of water ingress and staining. Signs of wood boring insect, and timbers soft and rotten in areas where damp, including to the ceiling boards immediately above. Need to establish history of previous repairs (or at least which members are still loadbearing, and if it matters that they have lost their connection). Some staining and dampness to plaster, but no major loose parts or detachment in this corner. Areas above at roof level to be investigated in detail. Loose plaster to be removed and repaired once fabric has dried out. Investigate structural timbers. (Action required to investigate roof above and timbers).

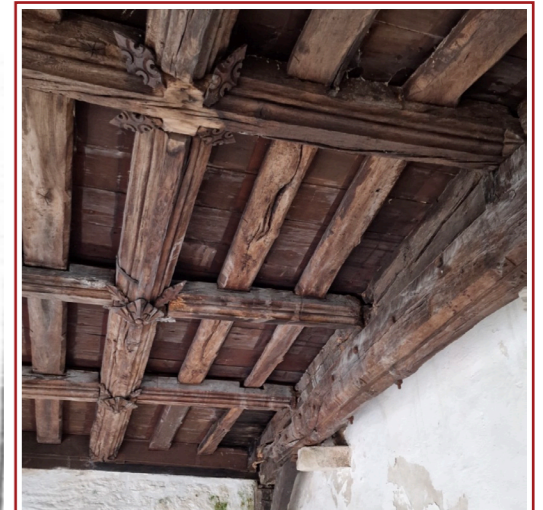
Nave: Timber ceiling bosses.
These appeared loose in many areas. One was removed to the centre (as it was very loose) and given to Rev Rosie Dymond for safe keeping until repairs and reinstatement can be organised. The remainder should each be individually checked for Health & Safety reasons, and the removed piece returned back to its original position and secured safely. (Action required to investigate the ceiling bosses).

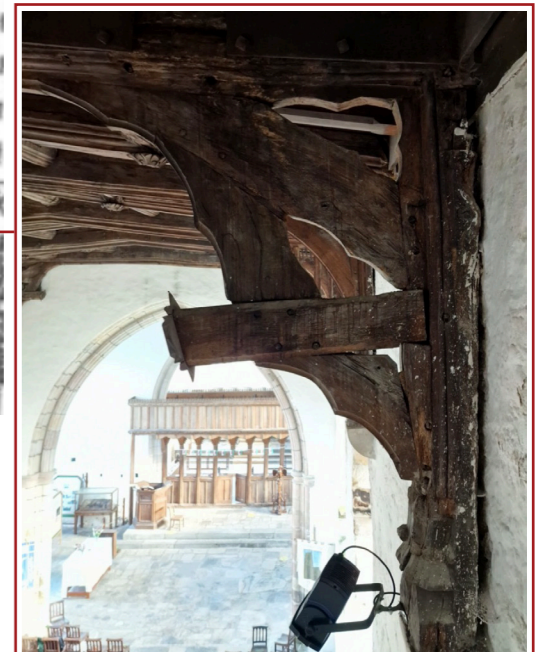
Nave: Other timbers in south-west
There are signs of wood boring insect to areas within purlins, and to uprights, but timber members do not appear significantly compromised or loose. Unsure if insect is active or not. No significant or obvious signs of water ingress from lift position to either area. (Action required to investigate timbers).

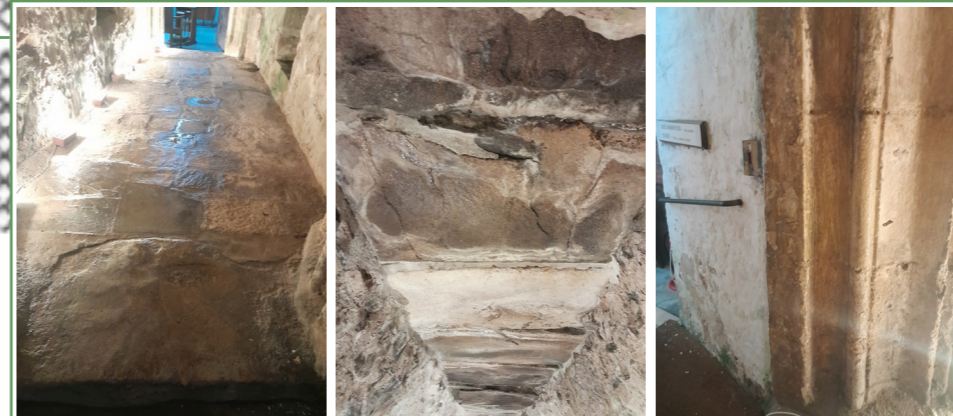
Passage: Area of recent water ingress
Photographs from site visit January 2024.
