NORTH TRANSEPT, CROSSING, CHANCEL & SOUTH TRANSEPT: GROUND FLOOR PLAN

Notes and photographs taken from site visit in May 2023.

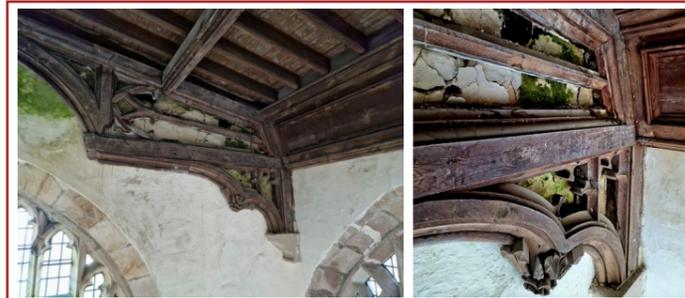
North Transept: North-east corner - timbers and plaster
Signs of water ingress and staining. No obvious signs of wood boring insect yet, and timbers not generally soft but were damp in areas, including to the ceiling boards. Staining and dampness to plaster generally, with significantly loose parts and detachment of localised patches to top length of north transept and in this corner. Areas above at roof level to be investigated in detail. Loose plaster to be removed and repaired once fabric has dried out. (Action required to investigate above).

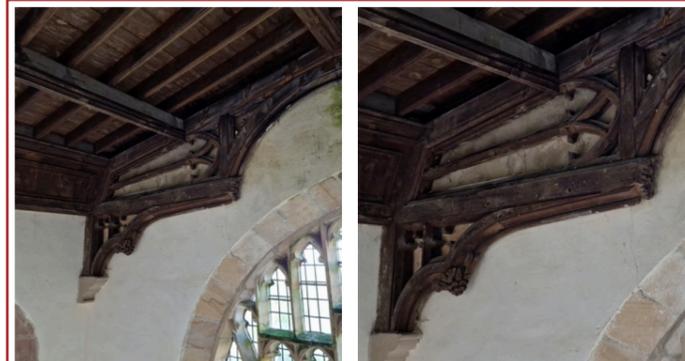
North Transept: North-west corner - timbers and plaster
Not possible to see any significant areas of water ingress or staining. Plaster appeared to be stable and not loose. All breathable and in lime plaster. In the time allowed, decided not to investigate closer, to allow time to move the lift to the nave, and prioritise completing survey to areas of greatest concern within day allowed for lift hire.

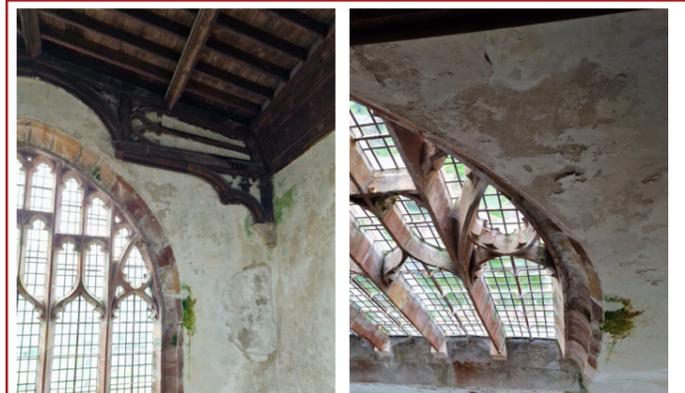
South Transept: South-west corner - timbers and plaster
No obvious signs of wood boring insect or softness to timbers. Staining and dampness to plaster, detachment of plaster in localised patches to base of kneeler stone and at high level in corner, but timbers appeared fine if not stained a little. Plaster appeared generally fair, parts loose to the corner.

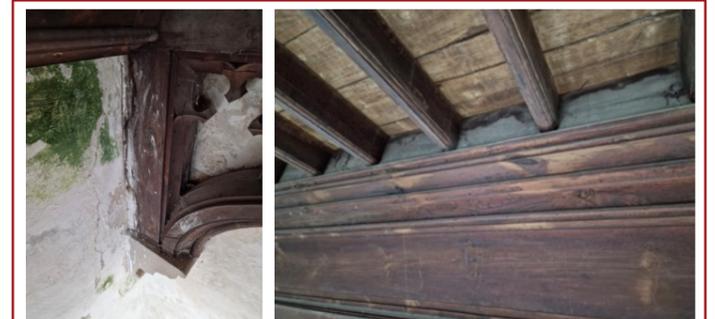
South Transept: Top of east wall - timbers and plaster
No obvious signs of wood boring insect or softness to timbers. More significant staining and dampness in corner, but timbers appeared generally fine overall. Areas above at roof level to be investigated in detail. (Action required to investigate above).

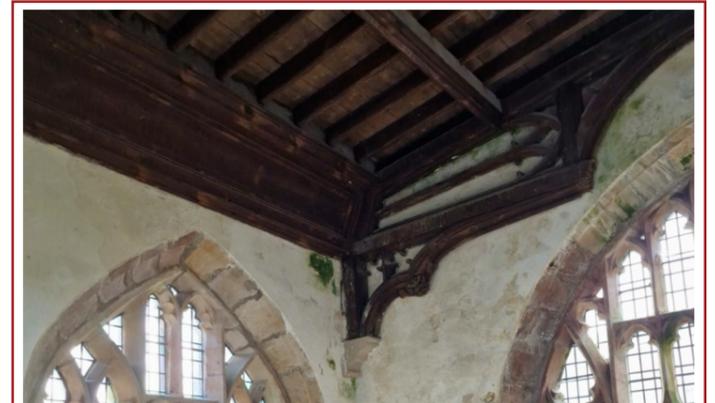
South Transept: South-east corner - timbers and plaster
No obvious signs of wood boring insect or softness to timbers. Staining and dampness to plaster, detachment of plaster in localised patches at high level in corner to base of kneeler, but timbers appeared fine if not stained a little. Plaster appeared generally fair.

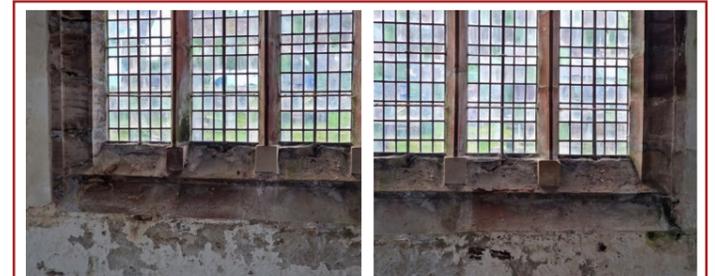
South Transept: W05
Base of ferramenta bars have blown the cill profiles in all positions. Repairs required to cill and base of mullions, in line with Ezra recommendations.
