# Bro Celynnin

## Ezra Report

Management and Maintenance Plan for Period 2024 - 2029

Conducted by  
Bethan Jones  
Swyddog Eiddo Archddiaconiaeth | Archdeaconry Property Officer

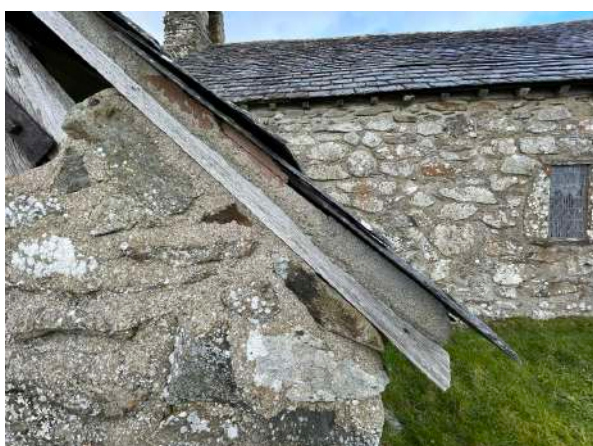
Generally in fair condition, there are slipped and cracked slates in places. Number of loose slate course – east corner of porch and North-east of north Chapel. There is missing slate to centre of NW roof slope of North chapel (internally there is evident of water ingress).

Valley are in good condition, new lead spitters have been installed to take the water away from the building.

Allow to fix all loose and cracked slates. B

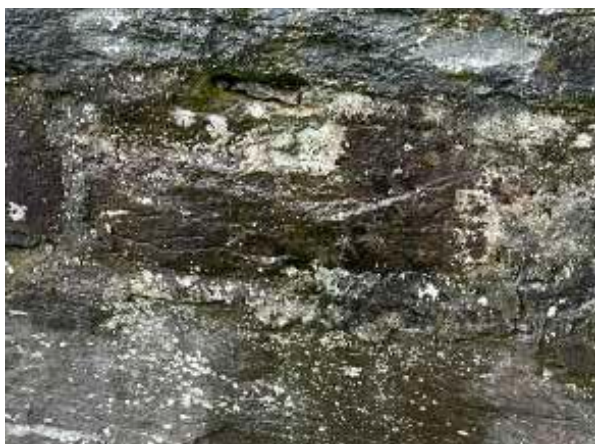
Walls generally in good condition with no obvious evidence of movement. There is evidence that buttress to Nave is trapping moisture in Nave wall.

Slate caps to both buttresses have come loose, only mortar fixing the top.

Condition of west gable wall is in poor condition. Although it wasn't raining during inspection, previous day of heavy rain was visible on the west gable. The wall was wet to the touch, especially to bottom of South-west corner. Cementitious pointing is visible in areas of west wall and section of mortar has cracked in this corner.

Allow to continue monitoring movement and small cracks to external walls by tell-tale monitor. B

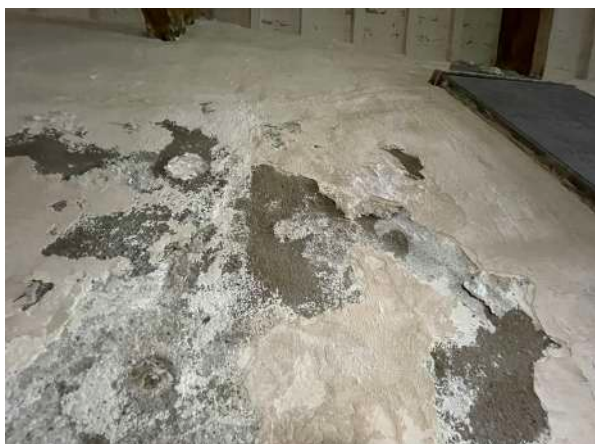
The plaster work to all walls is in poor condition and showing signs of inappropriate cement plaster and non-breathable paint applied in past alterations. Evidence of damp to finishes particularly within window reveals. North wall of nave and east wall of North chapel are particularly poor, with plaster to lower walls to chapel breaking away in large sections.

West wall, - green staining and wet. There is a worrying sign of damp to the SW corner by the door frame where the plaster is light brown. Timber lintol to door (west corner) showing signs of rot.

Allow to remove all plaster to walls and make good. B

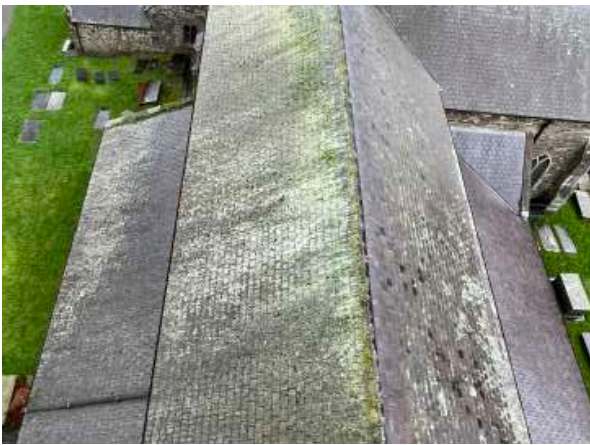
The condition of the slate roof and lead work is generally in good. The ridge lines are level. There are a small number of broken slates to both roof slopes, S2 and W2.

Valleys - south west lead valley, between roof slope S2 and W2, is in good condition, and clear of debris. There are slipped slates and debris in valley between E2 and S2 and vegetation at end of valley and between S1 and E2.

As stated in previous report, a small section of the flashing projecting stone, to roof slope S2, has fractured and broken away. At present this does not appear to be compromising the flashing detail.

There is vegetation approximately midway to the underside of this projecting stone.

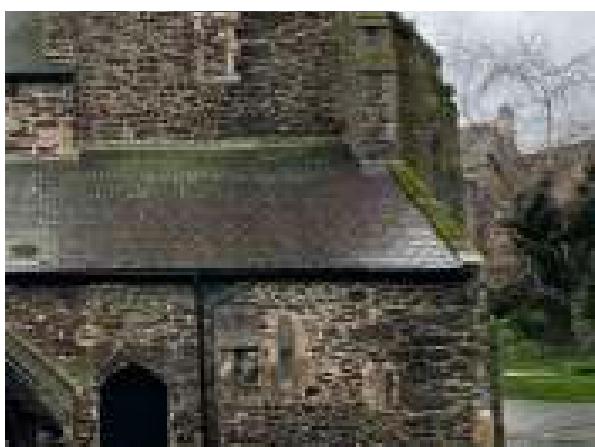
The condition of the slate roof is generally in good. There are a small number of isolated and broken slates.

Lead flashing has come loose between tower and nave wall.

There is a large area of organic growth west side of the roof slope, adjacent to the base of the tower. And also on east and west coping stones.

The leadwork and coping stone along the western verge have been recently repaired and repointed. The stonework of the coping stones on the eastern verge appears to be in fair condition. There is vegetation on the slate roof to west of north porch.

- Roof slope N4 - Replace broken slates. B
- Clear vegetation along coping stones on east and west elevation of N4. D
- Renew lead flashing between tower and nave wall (N4). B

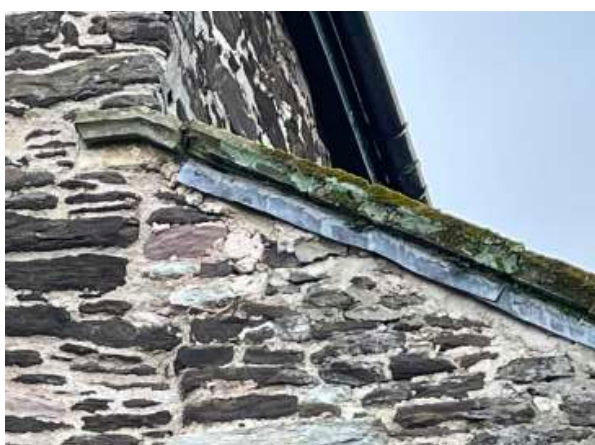
The condition of the slate roof is generally in good. There are a small number of broken slate to both roof slopes to N3. The ridge line is level.

The stepped lead soakers to the southern side of roof slope E1 are in poor condition.

There is missing mortar to the underside and between the stone copings generally thus allowing vegetation to grow.

| Replace broken slates. | B |
| Replace stepped lead soakers along the southern side of roof slope E1. | B |

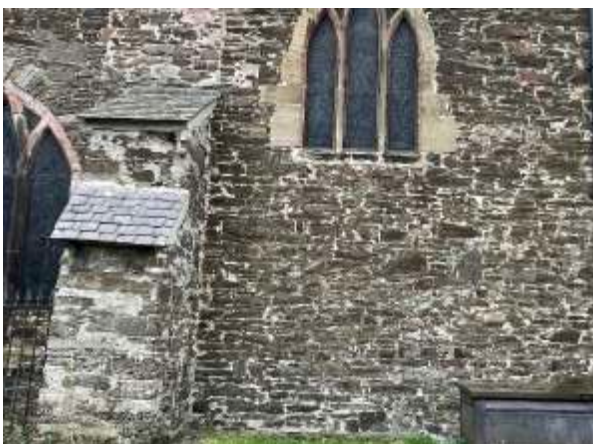
To north buttress, there are a number of cracked and loose slates and evidence of former ivy growth on the east face of the buttress. The condition of the pointing mortar is poor.

Vegetation growing under window SI, and corner between south nave and south transept.

*As stated in last Ezra report.*

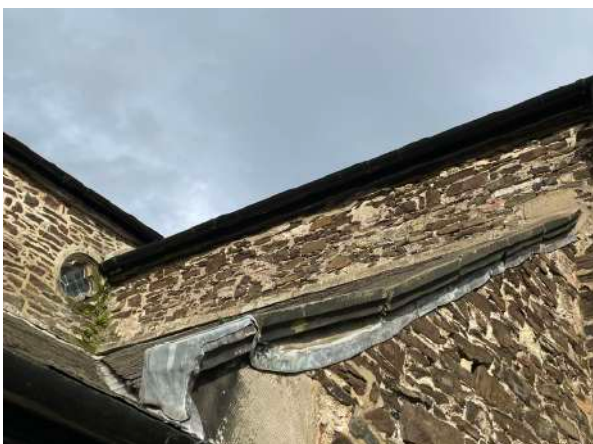
On the south elevation the masonry is in poor condition with a large number of the masonry weathered back from the pointing mortar. There are large voids to the upper right side of the gable under the coping stones and to lower left hand side of coping stone. The pointing mortar appears inappropriate and too strong for the masonry it surrounds thus there is a vertical crack between end corbel stone and pointing. The finish is also very poor with little aggregate visible which could affect the porosity of the mortar. Staining from mesh guard also.

Weathered stone to base of south-west buttress.

East elevation: Repoint all voids using an appropriate lime based mortar. B

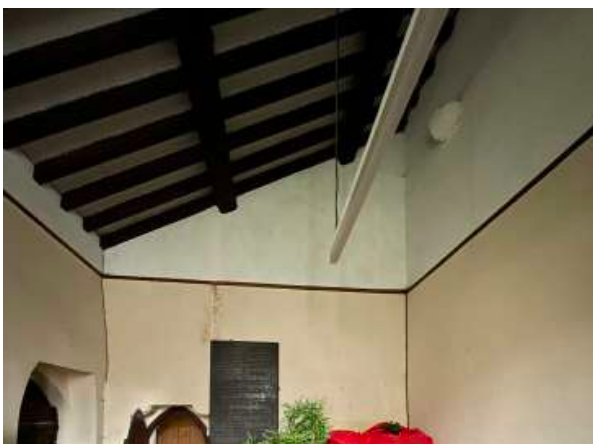
Past alterations, the plaster between rafters have been replaced by possibly sheet containing asbestos.

The ceiling generally appears to be in good condition. There does not appear to be any movement to the timbers. Some discolouration to some sheets.

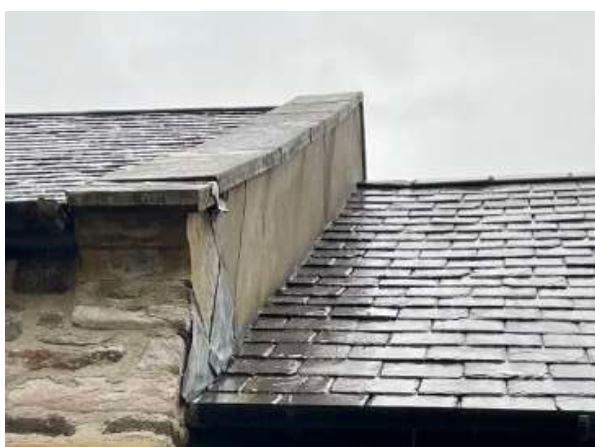
North gable, west side of cellar door, there are missing pointing to low level stonework.

As recommended in previous report, infill high level open voids to south elevation of Chancel (adjacent to door to South transept) using lime mortar. In the same location, replace missing and loose sections of hung stone slates fixed to the face of the timber wall plate. B

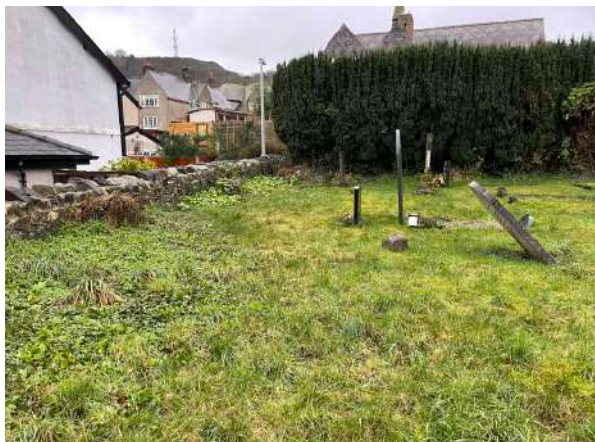
Tarmac in good condition. Grassed area with heavy foot traffic very muddy and slippery.

It would be a shame to spoil the aesthetic of the east side of the churchyard by continuing the tarmac path to connect to the public footpath. Maybe consider extending the path to cover the south transept gable with introducing ground membrane and gravel-based material.

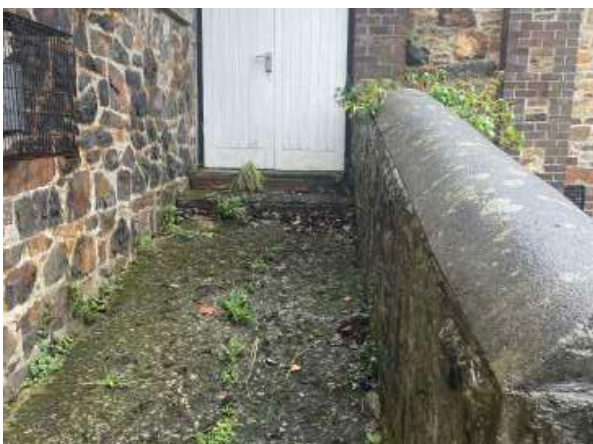
The concrete yard to the rear is in a very poor state with vegetation growing everywhere and open cracks making whole area and health and safety issue.

Reconfigure ramp to G08. Extend the ramp to remove 2 steps and lay appropriate surface grip. Introduce a handrail along the stone wall. A
