St Mary Church, Llanfair-yng-Nghornwy – Grade I

Prepared by Bethan Jones Swyddog Eiddo Archddiaconiaeth | Archdeaconry Property Officer

Investigative works to timbers and valley

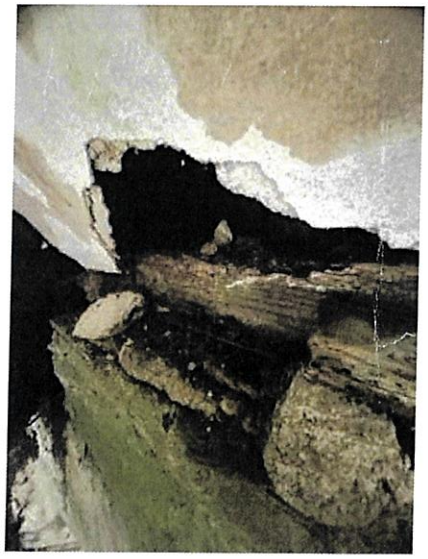
14.08.25 investigation, 9:30, heavy downpoor allowed us to see water dripping. (sample of wood in box).
In yellow there is a pound coin size hole.
