# St Benedict Church, Gyffin

RIBA Stage 03 - Design Report and Statement of Significance

# Gyffin, St Benedict

## Detailed Comment

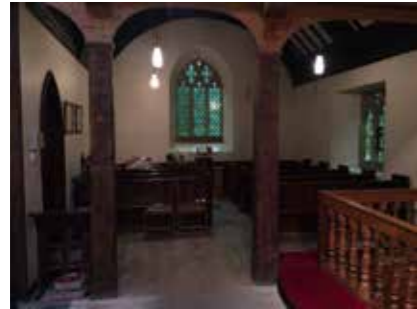
The ceiling is generally in good condition.

The medieval boarded wagon roof is set below the main roof line with a void above. We understand that the area above the boards were cleaned and consolidated during the works in 1991. A specialist report, prepared in 1991 includes a series of photographs of the figures. The condition assessment of this medieval ceiling should be undertaken by a specialist paint conservator who can

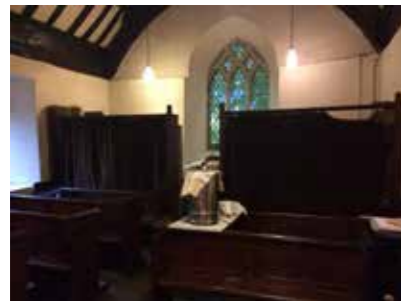
The south transept dates from the 16<sup>th</sup> century. Three arched braced trusses supporting purlins on oak spars spanning between them. All painted black. The ceilings between are plastered.

The ceiling is generally in good condition.

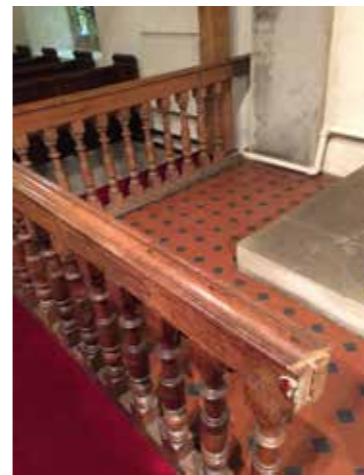
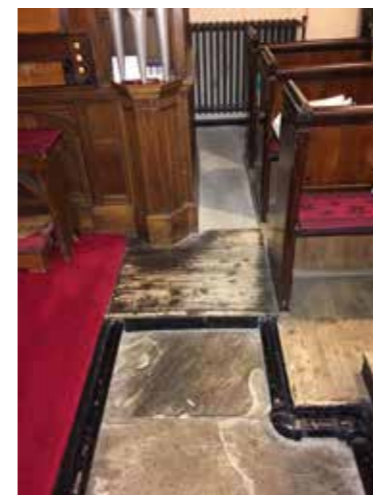
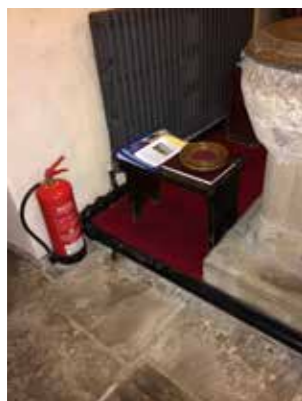
There is new stone flag floor along the centre of the space and a level timber floor beneath the pews.

The floor is in good condition.
