STRUCTURAL REPORT

Client: Church of St Mary, Betws-y-Coed, PCC

Project: Structural Inspection of the Tower

REPORT OF A STRUCTURAL INSPECTION OF THE TOWER AT THE CHURCH OF ST MARY, BETWS-Y-COED, CONWY, WALES

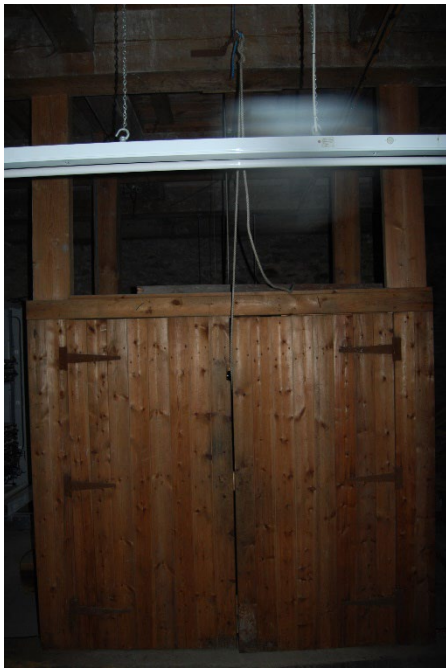
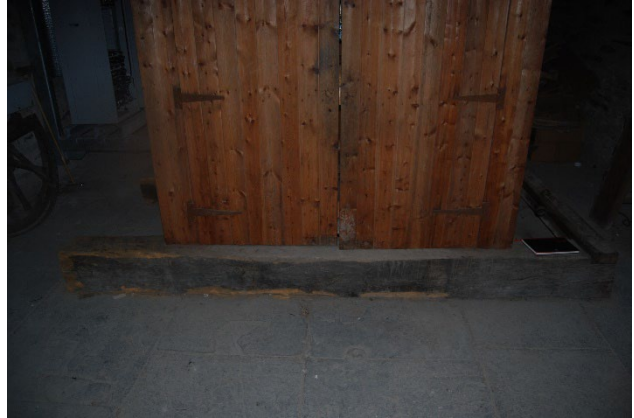
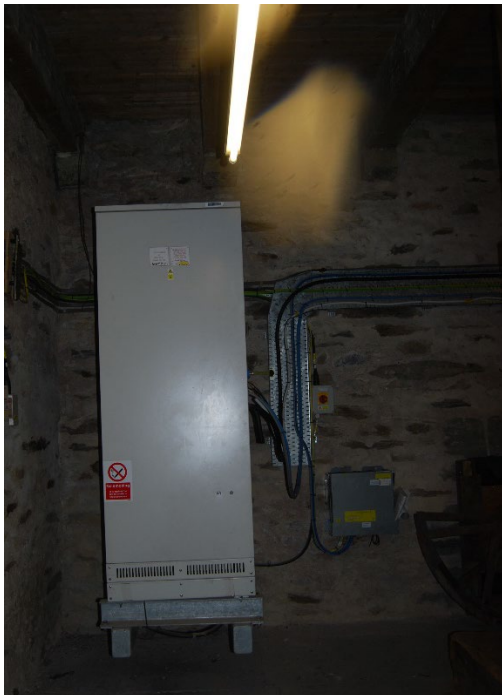
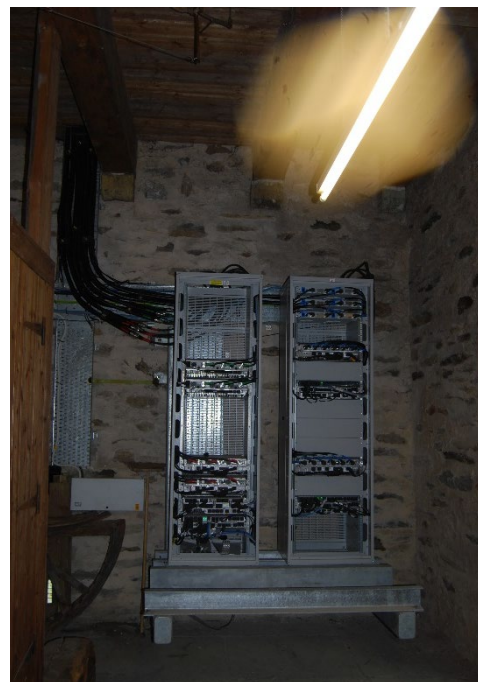
3.02 First Intermediate Chamber (Clock Chamber)

This chamber houses the clock mechanism, which stands in a wooden case and is supported on two timber spreader beams which run east west and bear onto a solid stone-flagged floor.

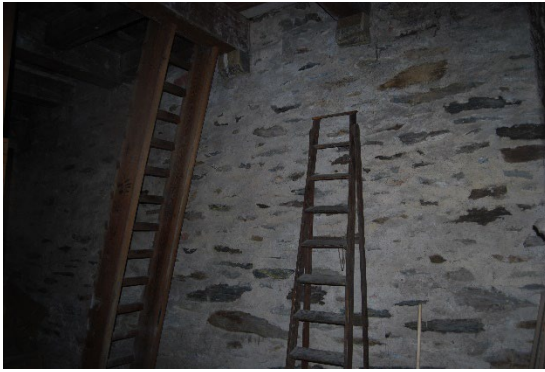
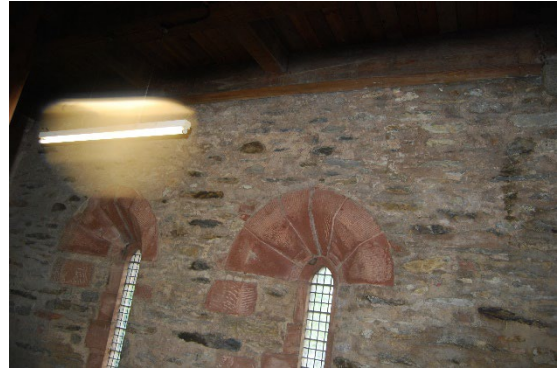
The chamber also houses mobile telephone equipment which stands on the floor adjacent to the east elevation wall.

The walls at this level are of exposed stone masonry with rather heavy “butter” pointing. The masonry appears to be in generally fair condition, consistent with its age, with no evidence of any significant cracking, recent or ongoing movement or other structural distress.

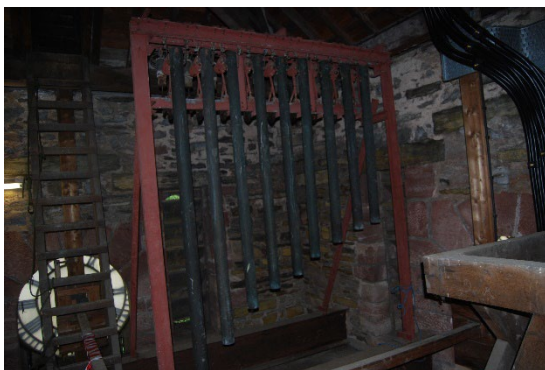
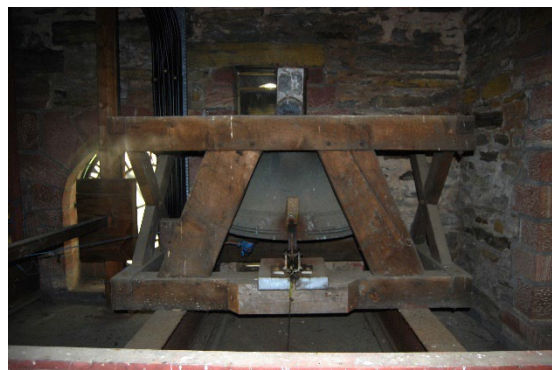
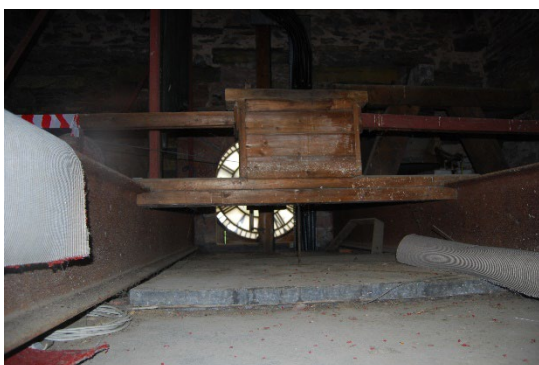
There are 4 no. steel I-section beams installed just above floor level. These run east west and are built into the east and west elevation walls of the tower. It is possible that these beams were installed originally to support a ring of bells.

At present, the beams support a ring of nine tubular bells hung in a metal frame, a bell hung for static chiming in a timber frame and the clock drive linkage mechanism.

In view of this, it is recommended that the existing steel beams and the belfry floor boards are removed so that a new grillage of steel foundation beams can be installed at a lower level in the tower, where the masonry is stronger. It should be possible, if desired, to retain the existing timber belfry floor support beams and install the upper, secondary, steel foundation beams running east west between them such that the tops of the beams are at, or just above, existing belfry floor level. The lower, primary, steel foundation beams can be installed running north south to support the secondary foundation beams. There are a number of competent bellhanging companies in the UK who will be able to design an appropriate twelve bell frame, together with suitable supporting beams.
