NAVE, PORCH, TOWER & PASSAGE: GROUND FLOOR PLAN

Notes and photographs taken from site visit in May 2023.

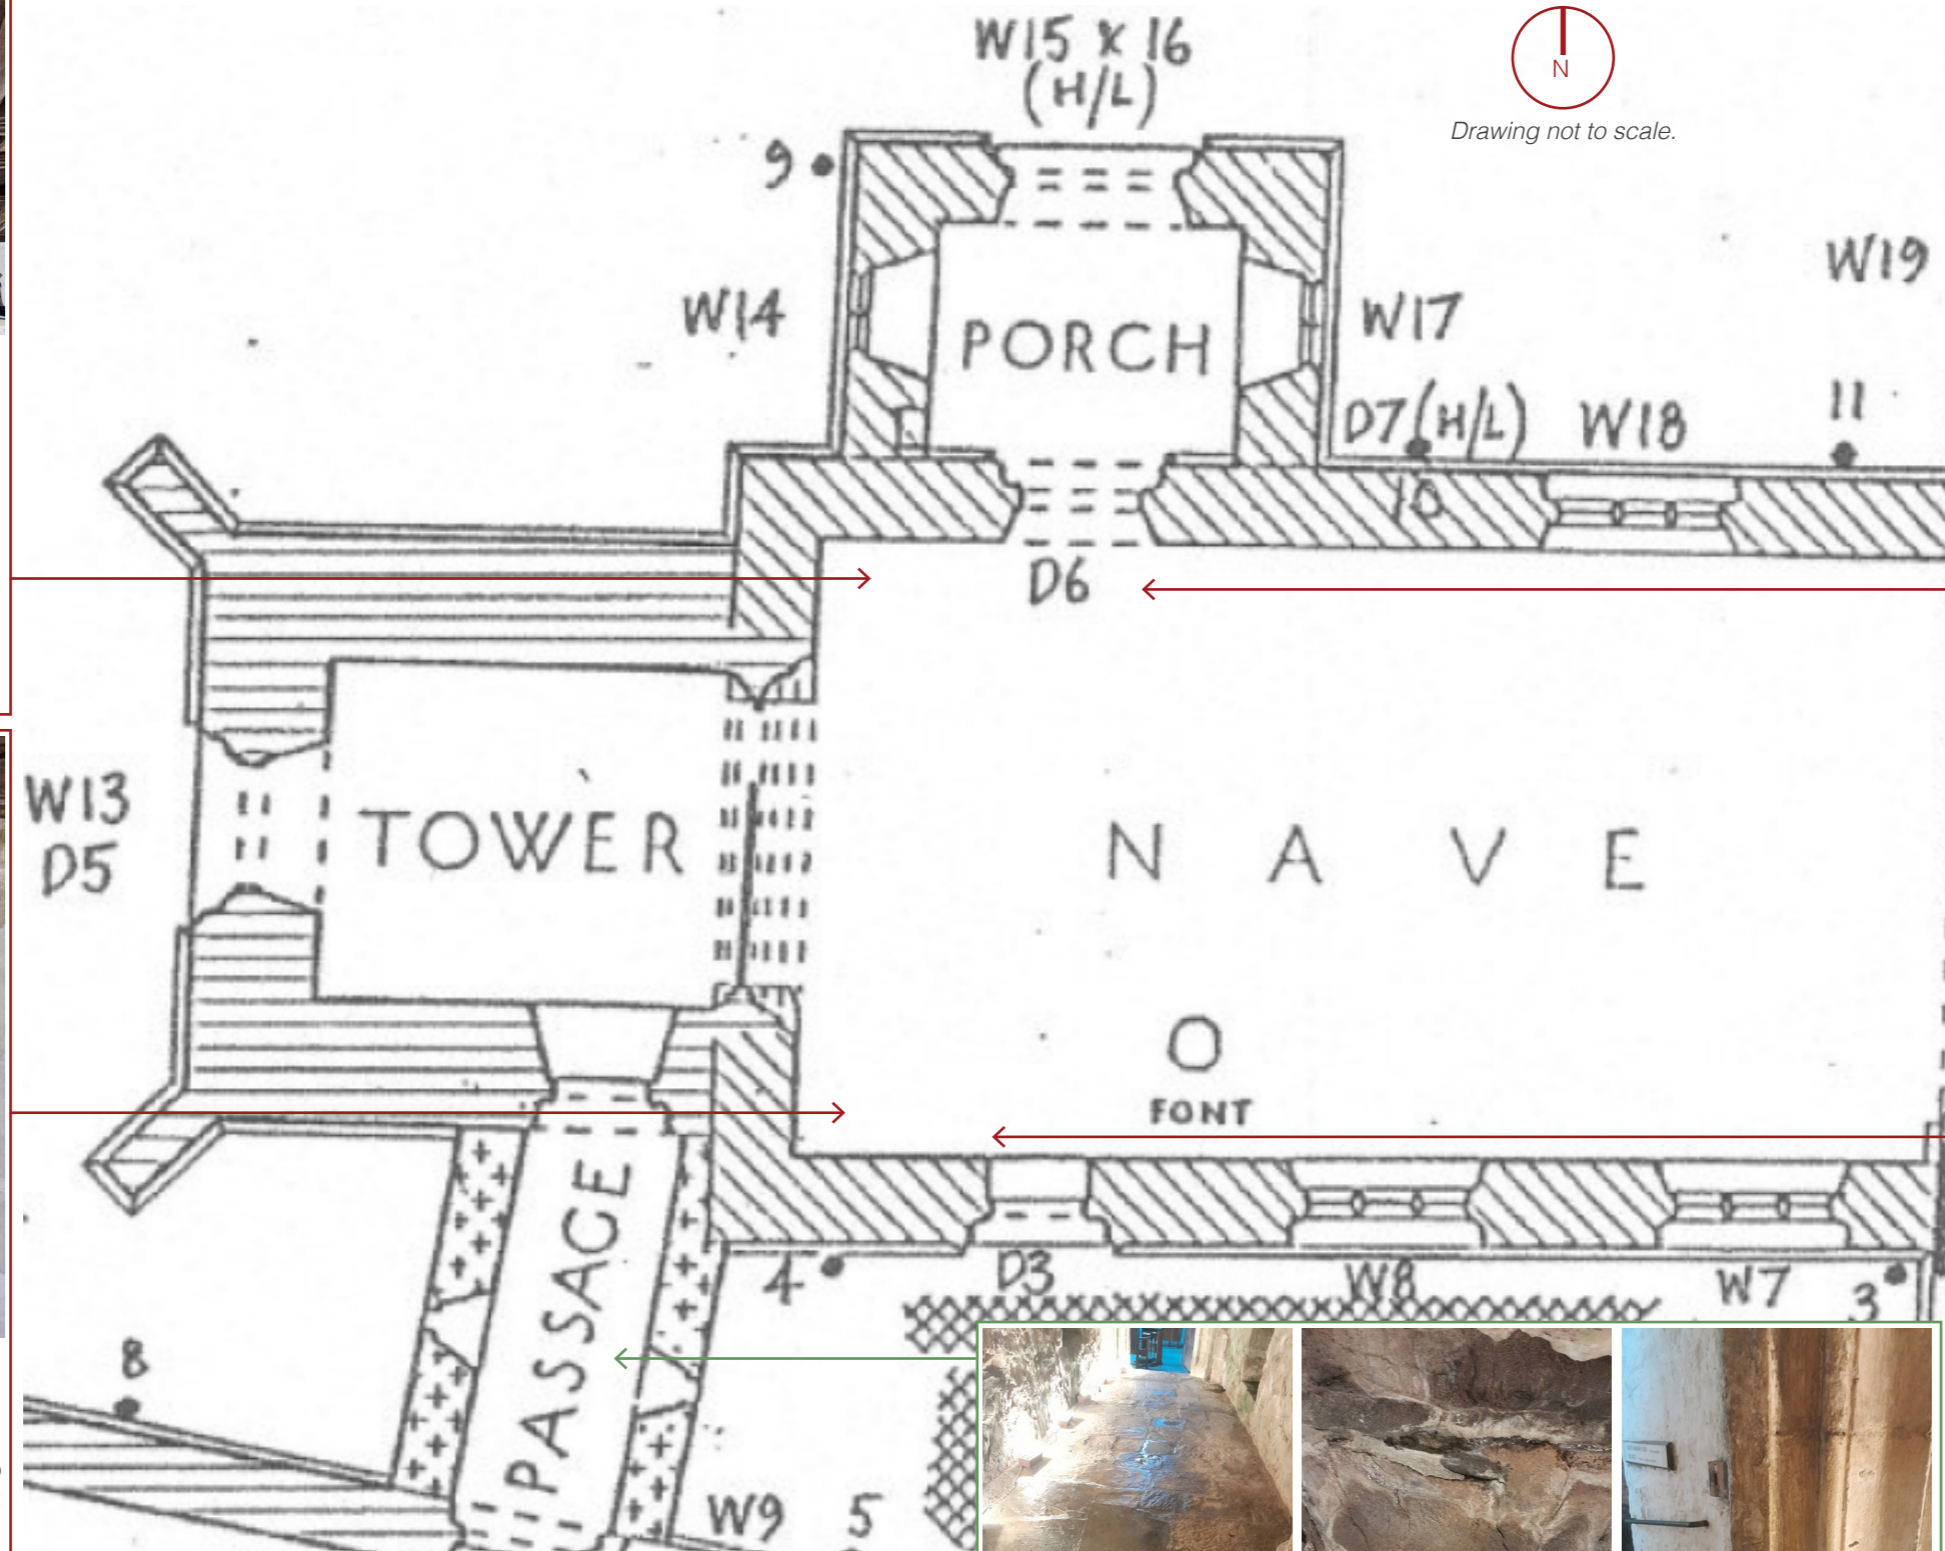
Nave: South-west corner - timbers and plaster
Signs of water ingress and staining. Signs of wood boring insect, and timbers soft and rotten in areas where damp, including to the ceiling boards immediately above. Need to establish history of previous repairs (or at least which members are still loadbearing, and if it matters that they have lost their connection). Some staining and dampness to plaster, but no major loose parts or detachment in this corner. Areas above at roof level to be investigated in detail. Loose plaster to be removed and repaired once fabric has dried out. Investigate structural timbers. (Action required to investigate roof above and timbers).
