NORTH TRANSEPT, CROSSING, CHANCEL & SOUTH TRANSEPT: GROUND FLOOR PLAN

Notes and photographs taken from site visit in May 2023.

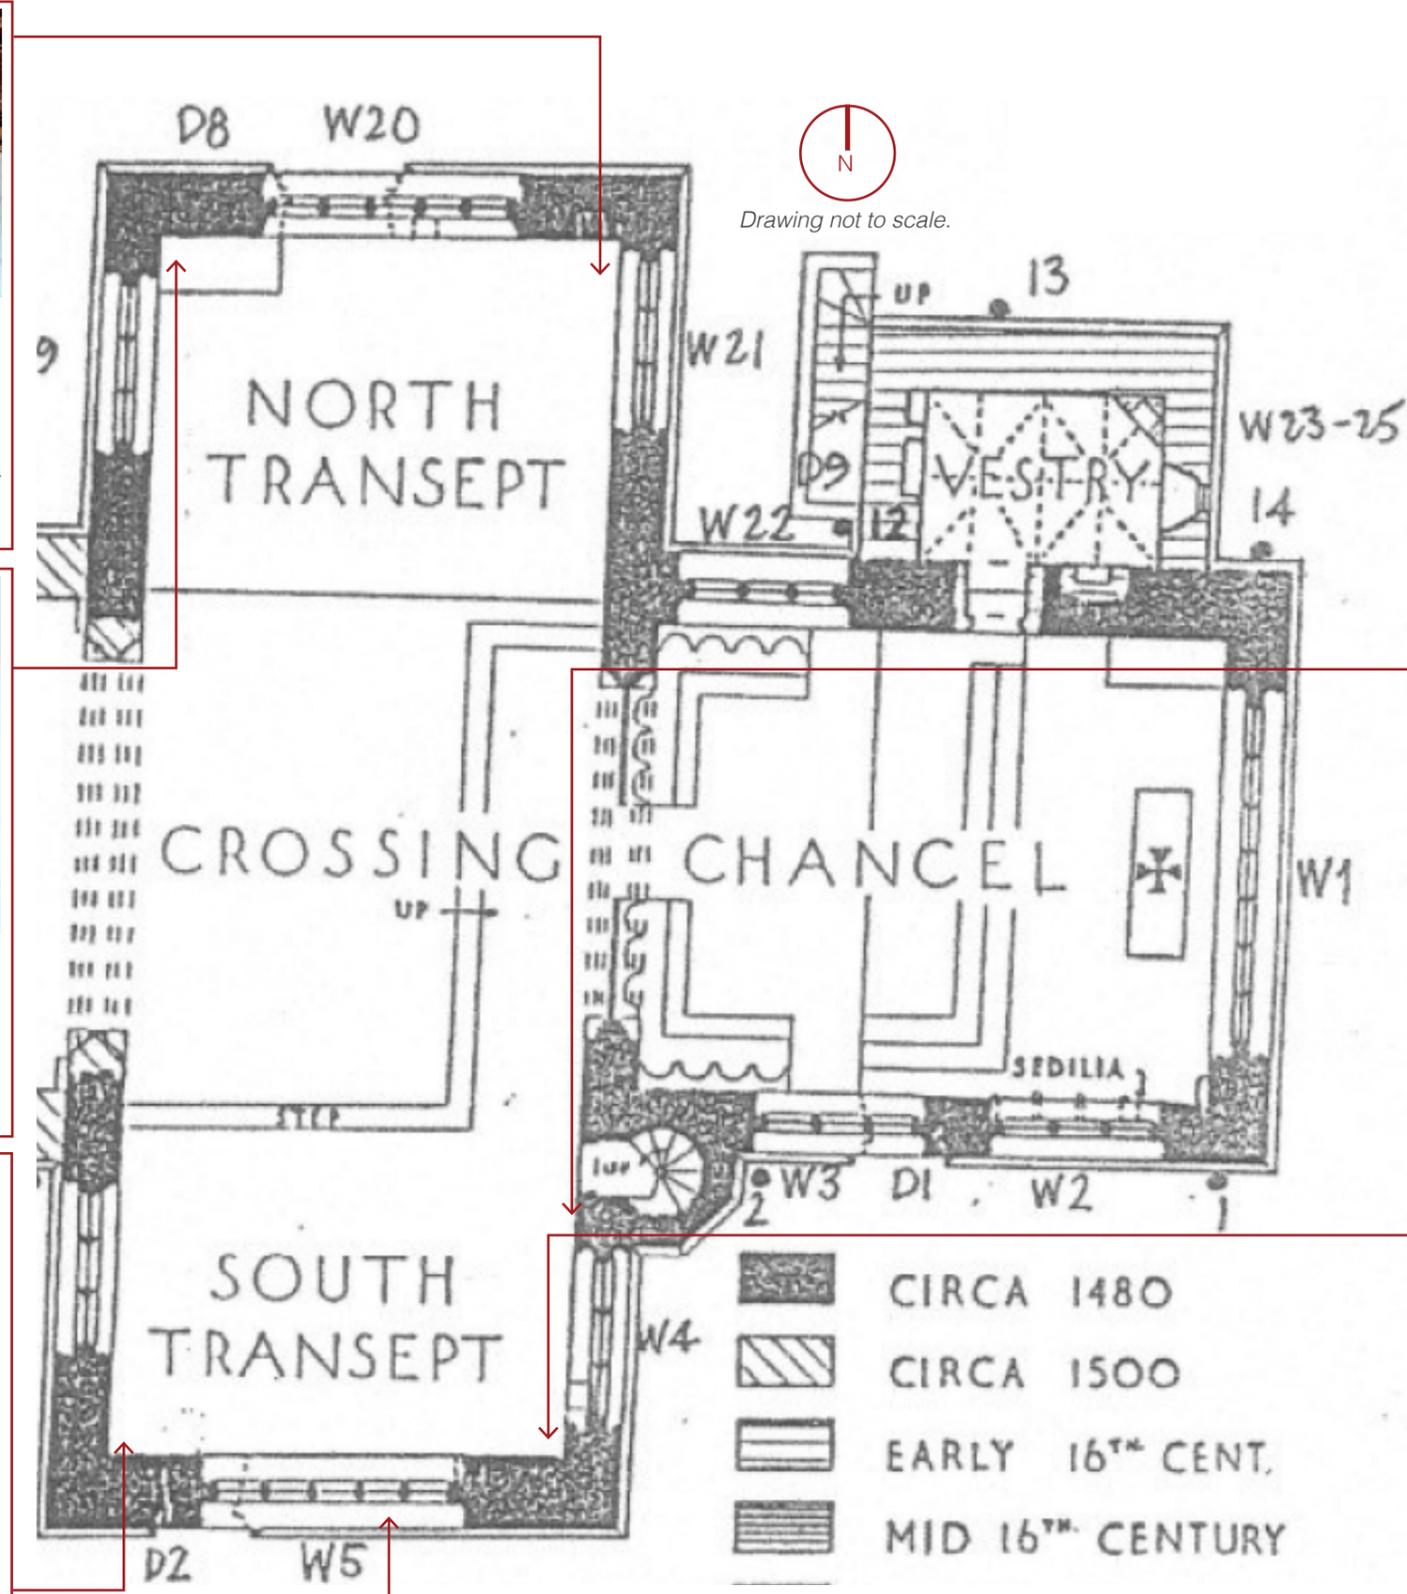
South Transept: South-west corner - timbers and plaster
No obvious signs of wood boring insect or softness to timbers. Staining and dampness to plaster, detachment of plaster in localised patches to base of kneeler stone and at high level in corner, but timbers appeared fine if not stained a little. Plaster appeared generally fair, parts loose to the corner.
