# Bro Celynnin

## Ezra Report

Management and Maintenance Plan for Period 2024 - 2029

Conducted by  
Bethan Jones  
Swyddog Eiddo Archddiaconiaeth | Archdeaconry Property Officer

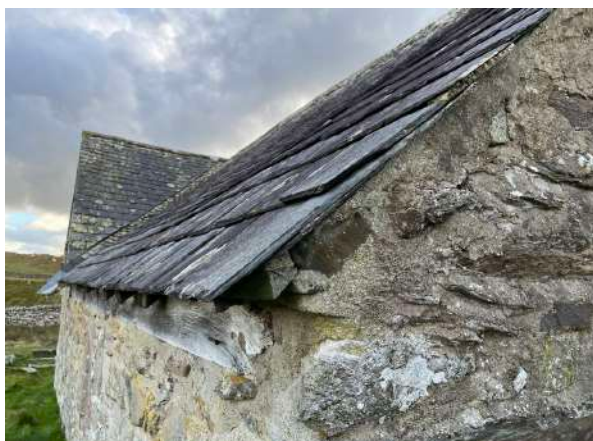
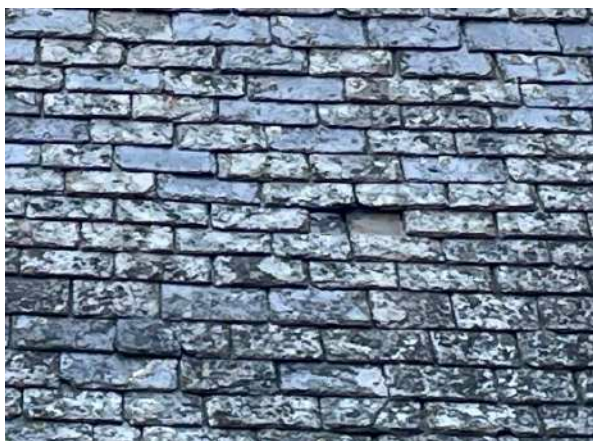
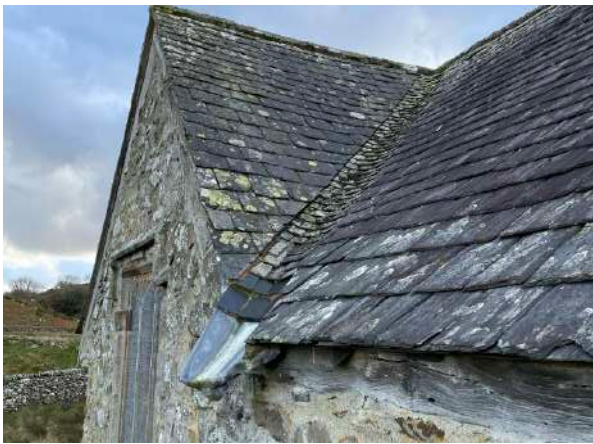
Generally in fair condition, there are slipped and cracked slates in places. Number of loose slate course – east corner of porch and North-east of north Chapel. There is missing slate to centre of NW roof slope of North chapel (internally there is evident of water ingress).

Valley are in good condition, new lead spitters have been installed to take the water away from the building.

Allow to fix all loose and cracked slates. B

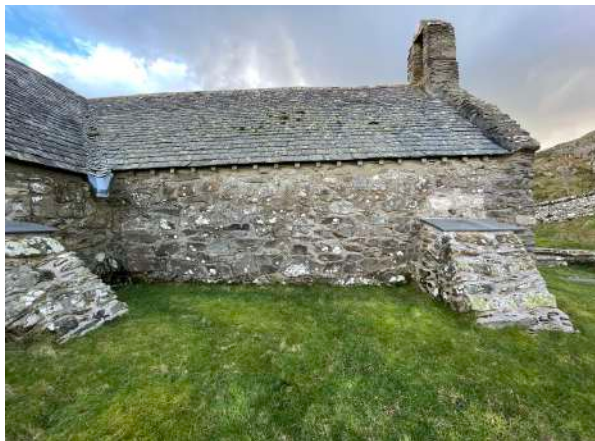
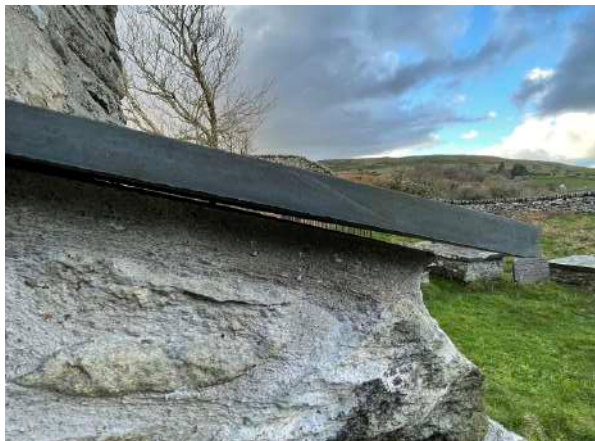
Random rubble masonry walls, generally still pointed in lime mortar. North chapel - Significant lean to north gable wall appears to have settled itself with no obvious evidence of fresh movement.

Walls generally in good condition with no obvious evidence of movement. There is evidence that buttress to Nave is trapping moisture in Nave wall.

Slate caps to both buttresses have come loose, only mortar fixing the top.

Condition of west gable wall is in poor condition. Although it wasn't raining during inspection, previous day of heavy rain was visible on the west gable. The wall was wet to the touch, especially to bottom of South-west corner. Cementitious pointing is visible in areas of west wall and section of mortar has cracked in this corner.

Allow to continue monitoring movement and small cracks to external walls by tell-tale monitor. B

Rake out cementitious pointing to west wall and repoint with lime mortar. B

Refix slate caps to both buttresses. B

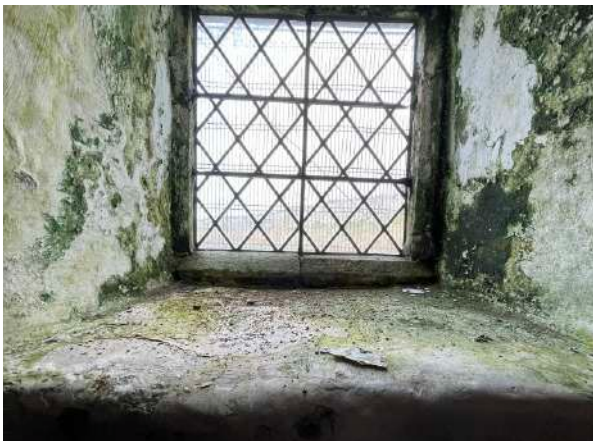
nlll – in very poor condition. There are green staining and peeling paint /plaster to window surround. Timber lintol is rotten and there is a crack to centre of cill.

Consult with a timber specialist to repair rotten timber lintols to sll and nlll. B

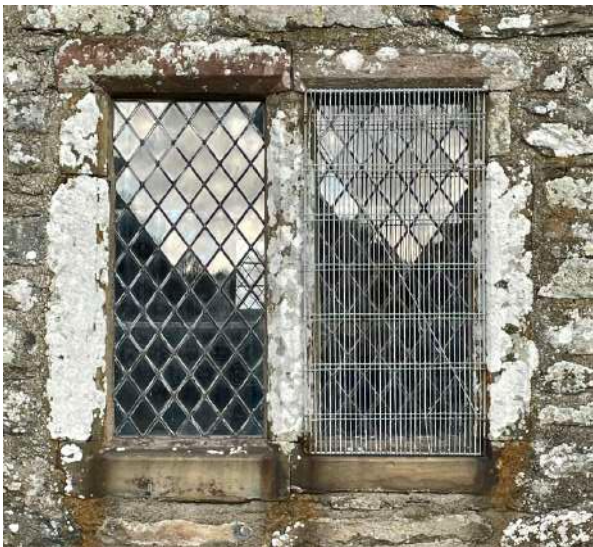
sll – Although glass in good condition, generally the window is in poor condition, with blistering paint to mullion and plaster cracking. Externally one mesh guard has been removed and is placed internally on the west wall of Nave. Stone delaminating.

Remove non-breathable paint to stone mullions and repair cracked mullions. B

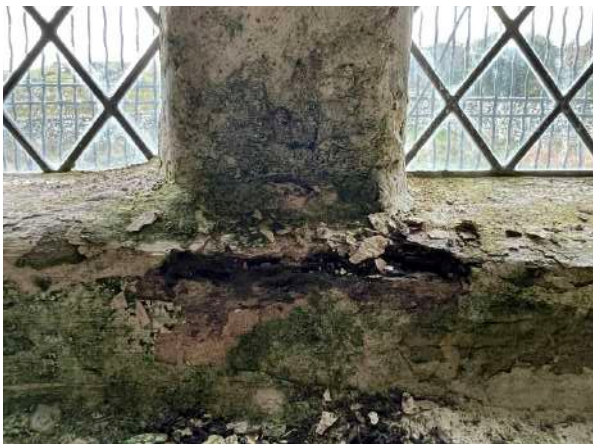
slll – In very poor condition. Delamination in cill. Timber lintol rotten. Crack in plaster window surround.

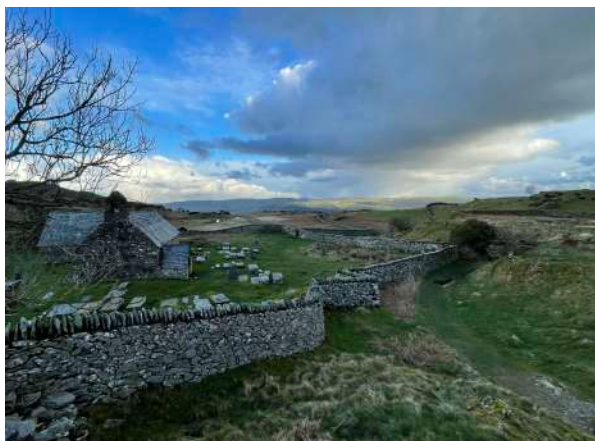
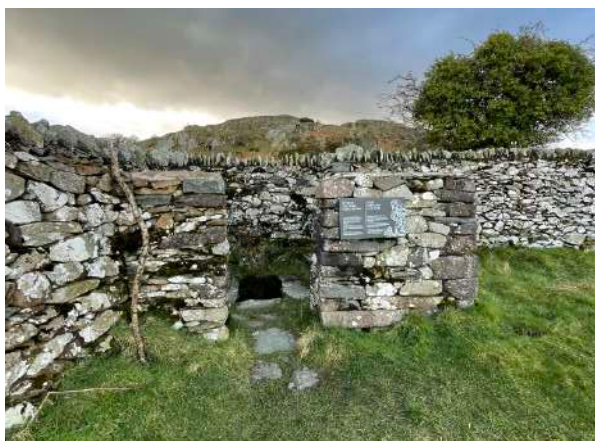
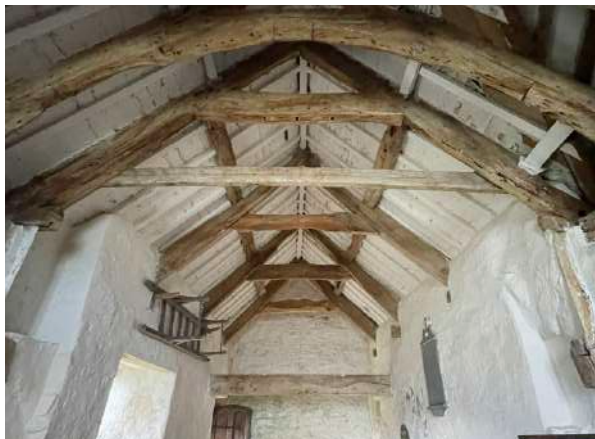
Walls are generally in satisfactory condition although area immediately adjacent to the well requires attention as coping of wall has been disturbed.

Allow to consolidate walls head adjacent to Holy Well to south west corner of church yard. A

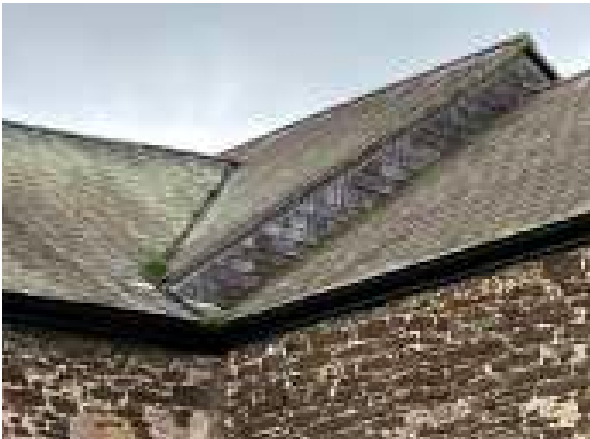
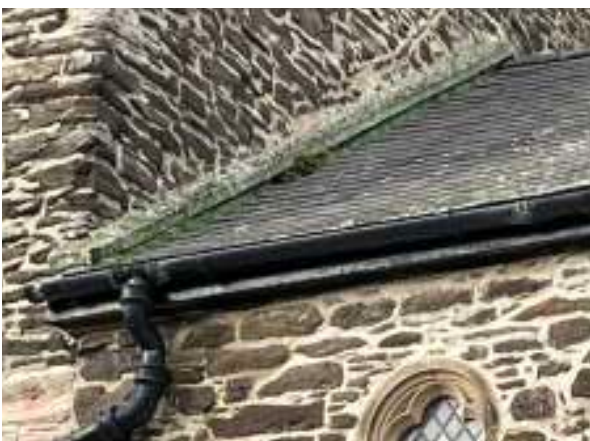
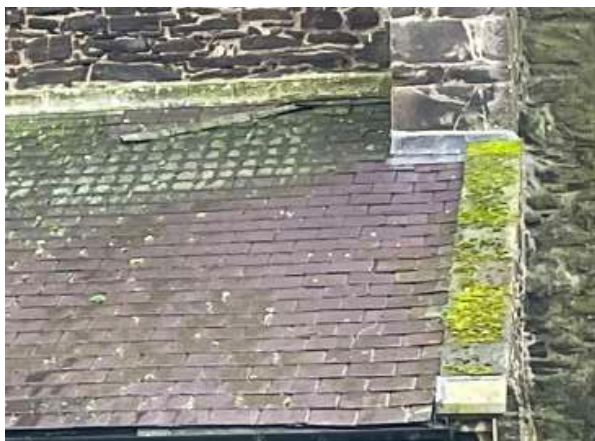
The condition of the slate roof and lead work is generally in good. The ridge lines are level. There are a small number of broken slates to both roof slopes, S2 and W2.

Valleys - south west lead valley, between roof slope S2 and W2, is in good condition, and clear of debris. There are slipped slates and debris in valley between E2 and S2 and vegetation at end of valley and between S1 and E2.

As stated in previous report, a small section of the flashing projecting stone, to roof slope S2, has fractured and broken away. At present this does not appear to be compromising the flashing detail.

There is vegetation approximately midway to the underside of this projecting stone.

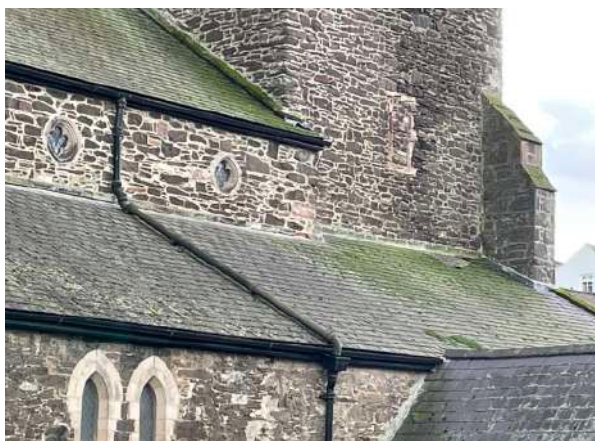
The lead flashing to the lower north west corner of the northern roof slope, roof slope N2, has lifted.

There are large area of organic growth on roof slope N2, but in particular to west side of the north roof slope. Is possible that this is due to the volume of water running off the east face of the tower and that this section of the roof slope is exposed to little direct sunlight resulting in the roof covering remaining wet for longer periods.

Dress down lead flashing to north west corner of the flashing on roof slope N2.

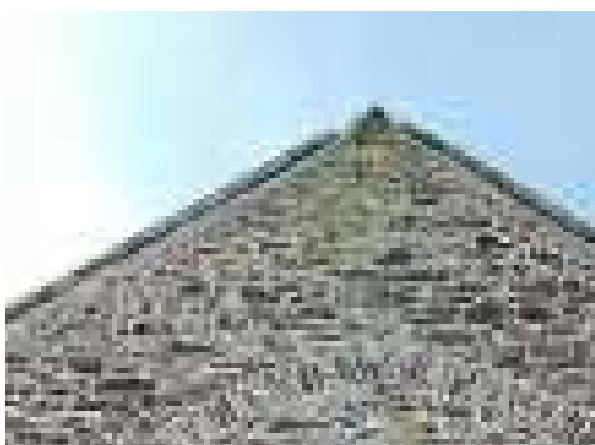
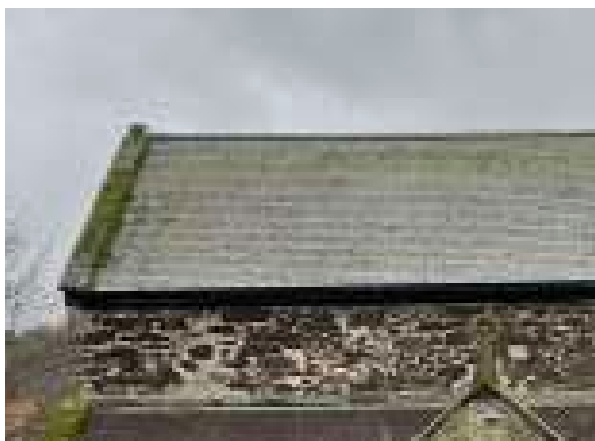
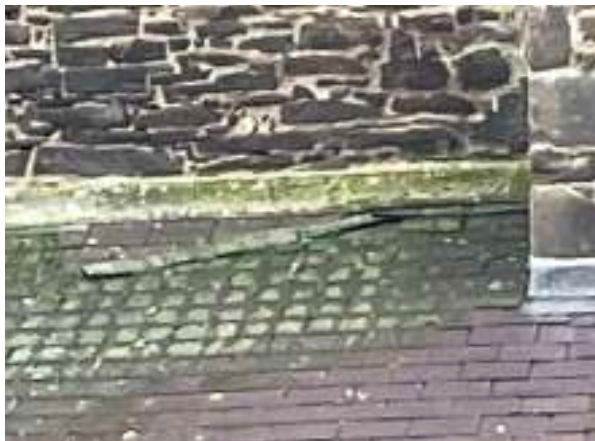
The condition of the slate roof is generally in good. The ridge lines are level. There are a small number of broken slate to both roof slopes and vegetation growing between roof and coping stones. To S1 roof slope, a piece of coping stone is missing.

Chancel roof - Replace coping stone to top S1.

Renew lime mortar pointing to underside and between stone copings of Chancel roof..

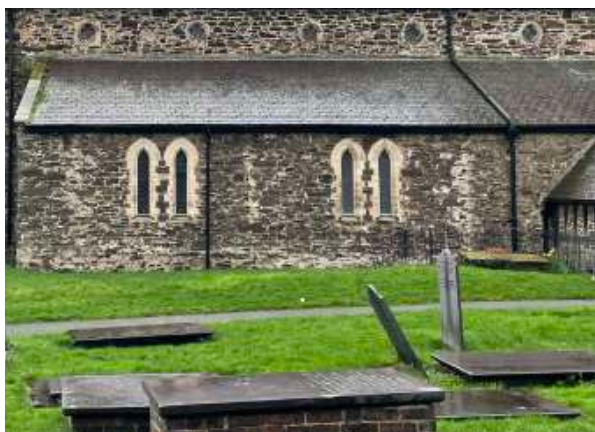
The condition of the slate roof is generally in good. There are a small number of isolated and broken slates.

Lead flashing has come loose between tower and nave wall.

The leadwork and coping stone along the western verge have been recently repaired and repointed. The stonework of the coping stones on the eastern verge appears to be in fair condition. There is vegetation on the slate roof to west of north porch.

- Roof slope N4 - Replace broken slates. B
- Clear vegetation along coping stones on east and west elevation of N4. D
- Renew lead flashing between tower and nave wall (N4). B

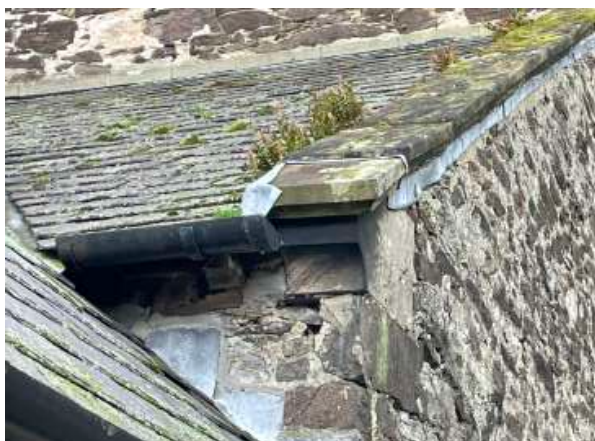
The condition of the slate roof is generally in good. There are a small number of broken slate to both roof slopes to N3. The ridge line is level.

The stepped lead soakers to the southern side of roof slope E1 are in poor condition.

There is missing mortar to the underside and between the stone copings generally thus allowing vegetation to grow.

| Replace broken slates. | B |
| Replace stepped lead soakers along the southern side of roof slope E1. | B |
| Repoint voids between masonry coping stones. | B |

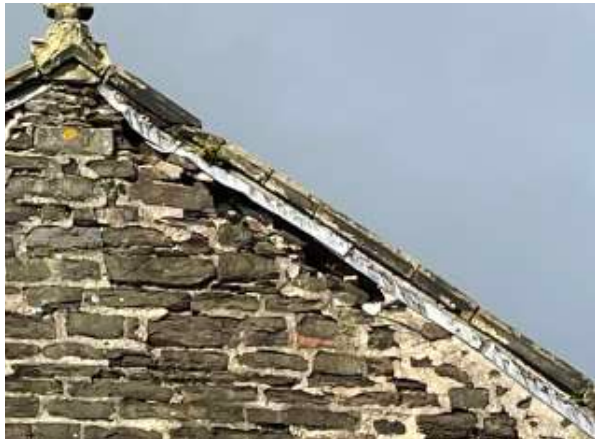
The condition of the slate roof is generally in good. The ridge line is level. There is vegetation along the coping stones. Areas of cracked copings and there is missing mortar to the underside and between the stone copings generally.

Remove vegetation from copings stones. D

Replace cracked copings and repoint voids between masonry coping stones. B

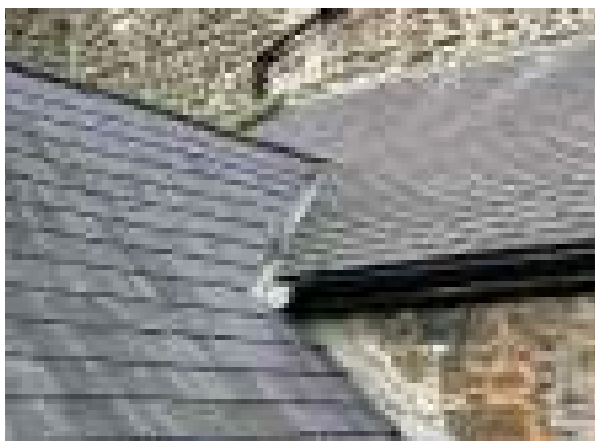
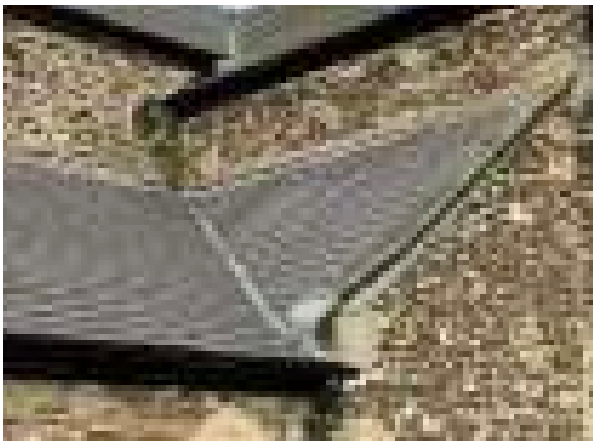
Three coping stones on the western side have been recently re-bedded and repointed. The coping stones to W3 are out of alignment and have open joints where vegetation is growing. The lead-work to the base and underside of the coping is in poor condition.

There is missing mortar to the underside and between the stone copings generally.

The condition of the lead flashing to the underside of the projecting stone was difficult to assess due to access. We understand that the condition has deteriorated however there is no water ingress at this point.

Replace broken slates. B

Lift existing coping stones, consolidate head of masonry wall, replace leadwork, re-bed existing coping stones and repoint. B

Replace lead flashing at abutment with the underside of the projecting stones. B

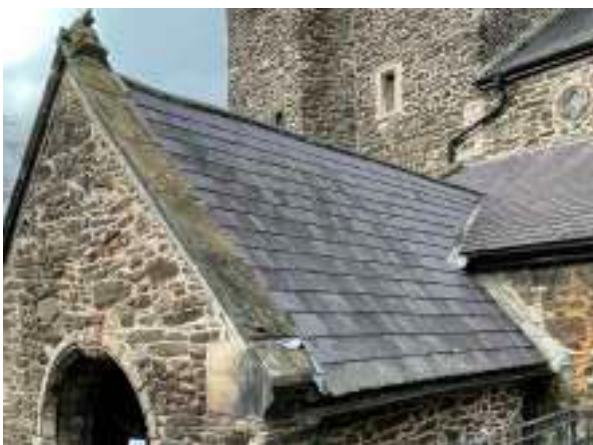
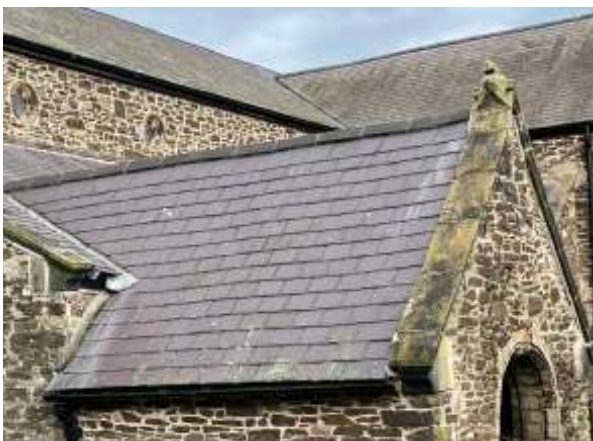
The slate roof is generally in good condition. There are a no cracked or slipped slates.

The coping stones are in poor condition, crack coping stone to west face and many are out of alignment. Open joints and vegetation growing between coping stone and roof on east face. The leadwork to the base and underside of is also in poor condition.

Lift existing coping stones, consolidate head of masonry wall, replace leadwork, re-bed existing coping stones and add new coping and repoint. B

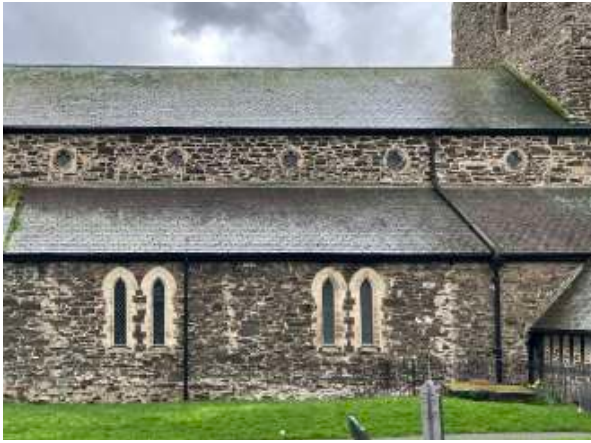
The roof covering is very poor condition. There are cracks in the covering allowing water to penetrate within. The perimeter drain is blocked with debris and vegetation preventing water discharging away. There is an outward lean to the parapet. Modern render has deteriorate and there are missing patches of top coat to internal face. Horizontal crack to stair turret over-run and timber door has weathered, sill green and rotting in places.

Remove cement to the back face of the parapet and replace with non-hydraulic lime render to ensure water can freely evaporate from the masonry through the render. A

Consider installing a downpipe to the tower to prevent all water being discharged along the masonry elevations. C

The fixings of all slate copings should be checked and secured if loose. A

All lead flashings to be replaced.

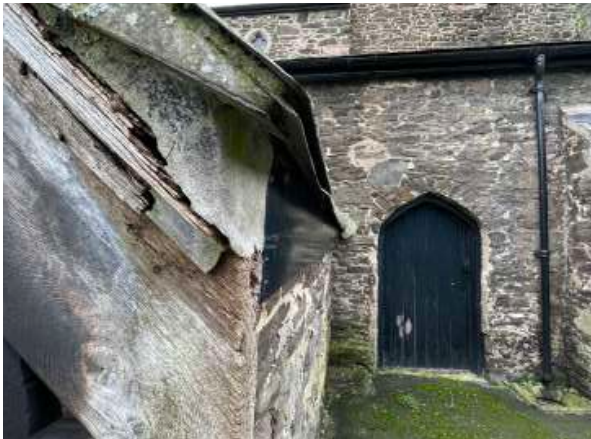
Rainwater good in fair condition. Flaking paintwork. Some moss has collected blocking part of the gully cover to the north-west elevation.

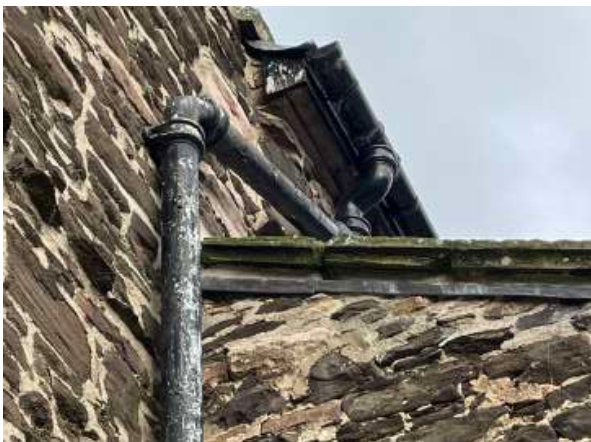
Downpipe in fair condition, flaking paintwork but the east gutter is rusty and with standing water indicating blockage to downpipe.

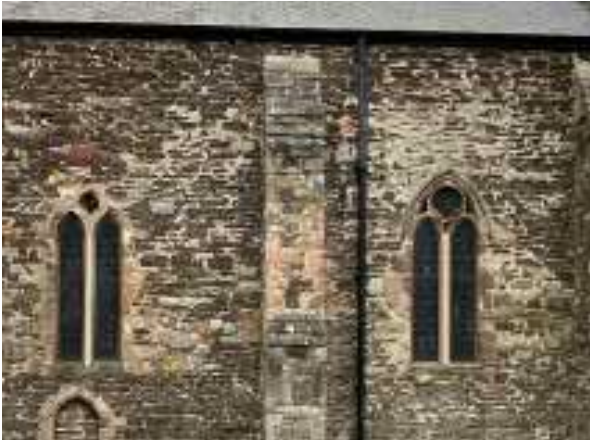
Rainwater good in fair condition with flaking paintwork, south-west downpipe in particular.

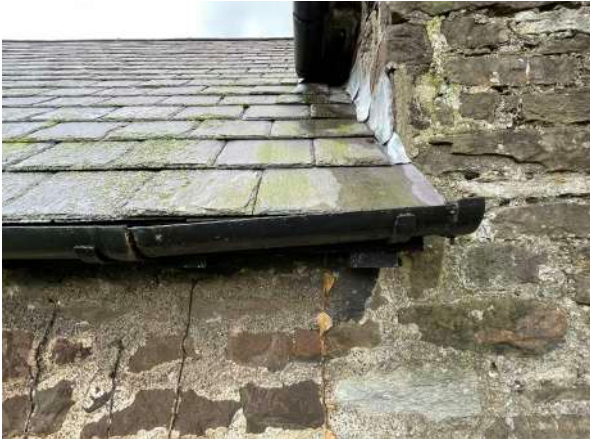
Rainwater in fair condition. Flaking paintwork.

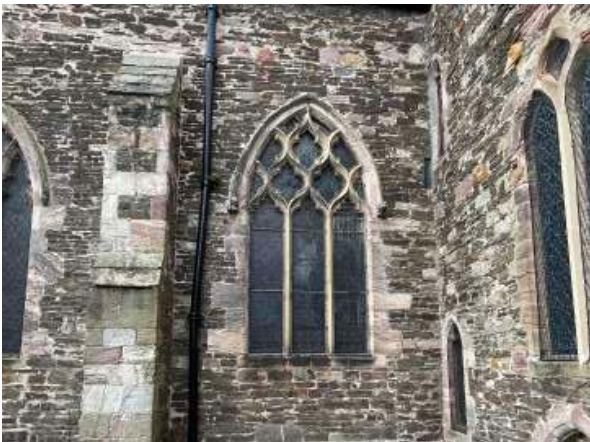
Rainwater good in fair condition. Flaking paintwork. The west gutter has fallen out of alignment and vegetation in gutters.

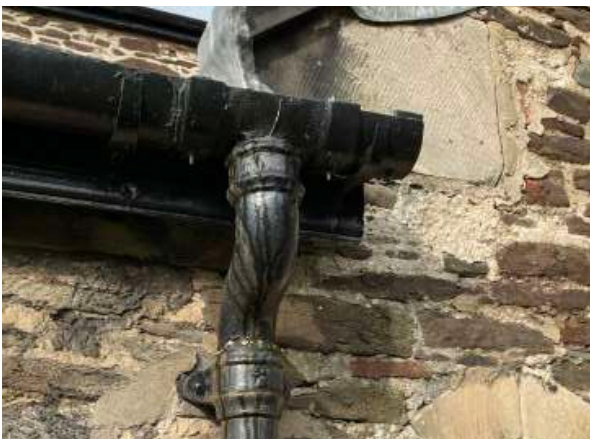
Rainwater good in fair condition. Flaking paintwork. Some debris has blocked the northern side of the east elevation gutter adjacent to the lead valley. The down pipe on east elevation has fallen out of alignment with 1no. downpipe bracket not fixed to the masonry wall.

Realign downpipes and gutters B

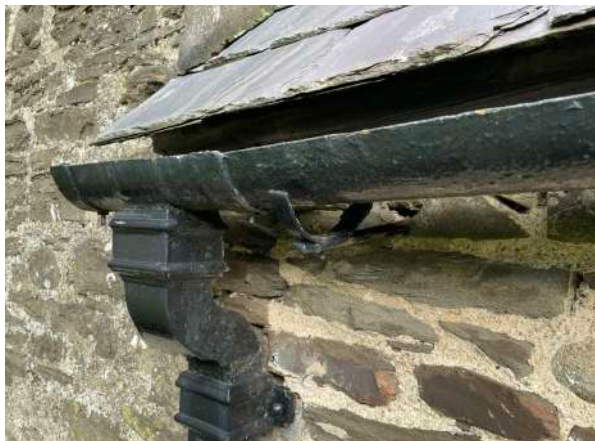
Both gutters have corroded, 2 stop ends on east gutter missing causing water to discharge onto the ground and has caused green staining on aisle wall. One end gutter missing to west elevation (near the porch door). The west bracket is also loose.

Replace both gutters to east and west elevation of south porch. B

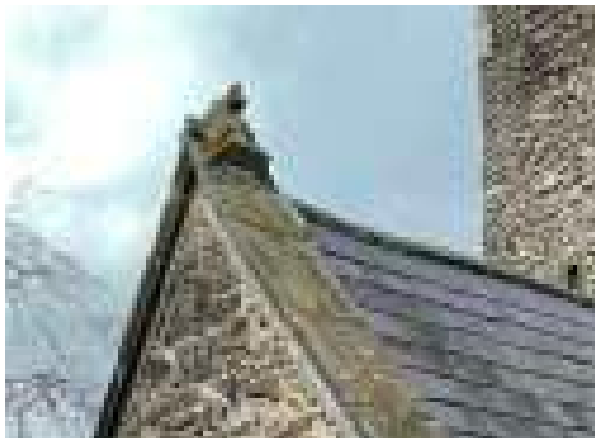
Vestry gable cross in good condition. Chancel east gable finial is missing and finial to south porch has broken. South transept carved cross to apex broken.

Reinstate stone carved finial / cross to south porch, south transept and Chancel gable to match historic photographs.

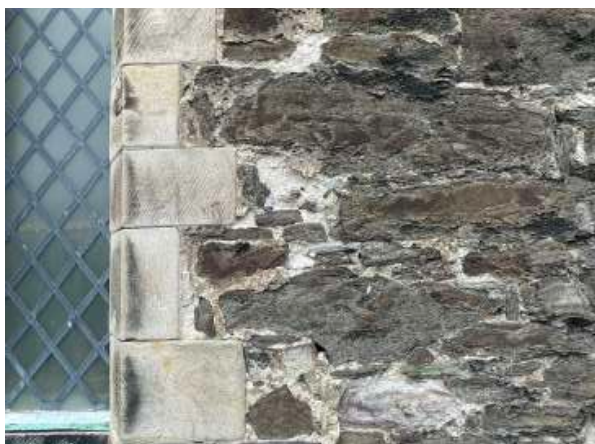
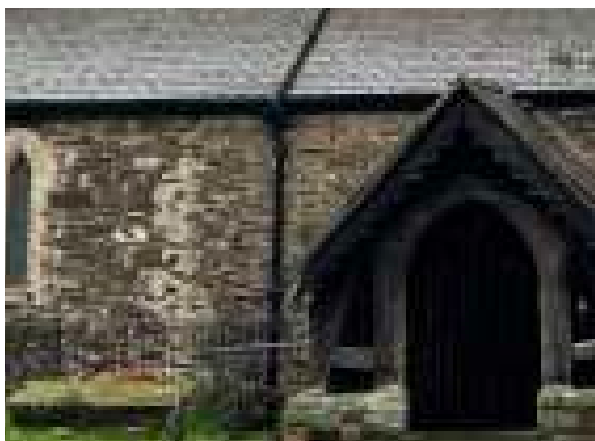
The west elevation has been recently repointed using a lime based mortar and is in good condition. Generally, the masonry appears to be in good condition however there are a small number of areas where the surface of the masonry has delaminated away, these stones appear to be face bedded. At present, these do not appear to be affecting the structural integrity of the masonry.

The quality of the mortar pointing varies across the elevation with areas of voids, recessed (weathered back) pointing, patches of cementitious repairs and recent lime pointing. To the east of the north porch there appears to be a vertical area of heavy pointing which we assume is a repair to a former crack. There are open voids under gutter near downpipe on north elevation.

Replace patch repairs undertaken using cementitious mortar with an appropriate lime based mortar.

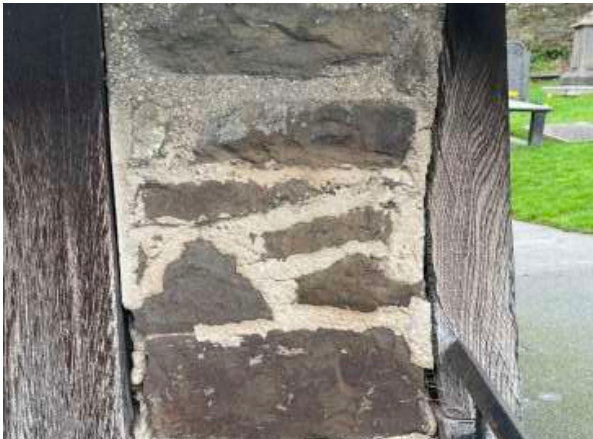
## North Porch

The masonry, timber framing and pointing is generally in good condition. The masonry at low level on the west elevation is damp due to the missing gutter. There is missing mortar within the timber frame on the east.

Repoint with lime mortar.

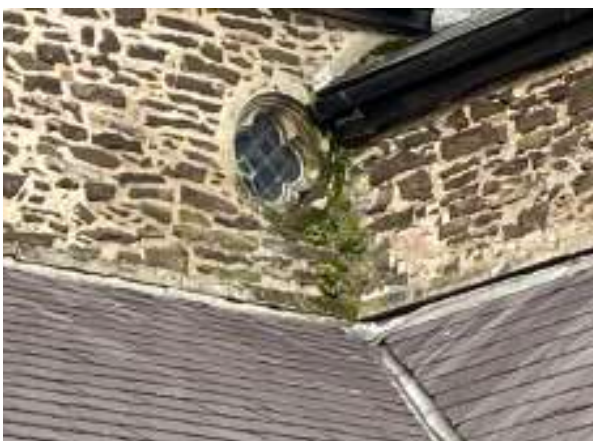
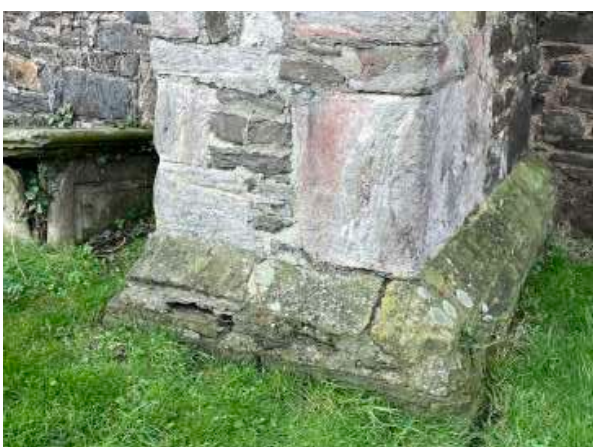
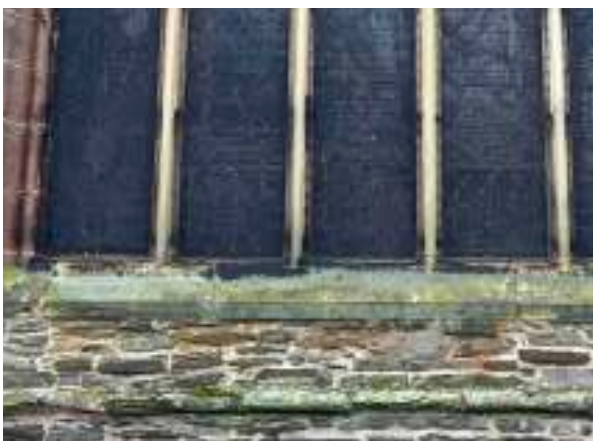
## Nave

The masonry generally appears to be in good condition.

The slate capping's of the buttresses are in poor condition with vegetation growing at high level.

The projecting stone course on the north elevation, above the aisle roof, appears to be in fair condition. The western stone has severely weathered back. There are approximately 4no. additional projecting stones which appear to have weathered back. On the south elevation, the projecting stones appear to be in better condition. There are approximately 5no. which have lost some of the detail to the underside of the stones. There appears to be a number of voids to the underside of this stone course where the pointing mortar has been lost.

To north buttress, there are a number of cracked and loose slates and evidence of former ivy growth on the east face of the buttress. The condition of the pointing mortar is poor.

Vegetation growing under window SI, and corner between south nave and south transept.

Carefully remove vegetation and slate capping to western buttress. Undertake mortar repairs to head of buttress prior to relaying slates. Replace mortar flaunching. Undertake 3m2 of repointing to the buttresses. B

To the north elevation: Replace weathered projecting stone to western end above the slate roof. Repair 4no. additional projecting stones. Renew lead flashing to these areas. Undertake close assessment of other projecting stones whilst access to undertake repairs is available. B

To the south elevation: Replace mortar to entire length of the underside of the projecting stone course. Ensure lead flashings are suitably dressed to the underside of the stonework. B

Carefully remove slate capping to western buttress. Undertake mortar repairs to head of buttress prior to relaying slates. Replace cracked slates with new. Replace mortar flaunching. Undertake 10m2 of repointing to the buttresses. B

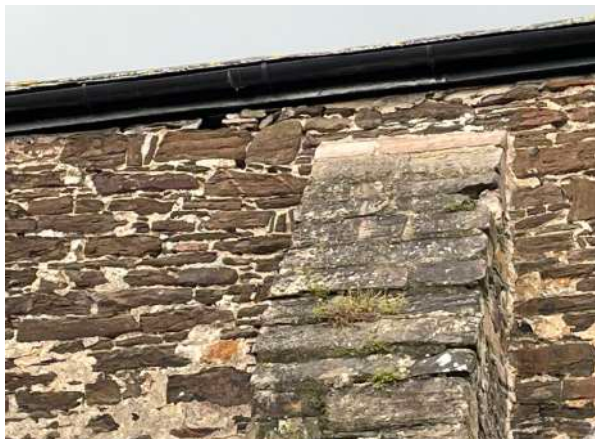
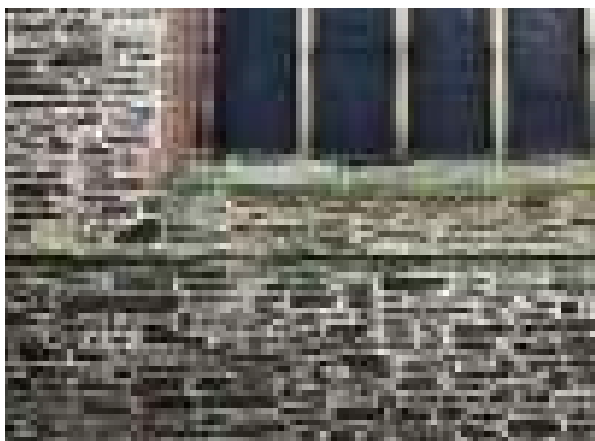
The masonry to all 3no. elevation generally appears to be in good condition.

Vegetation growing in open voids of south buttress, void to base of south-east buttress. And crack to north-east buttress.

Green staining to top of gable.

The string course to the underside of the east window is in poor condition with only approximately 2no. masonry units complete and free from defects. The remainder of the stone string course has either partly weathered with horizontal fissures (following the bedding), fully weathered or broken away.

On the north elevation. There are runoff staining from the sandstone mullion onto the face of the masonry on the north elevation. There is also runoff staining from the window guards on east window.

The projecting stone course on the north elevation, above the vestry roof, appears to be in fair condition.

The quality of the pointing varies in condition. On the north and south elevation the pointing mortar has generally recessed (weathered back) and there are isolated areas of voids particularly at high level on south elevation. There are also areas of poor quality cementitious pointing at high level and the eastern end of north elevation.

The pointing of the east elevation has been renewed however the finish is poor resulting in small voids around the masonry units which could allow moisture into the wall.

The buttresses are generally in fair condition, there is moss to the coping which may be retaining moisture. There are voids, small cracks and cementitious pointing to the masonry.

Repoint all voids, north, east and south elevation, using an appropriate lime based mortar. B

Repair sections of broken string course. Replace sections where the stonework has fully weathered or broken away. C

Rake out cementitious mortar at wall plate level of the south elevation. Repoint using an appropriate lime mortar. B

Repoint voids of south elevation using an appropriate lime based mortar. B

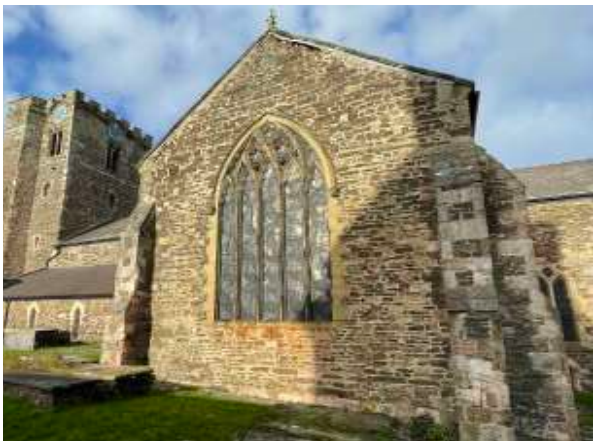
## Vestry

Generally, the masonry wall appears to be in good condition. The dressed projecting stone (west elevation), supporting the coping above, has moved out of alignment and has caused vertical void between it and the adjacent rubble masonry.

There is green staining to top of north gable.

The quality of the pointing varies in condition. Generally the pointing mortar is buttered over the face of the masonry and is in good condition. There are isolated areas of recessed (weathered back) pointing and some voids where the mortar is missing. The pointing to the ashlar quoins of the 1925 gable is missing. There are a number of voids along the wall plate of the north elevation to the earlier vestry (above the blocked door).

Allow to repair and re-bed loose masonry and the projecting stone supporting the copings on the west elevation where vestry was extended. Repair leadwork following masonry work.

Remove ivy from north gable.

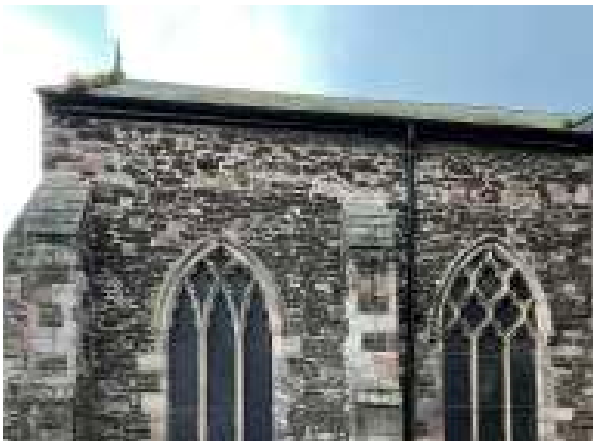
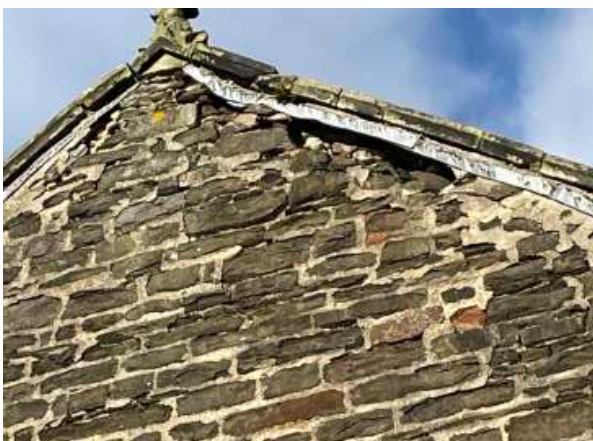
## South Transept

On the east elevation the masonry above the top of the buttresses differs from the smaller coursed rubble masonry below. The condition of this upper masonry appears to be more weathered than the masonry below. The condition and quality of the pointing varies, the area above the buttresses is a wider buttered pointing and of poorer condition than the weathered pointing below.

On the south elevation the masonry is in poor condition with a large number of the masonry weathered back from the pointing mortar. There are large voids to the upper right side of the gable under the coping stones and to lower left hand side of coping stone. The pointing mortar appears inappropriate and too strong for the masonry it surrounds thus there is a vertical crack between end corbel stone and pointing. The finish is also very poor with little aggregate visible which could affect the porosity of the mortar. Staining from mesh guard also.

Weathered stone to base of south-west buttress.

East elevation: Repoint all voids using an appropriate lime based mortar. B

East elevation: Rake out cementitious mortar along wall plate level and replace with new lime based mortar. B

To south elevation: Rebuild area of missing masonry to the underside of the copings and repoint area around corbel stone with appropriate lime mortar. B

To south elevation: De-frass friable face of stone work prior to repointing. Replace masonry where there is insufficient sound material with new. B

West elevation: Rake out cementitious mortar along wall plate level and replace with new lime based mortar. B

West elevation: Repoint entire area above the projected stone course using an appropriate lime mortar. B

Buttresses: Remove vegetation and repoint approximately 5m<sup>2</sup> of lime pointing to each buttress should be undertaken. Replace sections of fractured stones to base of the buttresses. B

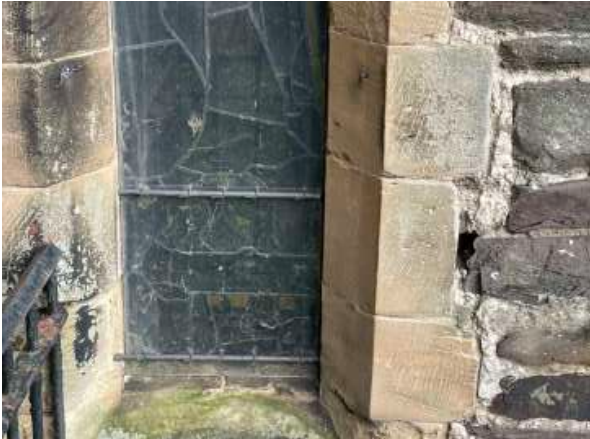
## South Aisle

The condition of the masonry and mortar varies across the elevation. There are voids to the underside of the coping on the eastern end and open void to side of window sXV The pointing below the ground level (to the perimeter drain level) is very poor. A vertical mortar repair to a crack has been undertaken adjacent to the south porch using an inappropriate mortar.

- Repoint voids within masonry using an appropriate lime mortar. B
- Rake out all mortar below the churchyard level (to the perimeter drain) and repoint using an appropriate lime mortar. B
- Rake out and repoint mortar repair to crack adjacent to the porch and repoint using an appropriate lime mortar. B
- Reinstate missing ventilation grille to west elevation. B

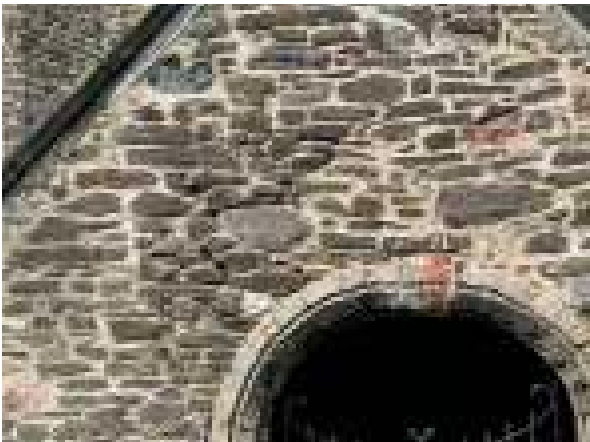
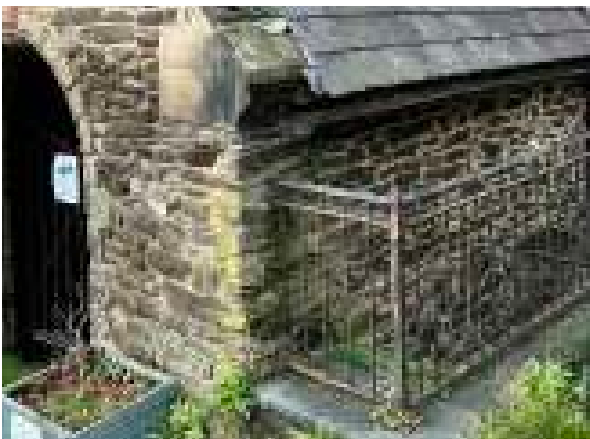
## South Porch

The masonry and pointing is generally in fair condition. Ivy is growing on the east elevation. There are areas of missing pointing and weathered sandstone on the south elevation

- Remove ivy from east elevation. D
- Repoint voids within masonry using an appropriate lime mortar. B
- All grilles embedded at low level of the masonry walls, providing ventilation to underside of floors, to be cleared to aid air flow. D

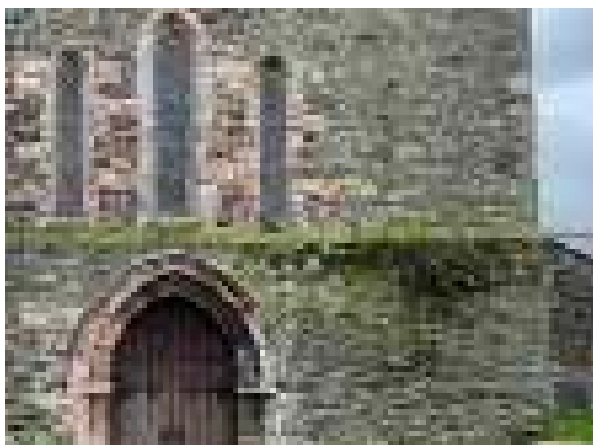
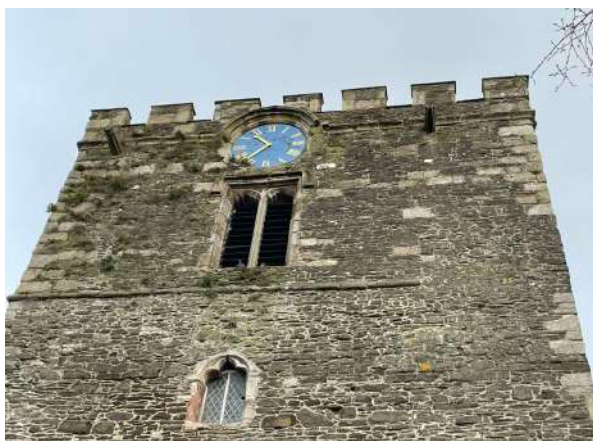
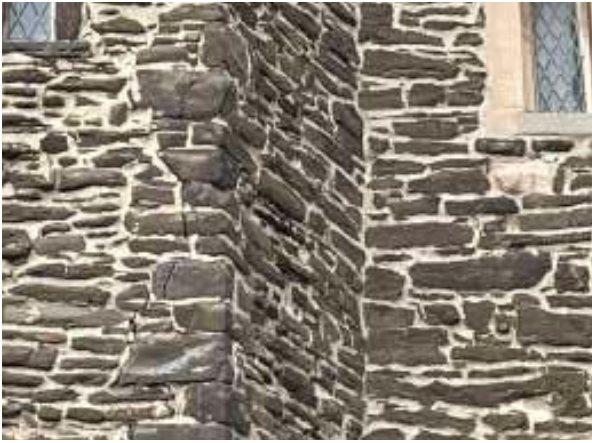
## Tower

The first stage: The condition of the rubble masonry appears to be in fair condition however the condition of the mortar varies with some sound, some friable and areas of voids where the pointing mortar is missing. Below string course, south of west door, there is vegetation and green staining indicating retained moisture. There are also small areas of vegetation around the buttress.

The second stage: deterioration of dressed stone to lancet window. The condition of the rubble masonry appears to be in fair condition. The string course, separating the second and third stage, appears to be in poor condition with delaminating stone. The condition of the mortar varies with some sound, some friable and areas of voids where the pointing mortar is missing. There are areas of vegetation around the buttress, and considerable amount of vegetation at belfry and parapet level indicating damp conditions. South wall stairs turret there is a crack running vertically from window SVII alongside quoins.

The third stage: vegetation to all elevations, but in particular to north side of west elevation. Shallow vegetation around the line of the existing roof indicating damp conditions.

Louvres in good condition.

The cracked areas on the west elevation should be checked behind the pointing to see if the magnitude of the cracks is reflected in the substrate below.

Missing stonework over the west window of the belfry should be replaced.

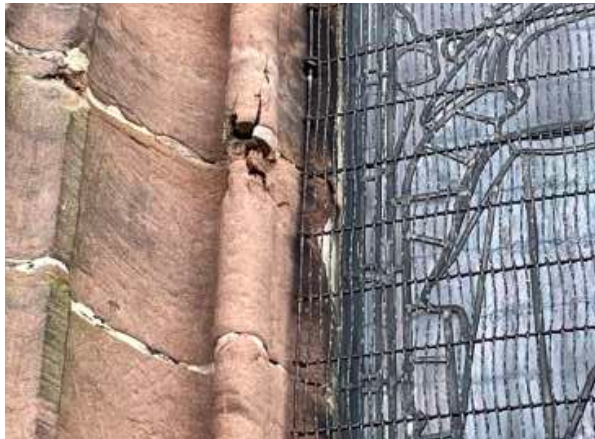
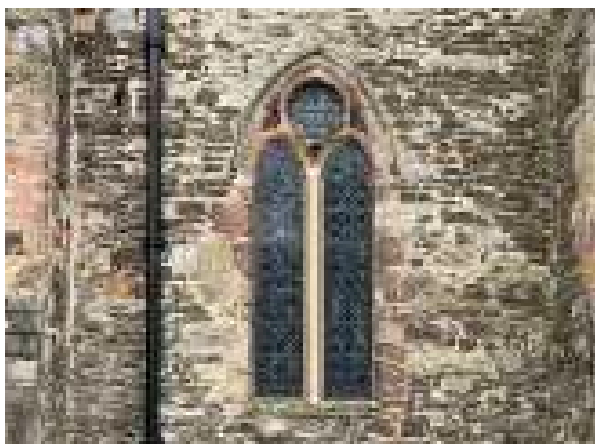
### Window I

The pale tracery appears to be in fair condition however there is black staining particularly around the fixing points for the metal guards.

The outer moulding of the stone arch has fractured away in 3no. sections (especially to top of arch) and friable sections elsewhere. This will impact the discharge of water.

Undertake masonry repairs to outer moulding of the stone arch. C

Consolidate masonry sill. C

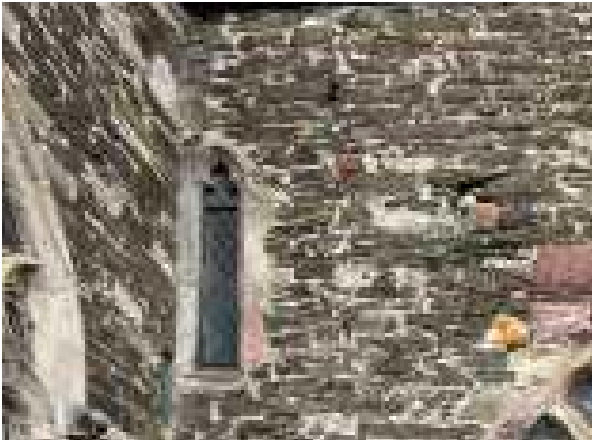
### Window sIII

The window appears to be in good condition. New mullion. Internally, patch render repairs around upper light.

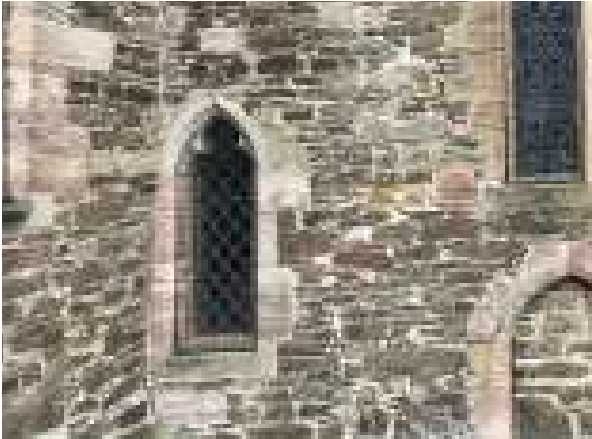
**Window sIV (high level window to S. Chancel)**

The masonry appears to be in good condition. There is a broken pane of glass towards the base.

Replace broken glass.

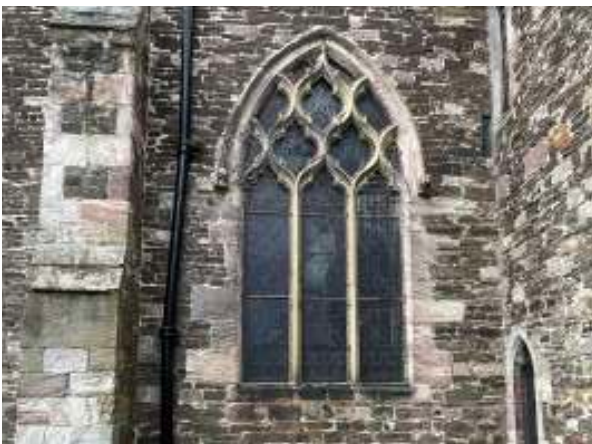
**Window sV (low level window to S. Chancel)**

The masonry appears to be in good condition.

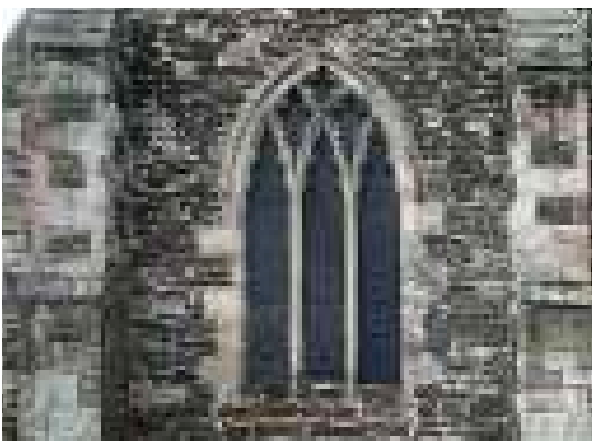
**Window sVI (East wall of S. Transept)**

The masonry and glazing appears to be in satisfactory condition. Hoodmould on right hand side has weathered. 2 new mullions and part tracery new. Crack to two sills.

Make good to cracks to sill.

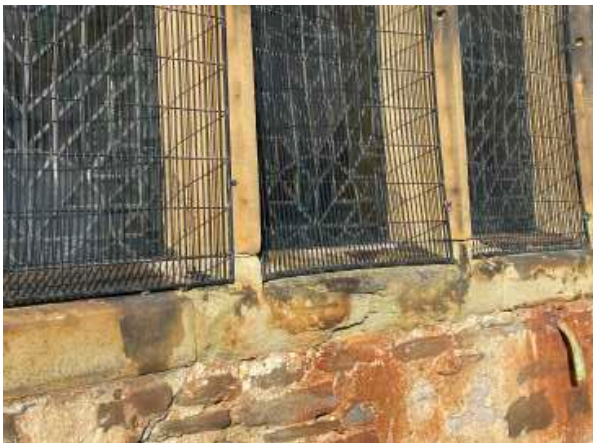
**Window sVII (East wall of S. Transept)**

The masonry and glazing appears to be in fair condition. Hoodmould has weather to top of arch. And ferrous staining to stonework under sill. Two crack to sill.

Make good to cracks to cill.

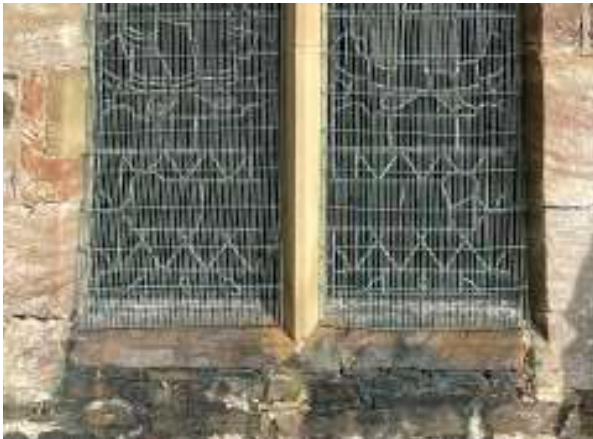
### Window sVIII

The masonry appears to be in fair condition. Hood-moulds are in good condition. But there are sections of fractured and weathered stone and missing pointing mortar to sills. There are black staining to mullions where mesh guards have been fixed, and there are holes in mullions where guards fixings once fixed. The lead has failed in places and window is bowing in numerous places.

Consolidate fractured and friable masonry. Repoint voids using an appropriate lime mortar.

Allow for a window repair schedule.

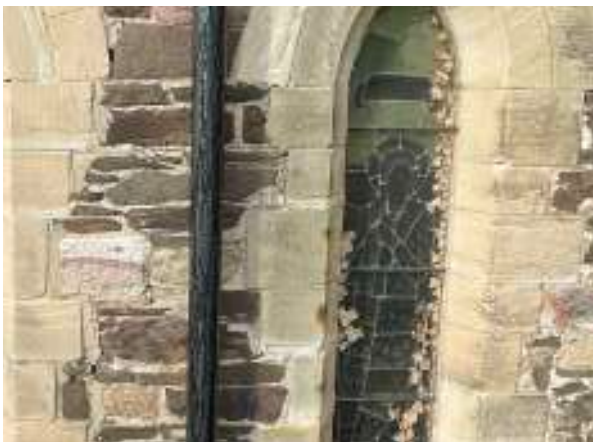
### Window sIX (West wall S. transept)

New mullion. Glazing appears to be in good condition, but crack to one sill and ferrous staining.

Repair cill.

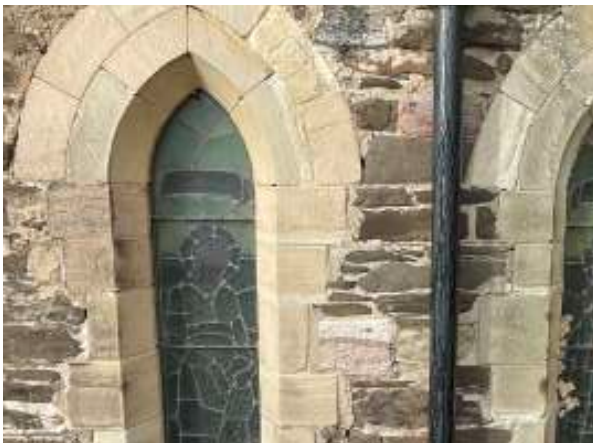
### Window sX

The masonry and glazing appears to be in good condition.

Remove ivy.

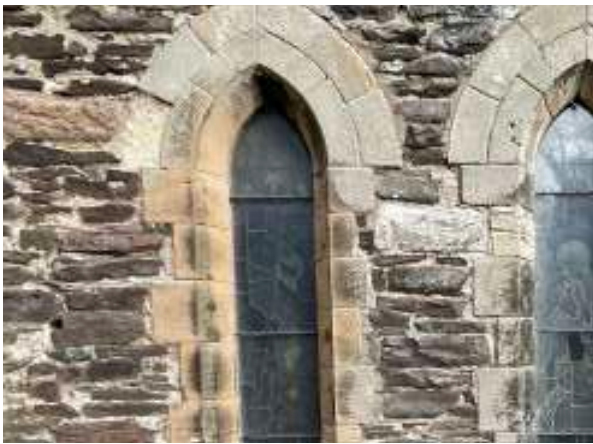
The masonry and glazing appears to be in good condition. Staining to sill. Open void, missing mortar between wall and freestone surround (right hand side)

Repoint missing void with lime mortar.

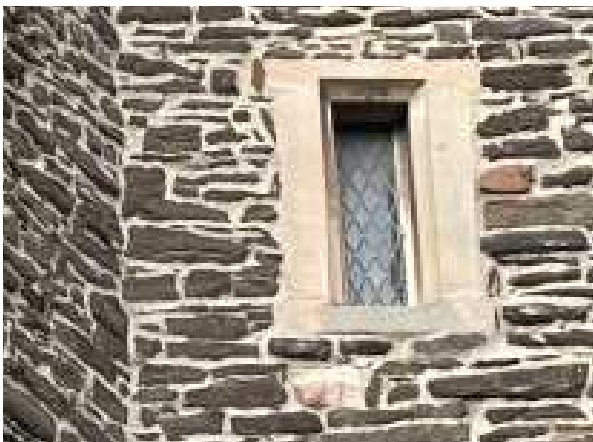
### **Window SI – SV (Nave – high level)**

The windows are generally in fair condition with some dark staining to the masonry. SI is stained green externally, and flaking plaster internally which we understand to be historical water ingress.

Clean green staining to window SI.
