# Bro Celynnin

## Ezra Report

Management and Maintenance Plan for Period 2024 - 2029

Conducted by  
Bethan Jones  
Swyddog Eiddo Archddiaconiaeth | Archdeaconry Property Officer

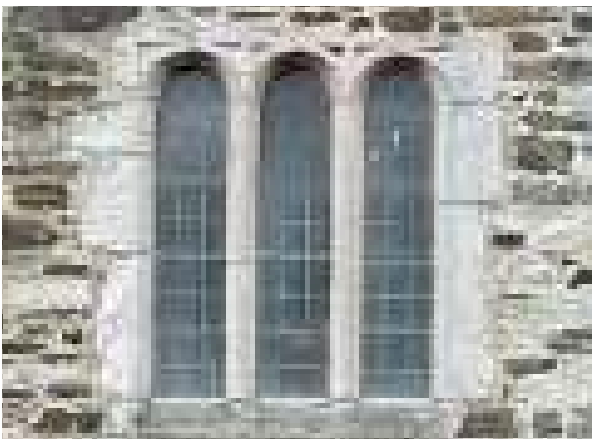
### **Window nII**

There are sections of masonry which have fractured and weathered back. This includes the head and sill. The new metal window guard has been fixed directly into the masonry instead of the mortar joints.

Consolidate fractured and weathered masonry. Repoint tracery where the mortar is missing.

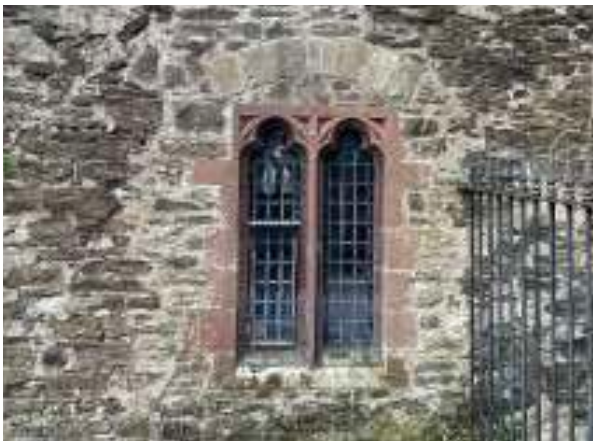
### **Window nIII**

The masonry has been pointed using a cementitious mortar however the masonry appears to be in good condition.

Replace cementitious mortar with new lime based mortar.

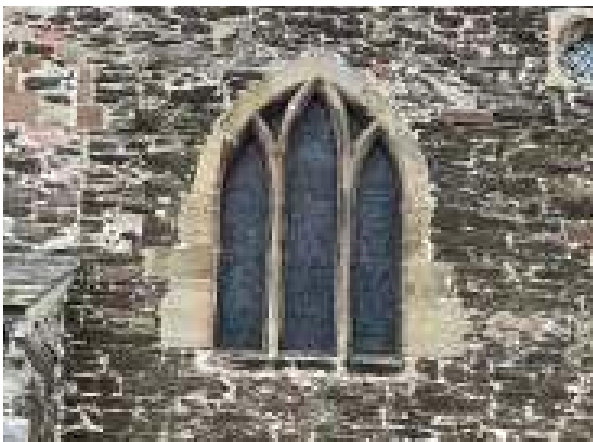
**Window nV**

The window is generally in fair condition with some dark staining to the masonry. There are open joints to mullions and sandstone is weathered in places. Broken and holes in glass.

Repoint tracery and mullions using a lime based mortar. C

Repair broken glass. C

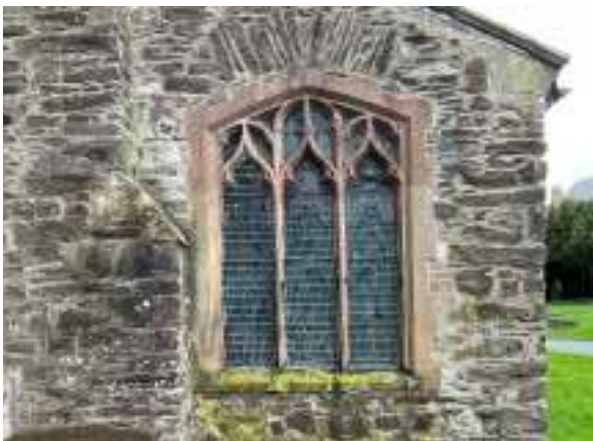
**Window nVI**

The window is generally in fair condition with some dark staining to the masonry and stone sill is weathered. Open joints to window surround and some holes in glass.

Repoint tracery and mullions using a lime based mortar. C

Repair broken glass. C

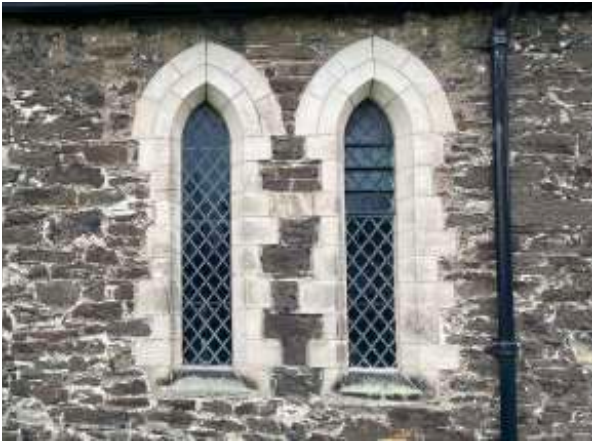
**Window nVII**

The window is generally in fair condition with some dark staining to mullions and sill stained green. Internally, plaster under lintol has come away. Mesh guard to centre loose.

Clean green stain and refix mesh guard.

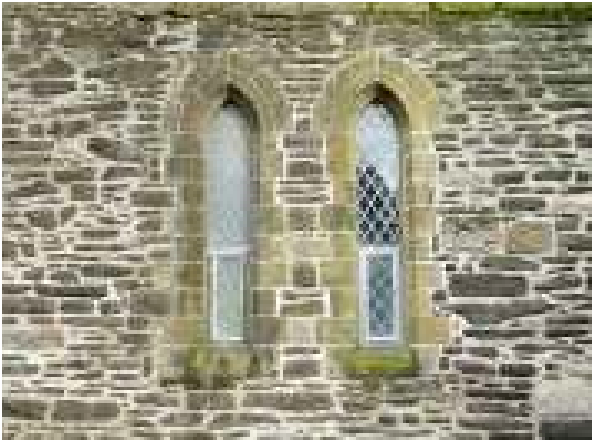
**Window nXIII**

The masonry is weathered but in good condition. Lime pointing to window has cracked to one area.

Repair pointing with lime mortar.

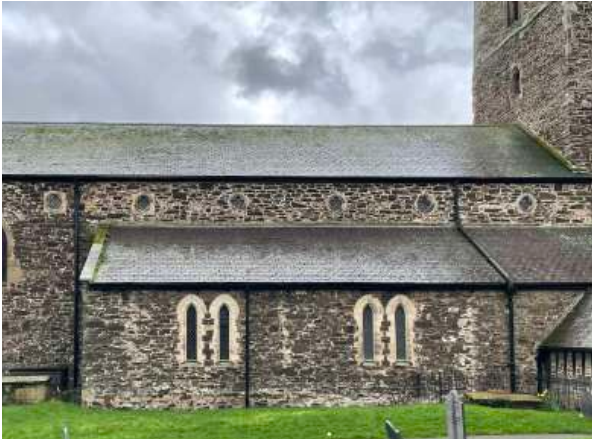
### **Window nXIV & nXV**

The masonry is in good condition and has been recently repointed. Green staining to sill.

Remove green staining.

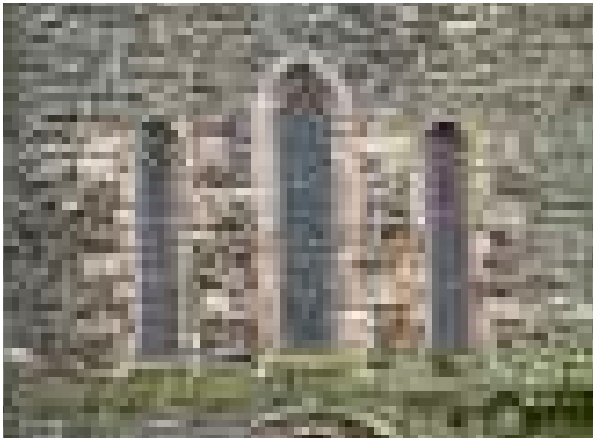
### Window WI (W. Tower)

In fair condition, broken glass.

Repair broken glass.

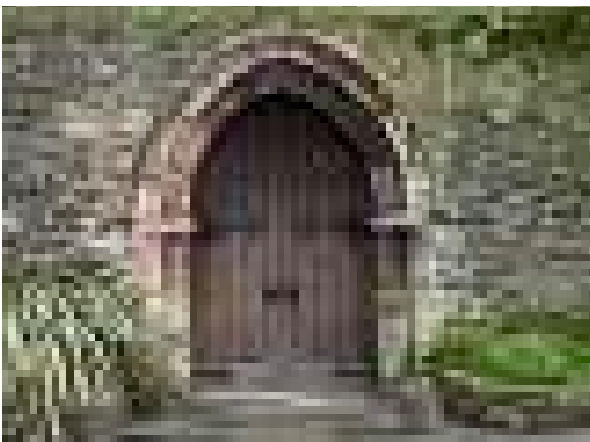
Internally, timber weather strip is missing.

Replace timber weather strip. B

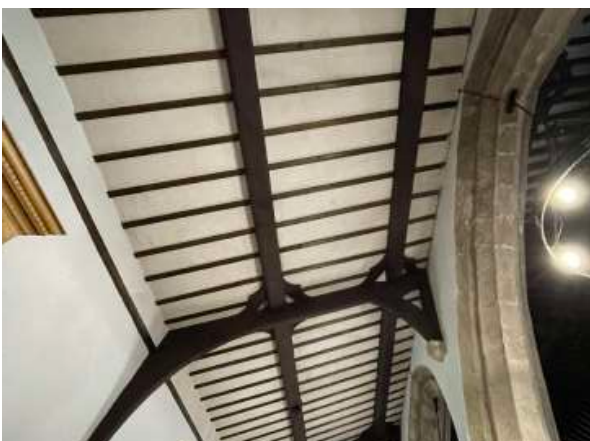
## Nave

The ceiling generally appears to be in good condition. There does not appear to be any movement to the timbers.

There are historic water staining to timber under valley between south aisle and south transept.

Past alterations, the plaster between rafters have been replaced by possibly sheet containing asbestos.

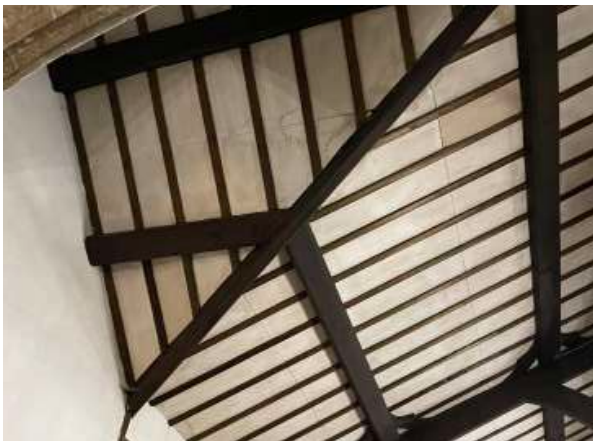
## North Aisle

The ceiling generally appears to be in good condition. There does not appear to be any movement to the timbers.

Past alterations, the plaster between rafters have been replaced by possibly sheet containing asbestos.

Small section of sheet is missing between aisle and chapel, and some water staining.

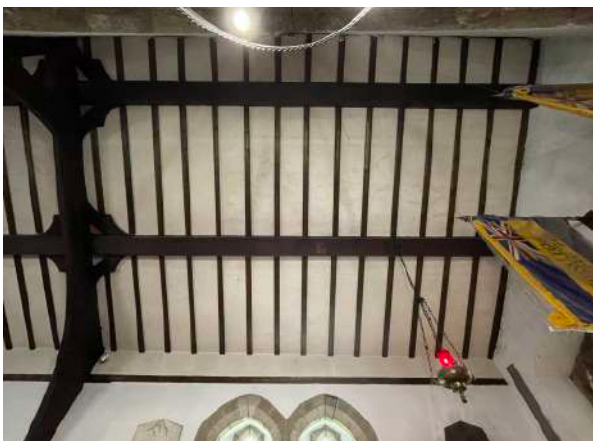
## South Aisle

Past alterations, the plaster between rafters have been replaced by possibly sheet containing asbestos.

The timbers are in good condition, no movement indicated. But the plaster between rafters are in fair condition, there are water stains caused by historic water ingress under valley W3 and S3, There is also water staining to south west corner S3.

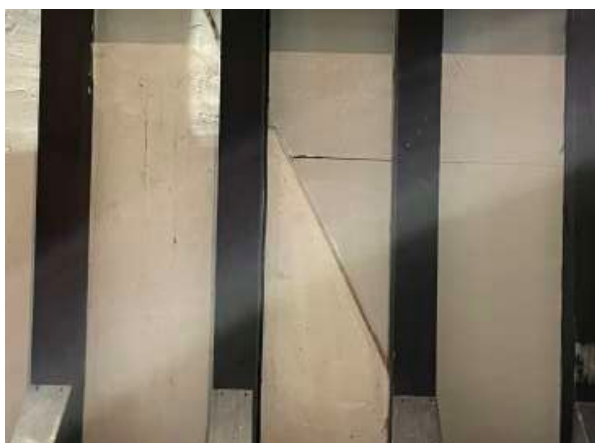
Ceiling structure appears to be in fair condition.

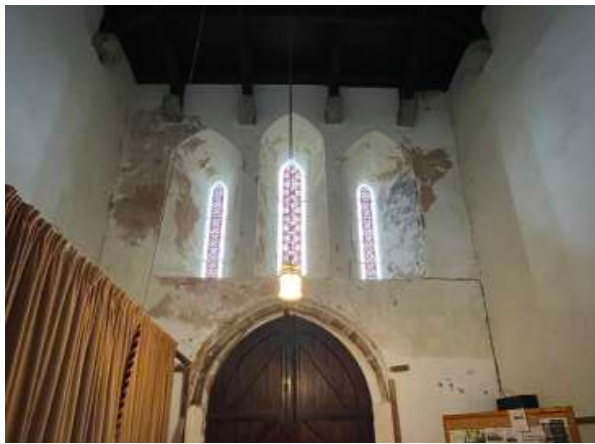
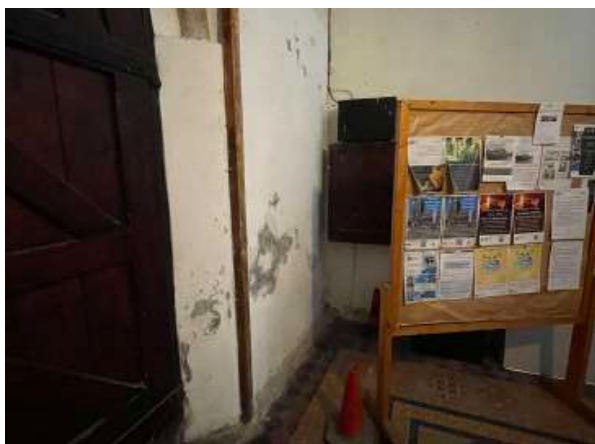
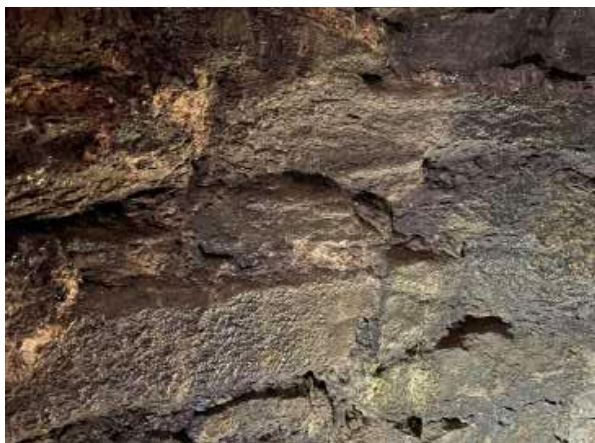
There is some cracking to the boarding and plaster between the rafters and condensation visible.

Repair cracks to boarding between rafters and make good decoration. C

All Church ceilings - determine if Asbestos is present to sheets. If Asbestos Management Report has not been conducted, allow for an inspection by Asbestos surveyor. A

Nave, Chancel, North & South Aisle, Vestry, Memorial Chapel, Parish room and South transept-redecorate. C

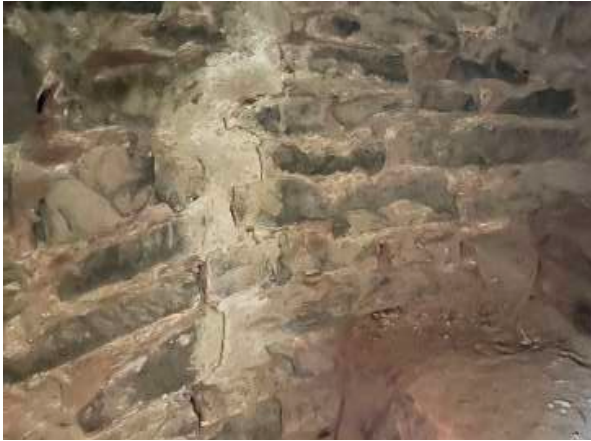
The condition of the wall varies along the height of the tower staircase. Generally, the walls appear dry however there are areas of white deposits in some areas. Vertical cracks in areas also.

The condition of the masonry varies; the rubble masonry of the outer wall is generally in good condition however the bedding and pointing mortar has failed in large expanses crumbling to a fine grade and collecting on the surface of the stone treads. The pointing to the central stone column is also crumbling in places.

The internal plaster around the heads of the lancet windows should be removed to confirm whether there is cracking in the masonry substrate.

The existing mortar should be raked out and re-pointed with a suitable non-hydraulic lime which is sacrificial to the stonework and allow free evaporation from the joints.

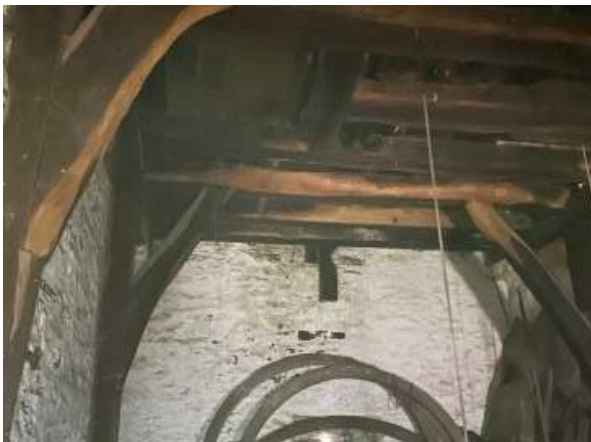
Due to the structural condition of the floor and lack of light, it was deemed unsafe to enter the room. Inspection was taken from chamber doorway with a torch, but due to access constraints, this limited the inspection.

Paintwork flaking from the walls. No cracks were noted. There was some daylight coming the blocked window on the north elevation.

Infill void within former window on north elevation with rubble masonry and repoint.

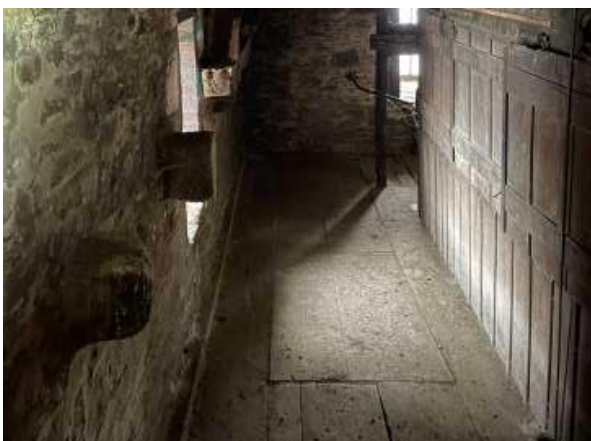
The pointing has recessed on the south wall. There is a vertical crack to the masonry in the SW corner.

Monitor crack to SW corner.

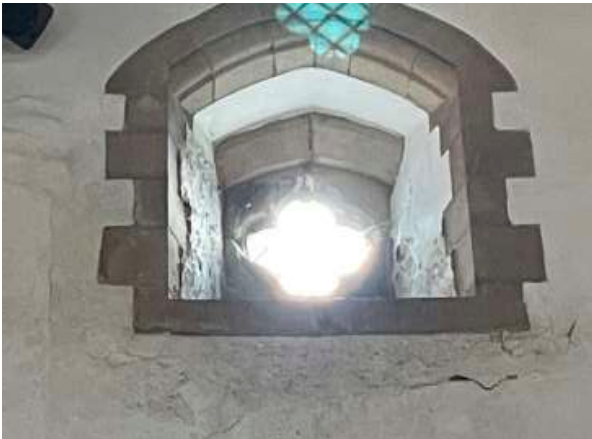
Access limited to due extent of guano and debris on floor and lack of light. The pointing has recessed on the south wall. There is a vertical crack to the masonry in the SW corner.

Infill void within former window on north elevation with rubble masonry and repoint. B

Monitor crack to SW corner. B

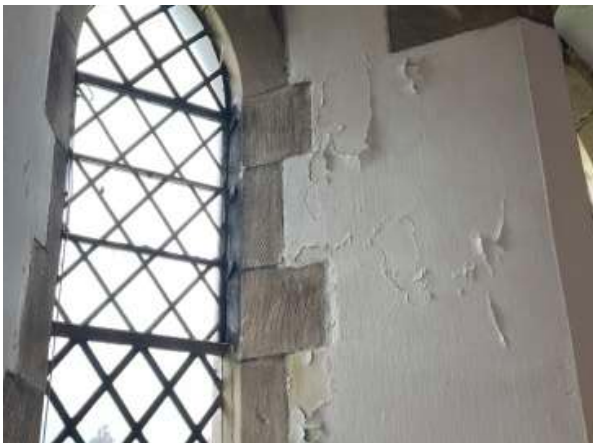
The walls generally appear to be in good condition. There are some areas of discolouring and possible dampness to the plaster around windows reveals, especially around window SI due historic water ingress. The stone arches appear to be in good condition. To west wall of Nave there is a high-level vertical crack.

Undertake isolated repairs and redecoration to the plasterwork. C

Monitor cracking. Consult conservation accredited structural engineer if the cracking appears to worsen. B

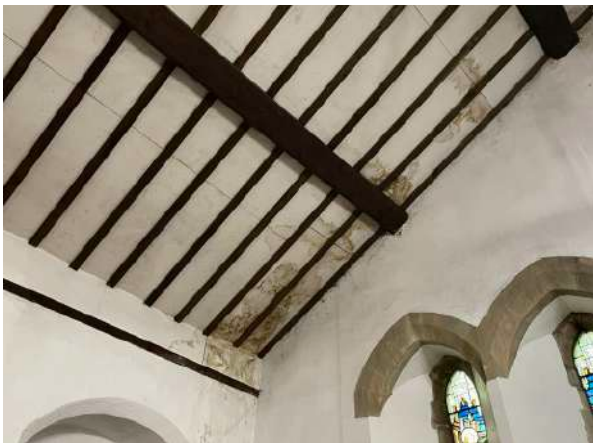
The walls generally appear to be in good condition. There are some areas of discolouring and possible dampness to the plaster around windows reveals. There is a section of missing plaster to low level on west wall.

Undertake isolated repairs to plaster and redecoration to the plasterwork.

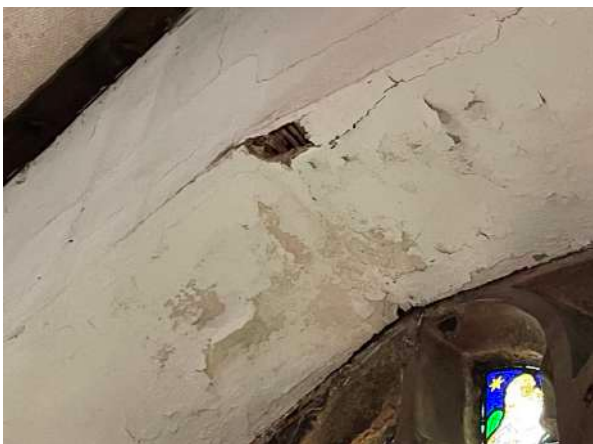
The walls generally appear to be in good condition. There are some areas of discolouring and possible dampness to the plaster around windows reveals and there is a water stain to south-west corner above south porch door.

Undertake isolated repairs and redecoration to the plasterwork.

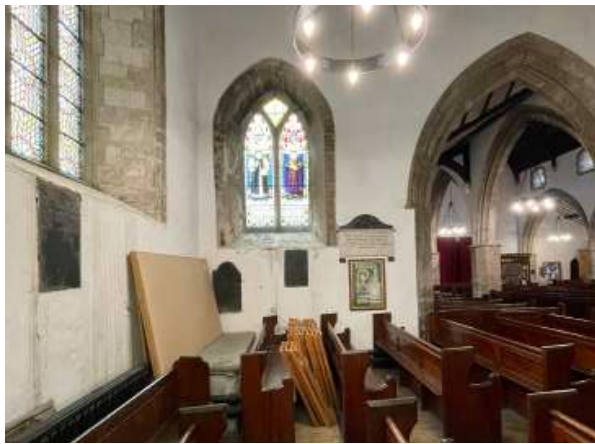
The walls generally appear to be in good condition. There are some areas of discolouring and possible dampness to the plaster around windows reveals. Small section of plaster above window nVII is missing.

Undertake isolated repairs and redecoration to the plasterwork.

Replaster section of missing plaster (above window nVII) with lime based plaster and redecorate with breathable paint.

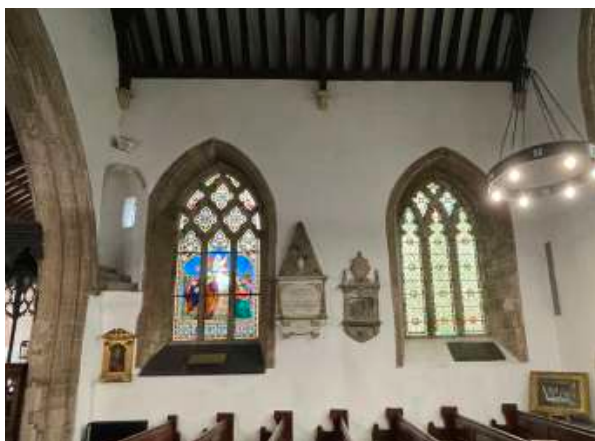
The walls are in very poor condition with large areas of dampness, flaking painting and water staining from the windowsills, especially to window sIX and sVIII. The plaster to the walls appears to be cementitious and trapping moisture behind.

Note: Following the external repair work, loose mortar should be carefully removed and all voids re-pointed using a lime based mortar. After a period of drying, the surface of the masonry could be lightly cleaned to remove any damp staining.

Carefully remove cementitious plaster to all 3no. internal elevations. Allow sufficient time to 'breath' prior to replastering using a lime based plaster. Re-decorate entire wall.

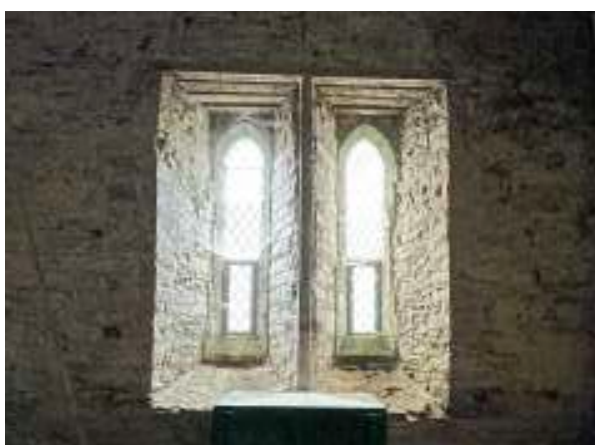
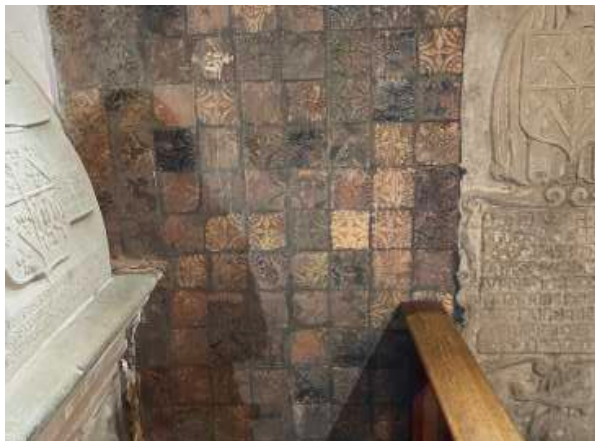
The north wall is drying out very well. The other walls (east, south and west) appeared to be in fair condition however it is possible that the modern thick gypsum plaster is preventing moisture within the wall to escape.

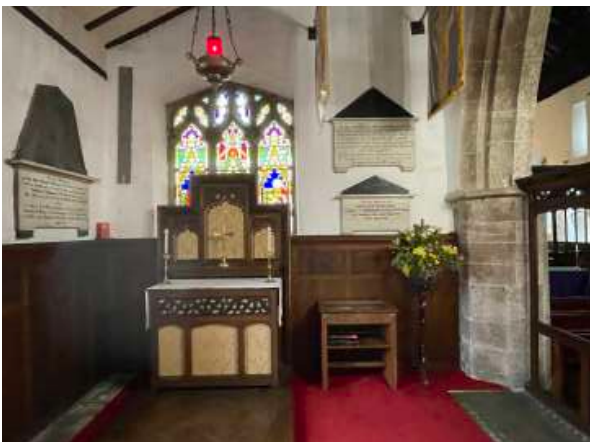
Historic crack to tomb and condensation/ damp visible to number of plaques, especially around the windows.

Covered under walls section.

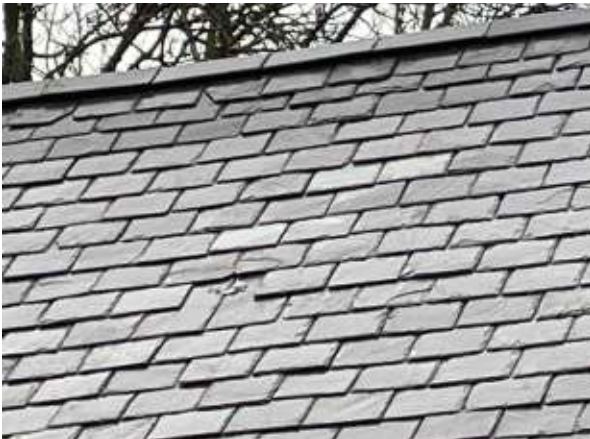
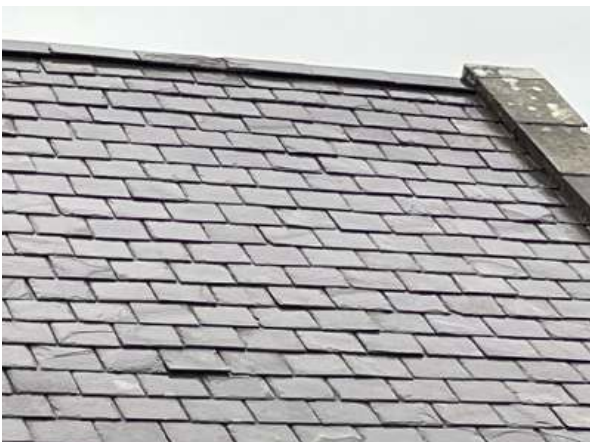
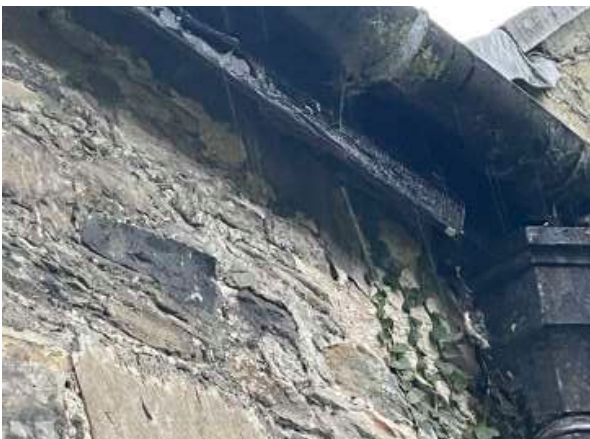
The roof is in fair condition. The lead valleys were clear and free from debris.

- Replace missing slate and refix all loose slates B
- Redecorate bargeboards on east elevation. D

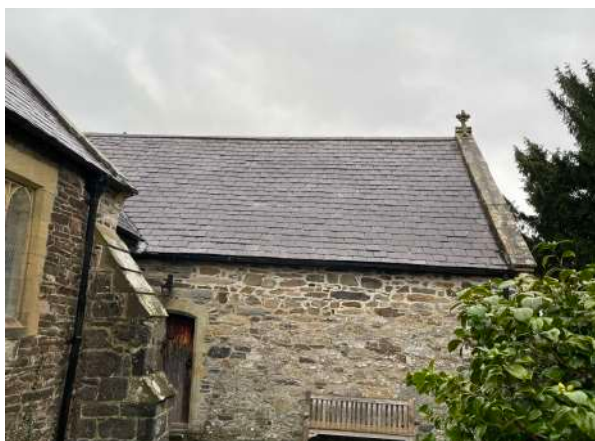
The render to the east elevation of the Nave, above the Chancel roof, has a number of cracks which may be allowing moisture to enter the church above the chancel arch. The point where the render meets the slate has been poorly detailed. Currently the render runs down directly onto the slate (we assume that there is no stepped lead flashing as the render doesn't appear to 'kick out'. This detail does not provide any flexibility for any movement in the roof or wall and will eventually fail.

North gable, west side of cellar door, there are missing pointing to low level stonework.

Repoint low level of north gable wall near cellar door. B

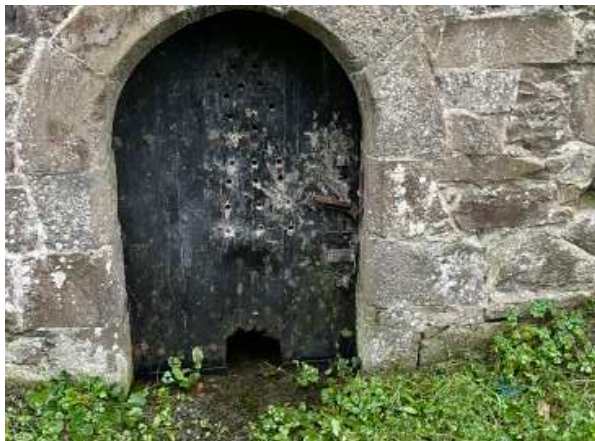
External door to Cellar: Due to the cellar being below the water table, the cellar constantly is submerged in water. On my visit there was approx. 1 feet of water. The condition of the lower door is likely to deteriorate and decay in the presence of moisture.

External door to Cellar: Undertake splice repair to bottom of boarded door and redecorate. Once done, fix gauze mesh to prevent small animals entering. C

External door to Cellar: Consider introducing additional ventilation to the bottom half of the door by applying a thin gauze mesh to the inner face of the door to prevent insects, mammals and birds entering the cellar. C

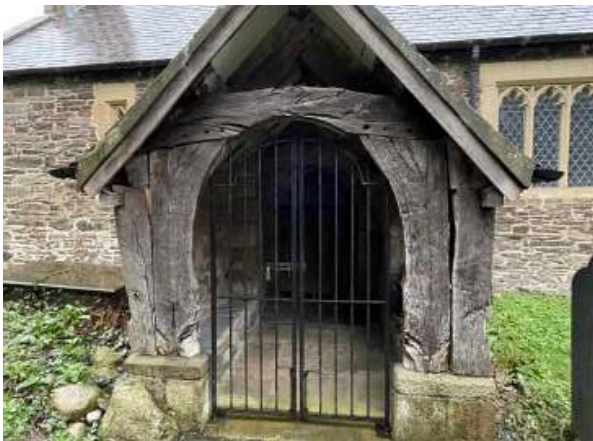
With heavy rain, the porch and floor were dry. The porch is in good condition. The early timber truss collar, adjacent to the Nave wall, has severe historic decay however this now appears dry and stable. This collar has been covered by the later collar fixed to the truss facing the porch gates.

None, covered under Churchyard and environs.

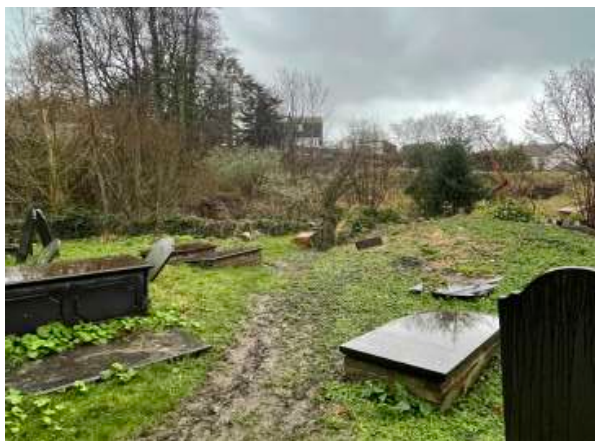
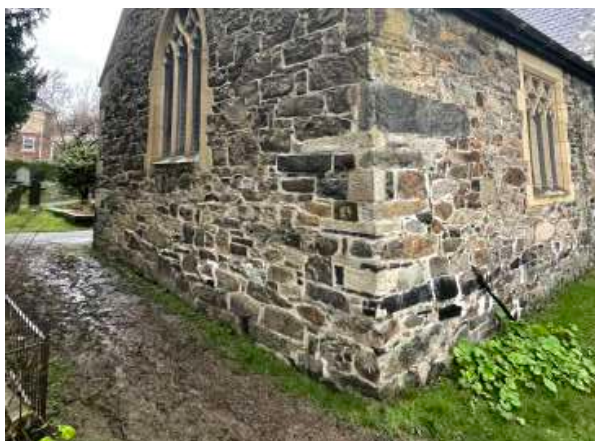
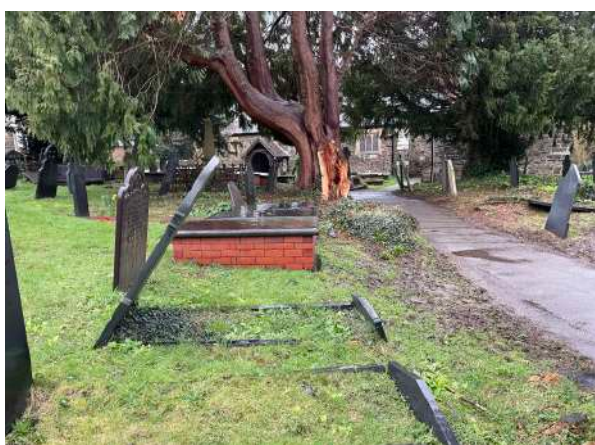
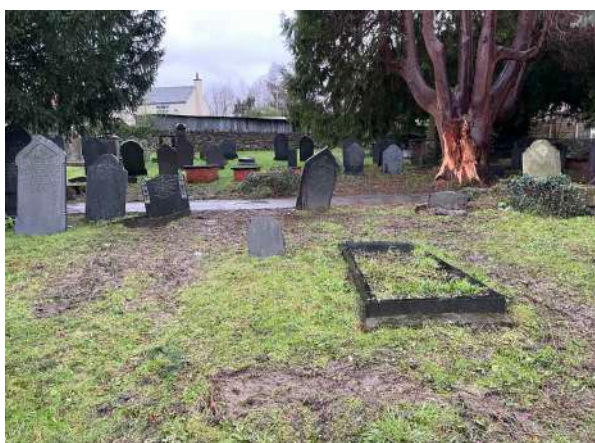
It was difficult to assess the condition of all the boundary walls, some areas have ivy / vegetation growing especially on the south and south-west boundary wall. The tarmac path is in good condition. The well-trodden foot path to the north-east of the churchyard was extremely muddy and slippery due to the heavy rain and existing ground being saturated.

A large section of cypress tree located southwest of the path in the churchyard came down in storm on January 21<sup>st</sup> 2024. (the fallen tree has been cleared since my visit on 22<sup>nd</sup> January 24’) This caused damage to gravestones on the other side of the pathway. (south-east)

Cut back overgrown vegetation to the north, south and south-west boundary wall of the churchyard and allow to undertake isolated repairs to stone wall once vegetation removed.

A report on storm damage Gravestone to be conducted in line with H&S.

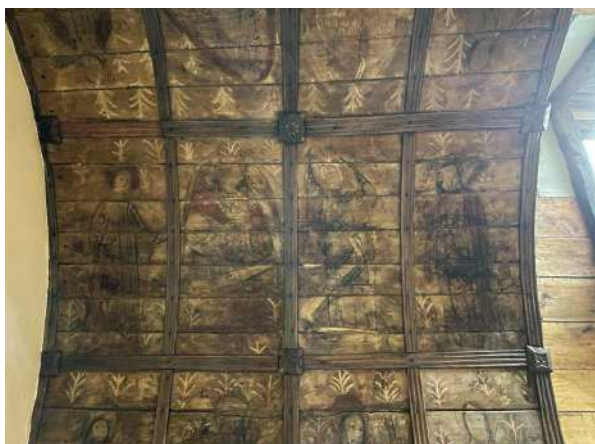
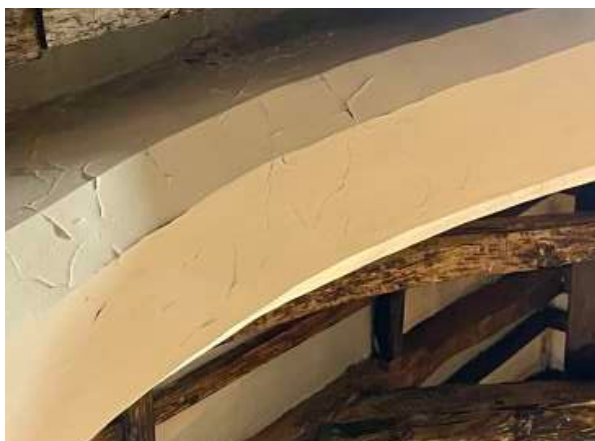
The medieval boarded wagon roof is set below the main roof line with a void above. The ceiling is generally in good condition.

The south plastered arch (between nave and chancel) has blistering plaster and water ingress staining indicating there are external issues in the junction between roof and wall. (this is covered under external roofs).

As the painted timber wagon ceiling has not been inspected by a specialist since 1991, we would recommend that a report on the current condition is undertaken.

As recommended in the last Ezra report, recommend monitoring the temperature and humidity levels within the church is monitored. This can be done by fitting battery operated humidity and temperature sensors which will record the findings every hour. This information will be critical in the long-term conservation of the painted ceiling. The recordings will inform the specialist conservator if there have been any environmental changes which have contributed to any accelerated deterioration.

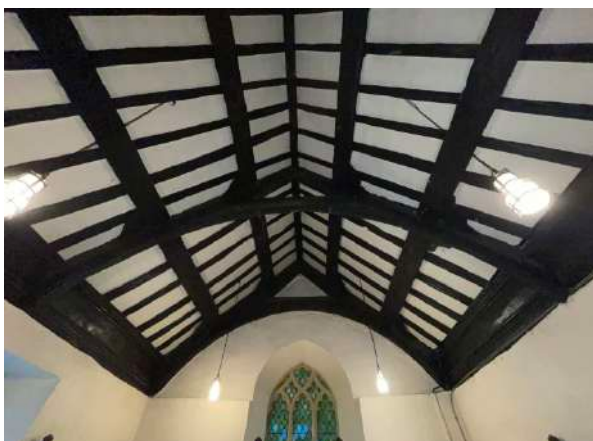
The ceiling is generally in good condition. A small section of plaster has fallen, (lath and plaster) between chancel and transept on east side.

The small section of void in the timber truss nearer the Chancel is missing.

Piece of timber on truss is missing, to be inspected by timber specialist.

Allow for a timber specialist to get high level access to oversee the condition of the timbers. (covered elsewhere)

Repair section of missing plaster with lime plaster.

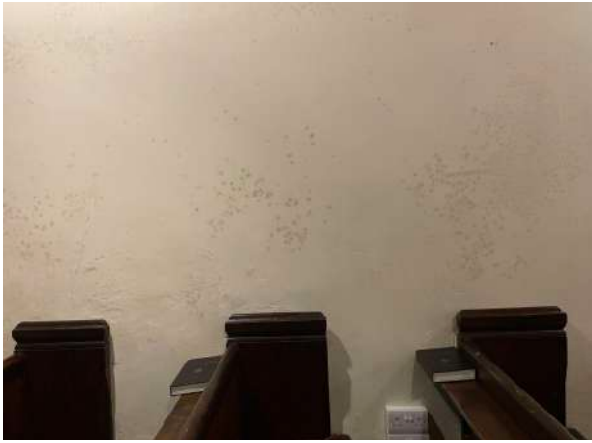
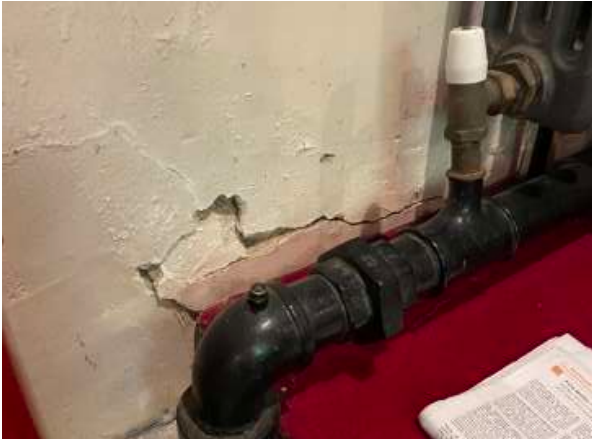
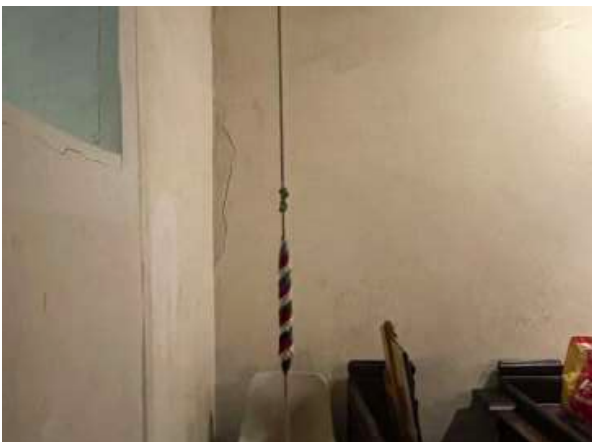
At the western end of the Nave there is a vertical crack in both corners (on the north and south wall). It is possible that this relates to the stabilisation of the western gable. Noted under external walls that there is a vertical crack at high level to north-west corner of the west gable.

There are damp stains on both south and north elevations, but considerably more on the north elevation. In window reveal of WI, there are areas of dampness, blistering plaster and flaking paintwork. This may be a result of a non-breathable paint and plaster skim applied to the surface of the wall and the quality of the external pointing. Please see recommendations under Aesthetic improvement.

Crack to base of north wall near central heating pipe / pulpit.

Following the external repointing, covered elsewhere within this report, the condition of the wall should be reassessed to see if this moisture levels have reduced thus avoiding the need to undertake immediate action internally. Should the dampness remain, we would recommend removing the non-breathable paint and plaster and replaster using a lime-based plaster and a breathable (ideally limewash) coat.

The vertical cracks were noted in both previous Quinquennial inspection and Ezra report of 2018. These cracks should be monitored. If there is evidence of the cracks worsening, (widening or increasing in length) a conservation accredited (CARE) structural engineer should be consulted.

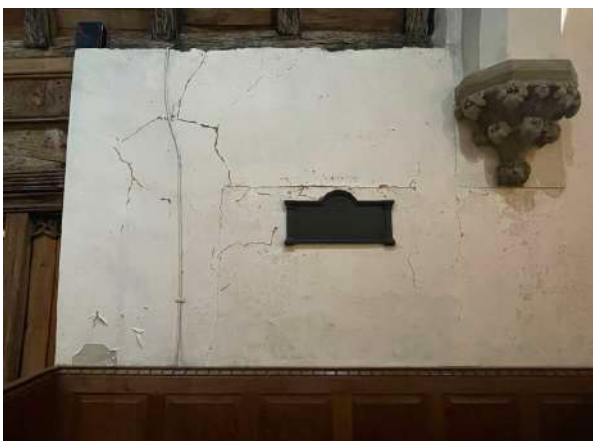
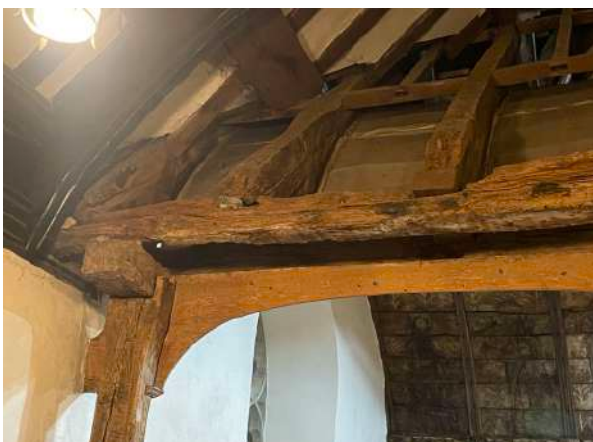
It was noted in the last Ezra report that on the south elevation there was an area of dampness, blistering plaster and flaking paintwork. This may be a result of a non- breathable paint and plaster skim applied to the surface of the wall and the quality of the external pointing or the void above. During inspection this area has considerably deteriorate, which coincide with the external issues, there is also evidence of slug trails on the timber wall plate.

The timber parclose screen is in fair and stable condition. A section of the reed moulding has split however this is visible in the 1948 RCAHMW photographic record and does not appear to have widened.

The 'wall plate' of the timber screen dividing the Chancel and North transept and the feet of the rafters bearing onto the screen has decayed and lost a large amount of its width. This appears historic as there is existing 'packers' in situ supporting the rafters. Despite the loss, the timber appears dry and retains its integrity

On south wall of chancel once external works have been addressed, remove the non-breathable paint and plaster, and replaster using a lime-based plaster and a breathable (ideally limewash) coat.

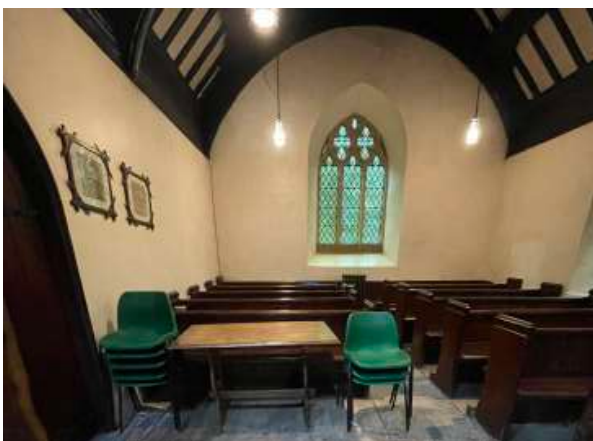
The walls appear to be in fair condition. Damp and peeling plaster to north gable wall. There is some hairline cracking to the gable wall, running above window nIII and to northwest corner of gable, but nothing noticeable externally.

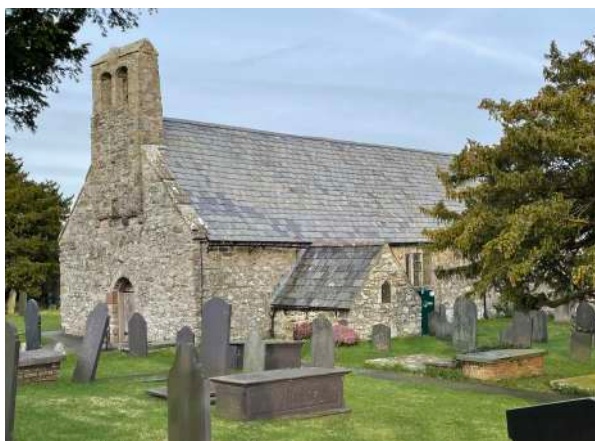
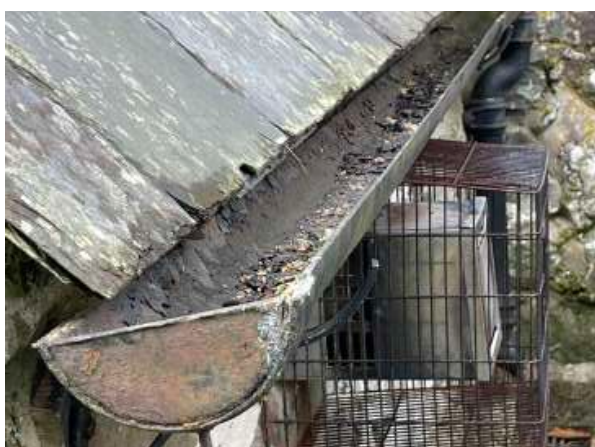
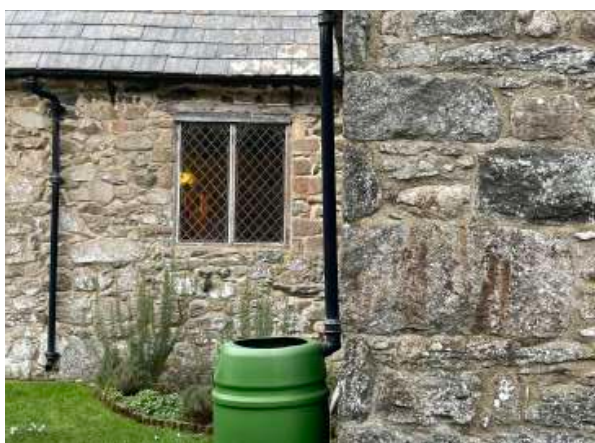
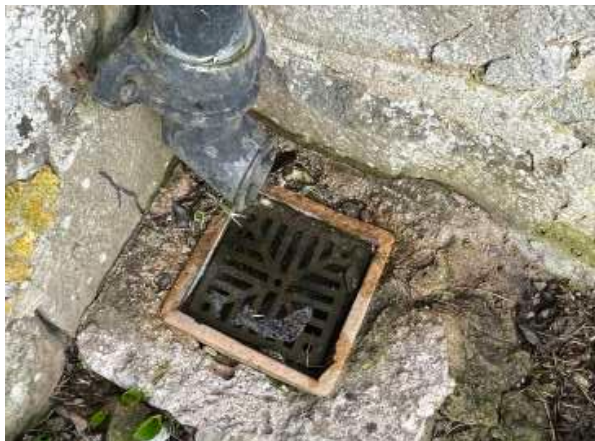
Cast iron good in fair condition, east gutter on vestry is rusty.

Remove rust and re-paint. D

North elevation has only one downpipe for the perimeter of the roof. It would be worth considering installing additional downpipe to the north-west side to even distribute the roof surface water. F

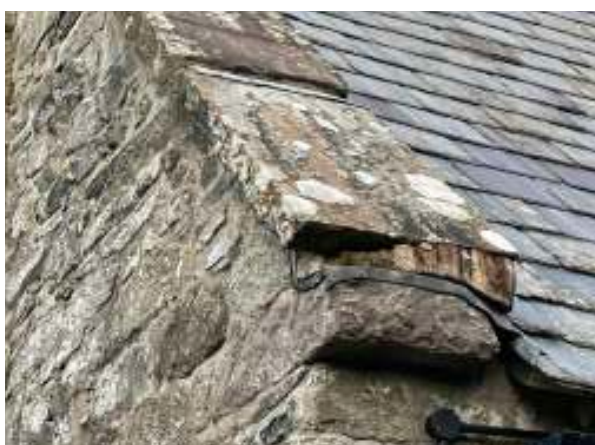
Generally in good condition although evidence that cementitious mortar was used during the 1970s restoration.

Allow to rake out cementitious mortar and replace with more appropriate lime mortar.

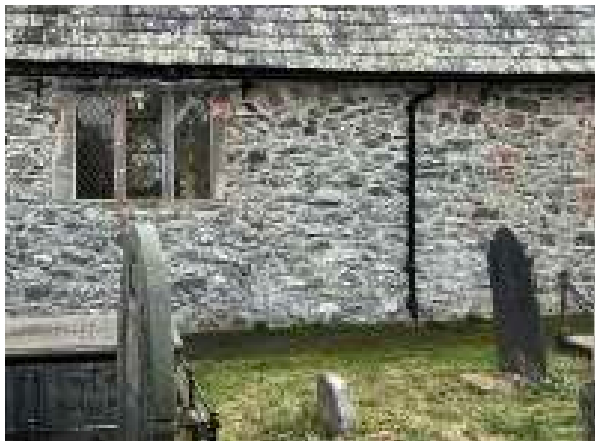
Missing mortar to end of coping stone to south of west gable.

Rake out cementitious mortar and make good with lime mortar.

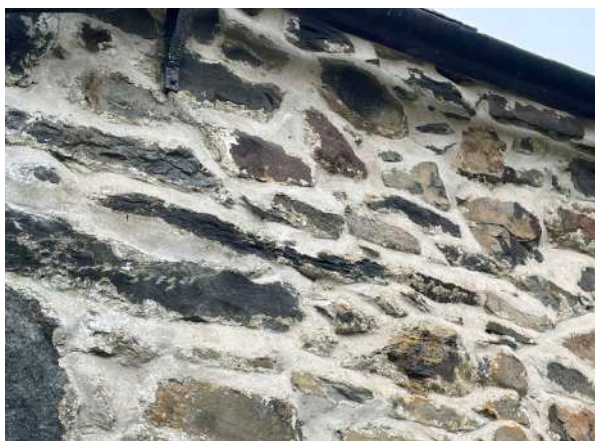
Walls generally in good condition, although cementitious pointing is inappropriate for a building of traditional construction.

Allow to rake out cementitious mortar and replace with more appropriate lime mortar.

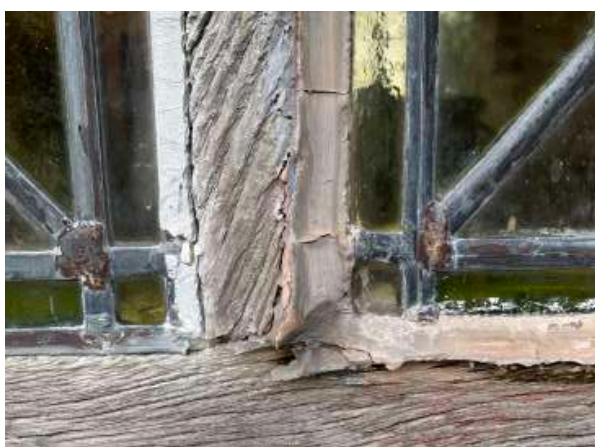
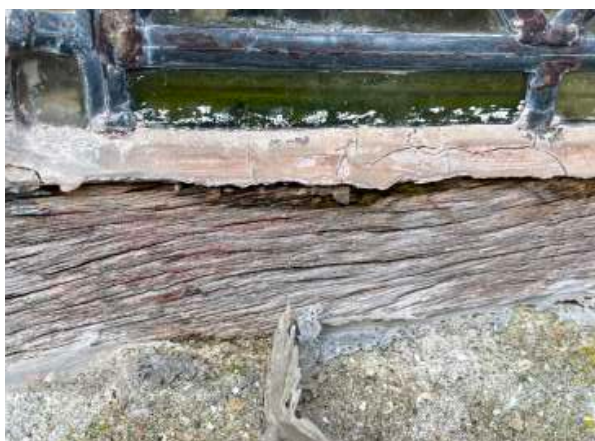
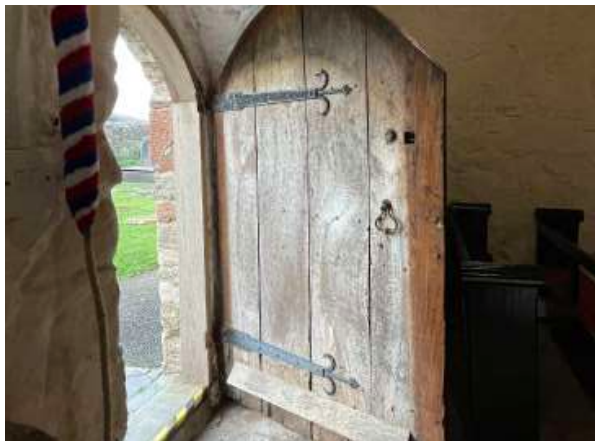
Generally windows all in good condition although there is evidence of water ingress to head of window sIII, and plastic mastic has been used to window sIV. The timber to the bottom east corner of window sIV is in poor condition and may be allowing water ingress.

Allow to undertake simple repair to timber frame of sIV.

Allow to point head of windows internally to windows sIII and sIV.

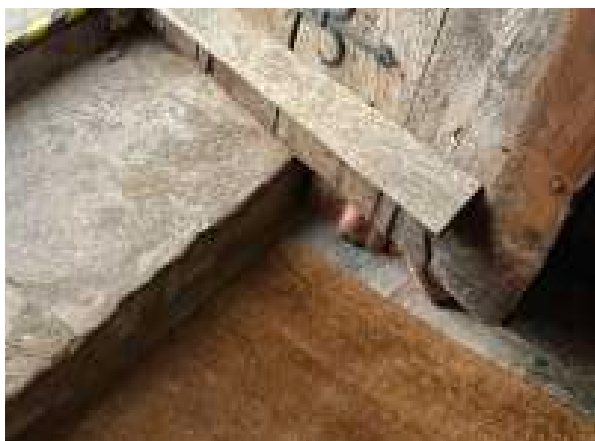
West door in fair condition, the bottom right corner (opposite side of the hinge) is showing signs of water ingress.

Allow for splice repair to bottom of door.

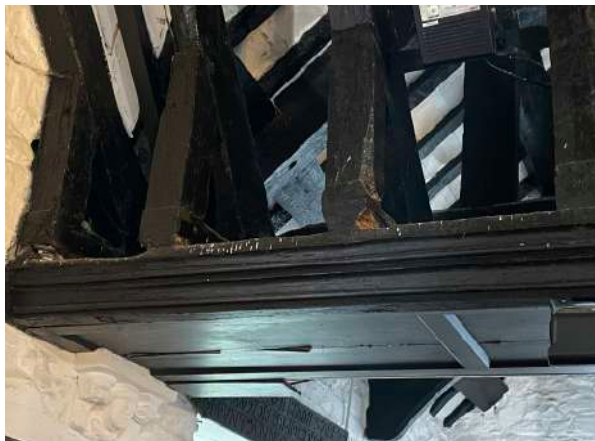
Generally roof structure and ceiling in good condition some evidence of failed torching present but otherwise roof in good condition considering its age.

Remove guano from beam between chancel and south transept. D

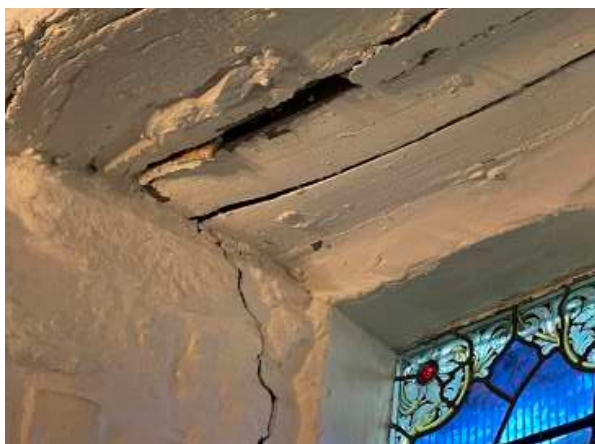
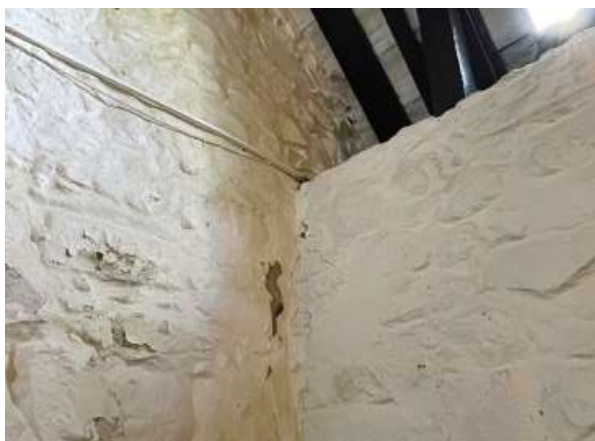
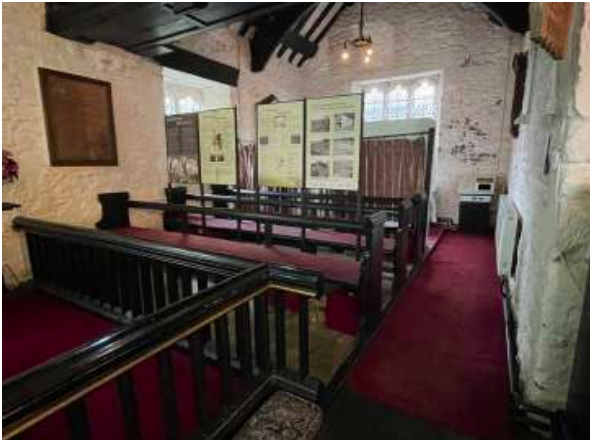
Generally fair condition, damp staining, and peeling plaster present, especially to west wall, to window reveals, south transept, north wall of Chancel and south wall of Nave. Water ingress evident adjacent to window sIII and sIV.

nIV – west side there is a vertical crack between the wall and window frame.

Allow for a structural report to check the cause of crack near window nIV. B

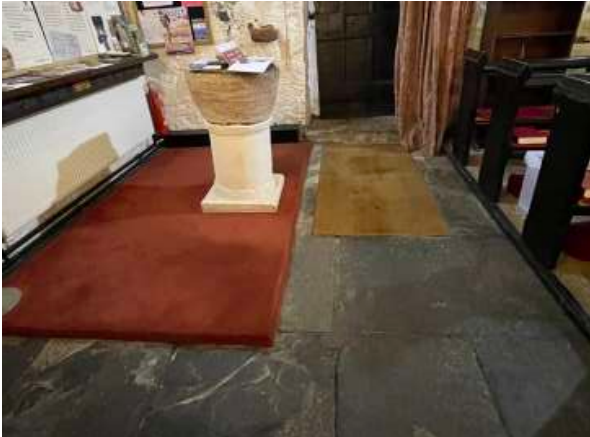
All generally in satisfactory condition, although suspended timber floor is springing towards south end of the south transept.

Allow to open up and investigate floor void in south transept. B

Allow to undertake any remedial works required and introduce ventilation to floor void of south transept. B

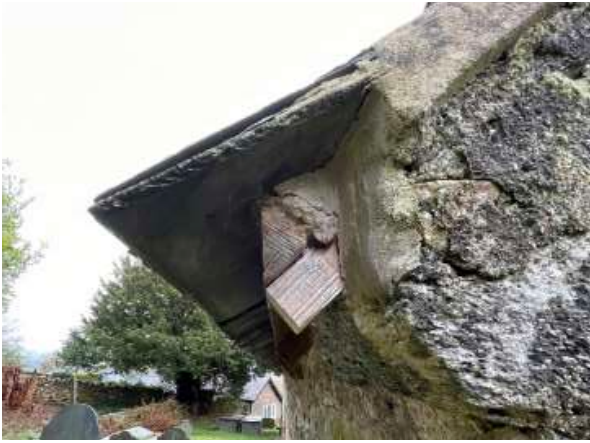
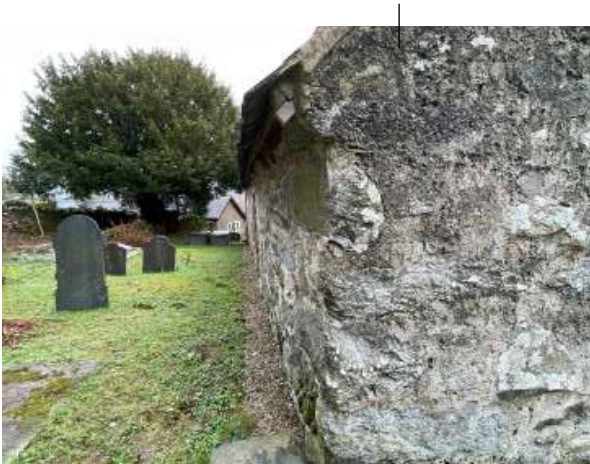
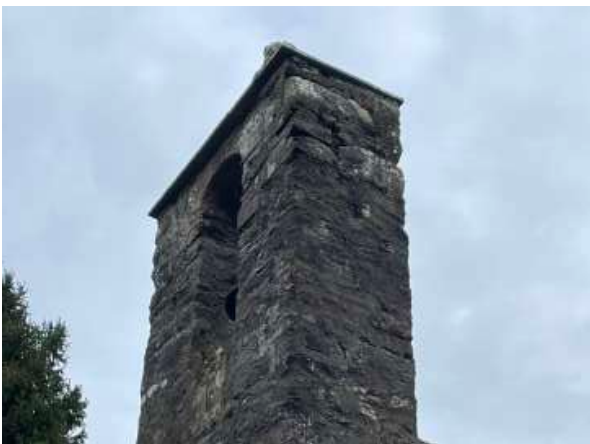
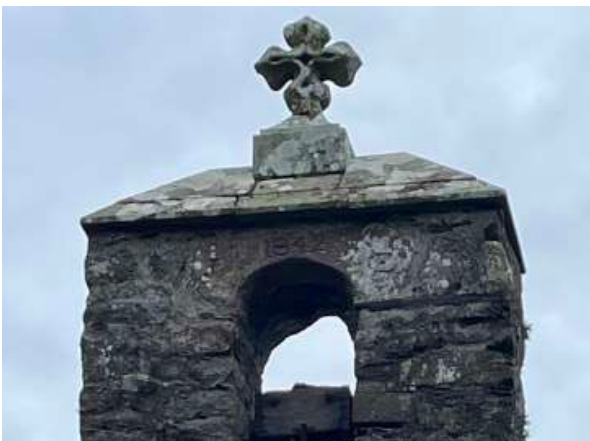
Stonework all generally in good condition although there are vegetation present in open voids and pointing is suspect in places and cementitious in areas.

Allow to rake out and consolidate and repoint using appropriate lime mortar.
