# Bro Celynnin

## Ezra Report

Management and Maintenance Plan for Period 2024 - 2029

Conducted by  
Bethan Jones  
Swyddog Eiddo Archddiaconiaeth | Archdeaconry Property Officer

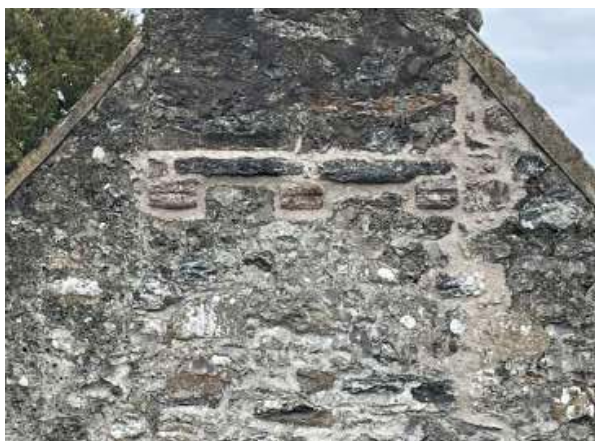
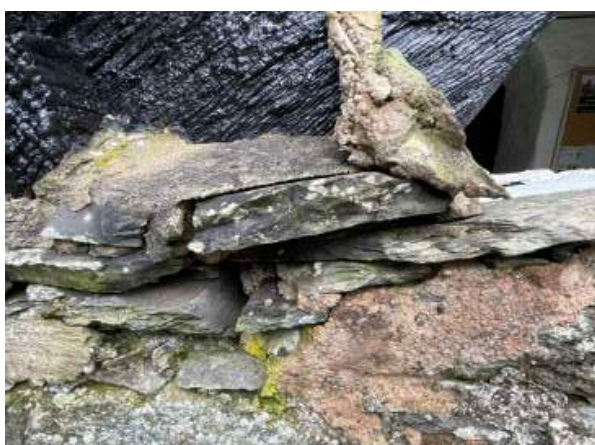
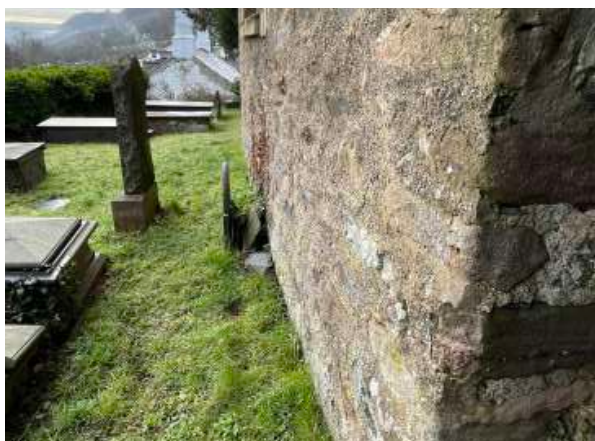
Pointing generally in fairly poor condition to perimeter of church bar south gable of south chapel. Damage has been done to stonework to west gable of Nave due to hardness of pointing used in previous repairs.

Porch – end of the wall where the roof trust sits, cementitious pointing is loose on both sides.

Allow to undertake full repointing exercise to external elevation of church using appropriate lime mortar. C

Allow a tell-tail to be installed on the Voussoir. B

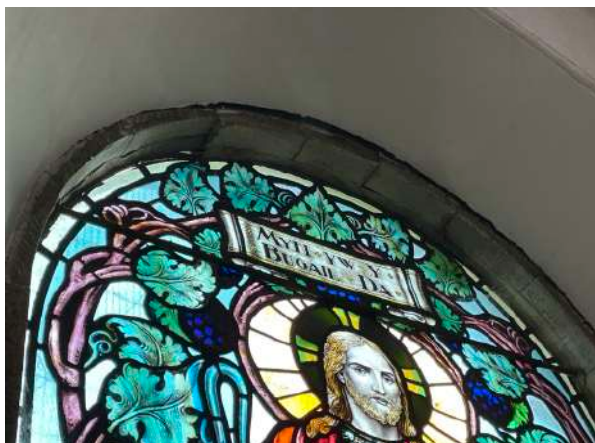
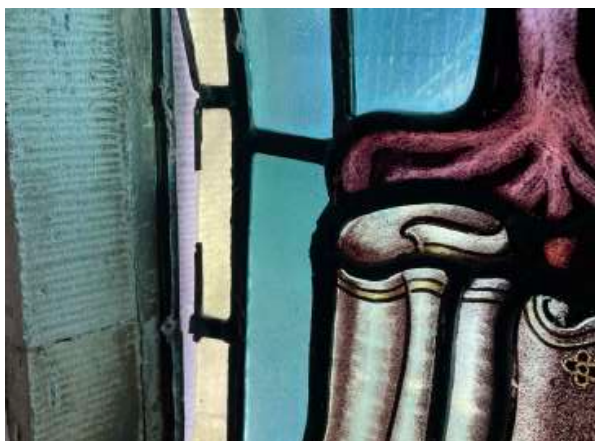
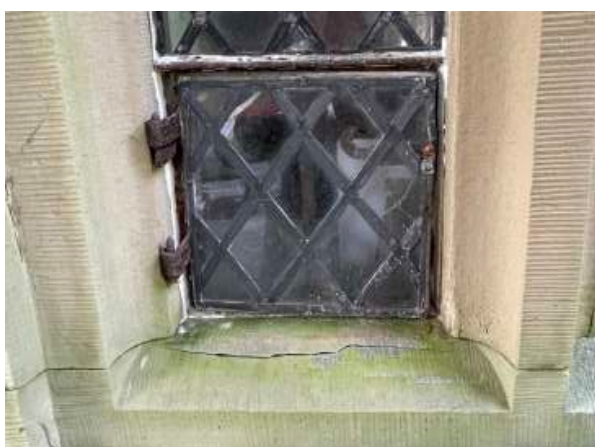
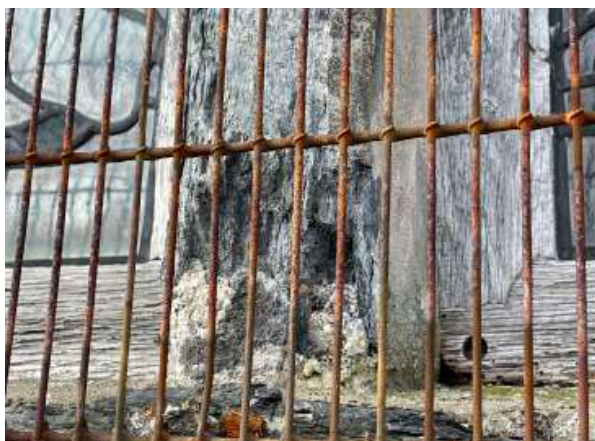
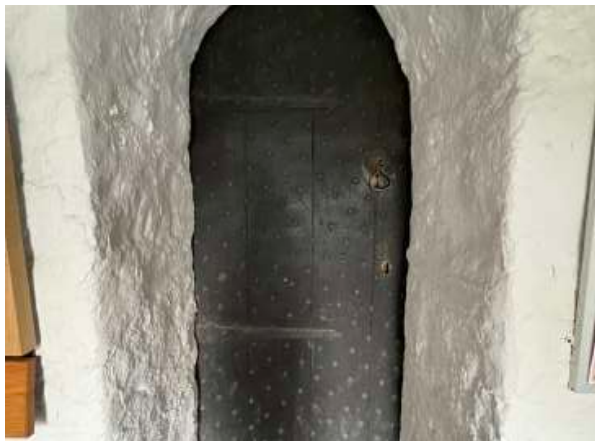
Windows generally in fair condition. Both hoppers are rusty and in poor condition.

I – the structure of the stone arch has become weaker due to stones at centre top have moved / dislodged. The lead is showing its age and has caused the window to bow in numerous places. Ferrous metal mesh.

sII – stain glass in good condition. Ferrous mesh. Bottom of central timber mullion showing signs of decay, cementitious mortar has been used in past to fill. Bottom frame (right hand side looking externally) starting to rot.

sIII – right hand corner of stone window frame (looking externally) stone has blown. Missing lime mortar to window.

sIV - Leaded lancet above is missing to sIV and mortar.

wI - has Perspex fixed externally. Internally small section of stone mullion has fractured and mortar to window loose.

nII – hopper rusty, and crack to stone sill.

nIII – some areas of lead are failing and hairline cracks to some glass panes visible. Hairline crack to stone arch above stone mullion (right hand side looking onwards)

nIV – missing mortar to bottom of window (right hand side) hairline cracks in some glass panes. Missing mortar in stone mullion joints.

Allow to remove all evidence of putty and replace with more appropriate lime mortar to majority of windows. B

Allow to overhaul opening hopper to window sIV and replace missing lancet. B

Allow to replace security grills to windows I and sII with more appropriate non-ferrous security grills. B

Allow to overhaul opening hopper to window nII and to undertake stone repair to sill below. B

Allow for timber splice repair to window sII. B

Remove Perspex to window wI. B

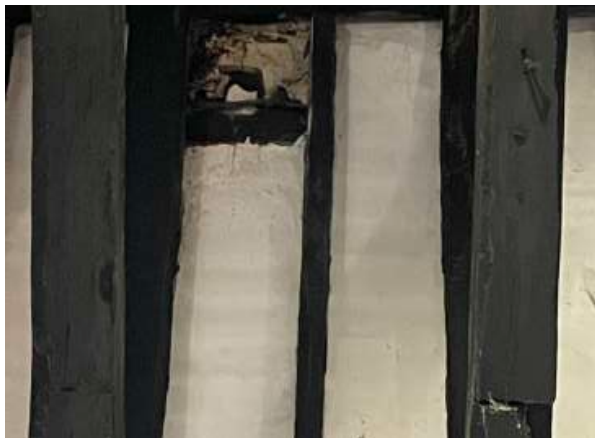
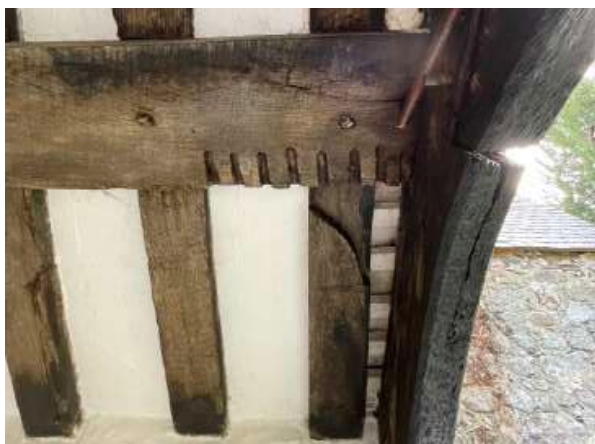
Roof structure generally in satisfactory condition. Plaster is flaking to Nave roof, especially to the north. Day light and vegetation visible (north side) caused by slipped slate.

South chapel - upper sections of plaster below ridge beam (north-west roof slope) and below ridge beam on south-east are missing. Peeling plaster visible here too.

Truss above altar has failed torching.

Nave roof – once exterior works is complete, repair and replaster ceiling with lime mortar.

Replaster areas where plaster is missing.

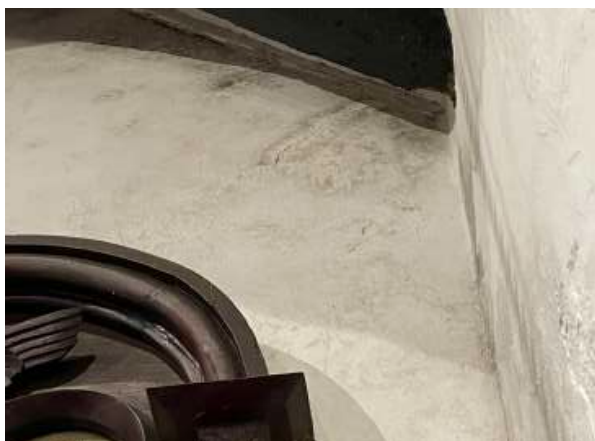
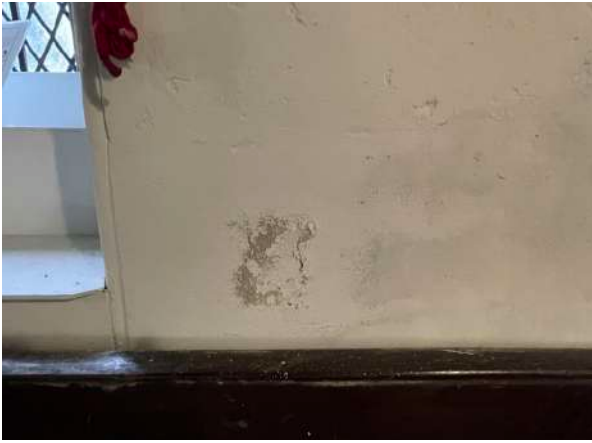
Walls generally in satisfactory condition although evidence of damp to low and high level to entire perimeter of the church bar southeast corner of south chapel. Woodlice have taken residence to north-east corner. Evidence of failing plaster to south and north walls of Nave. Decorative finish to north wall of Nave, east wall of south chapel near sII, and west and south wall near sV is generally poor.

South gable wall of south chapel showing signs of damp.

East gable wall is leaning outwards, cracks visible.

Allow to remove failing plaster and lime wash exposed substrate below to encourage drying out. B

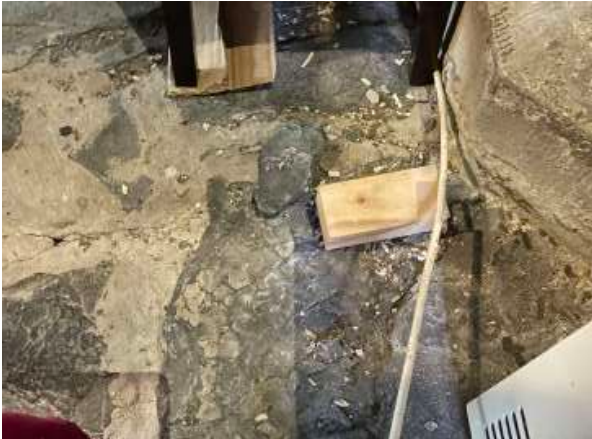
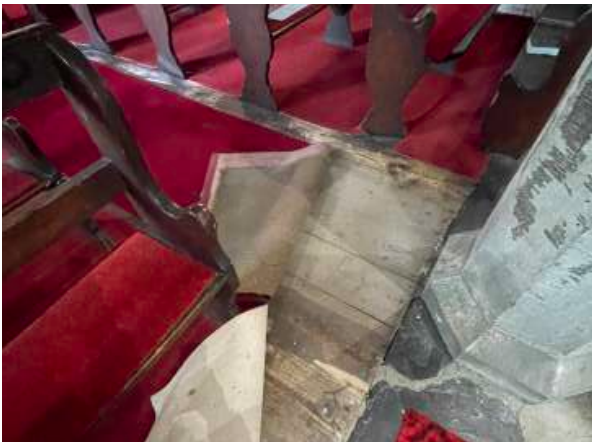
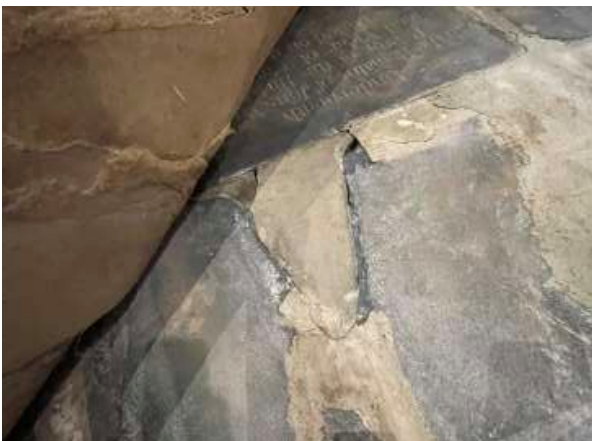
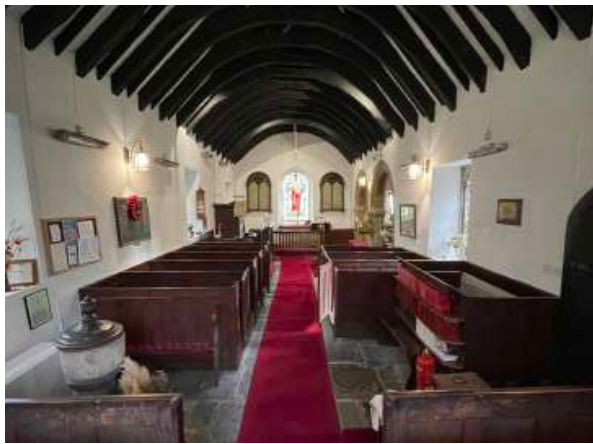
Slate flagged floor generally in satisfactory condition, although some pointing has failed leaving open joints.

Delamination of slate to south-east of the nave (by sV) is another sign that there is a need to investigate ground saturation, recommendation covered under church yard and environs.

The northern pew plinths to the Nave are springy in sections suggesting failure of floor joists below as well as to floor centrally to south chapel. Upper terrace of raked seating to west end of Nave is also springy which suggests issues with joists.

Allow to open up and inspect floor void to south chapel C

Allow to undertake repairs to south chapel floor, north pew plinth to Nave and upper terrace of raked seating to west end of Nave, introducing ventilation, at the same time to prevent return of issue. C

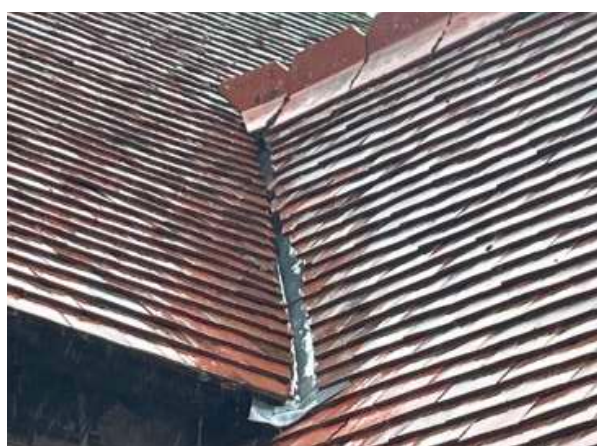
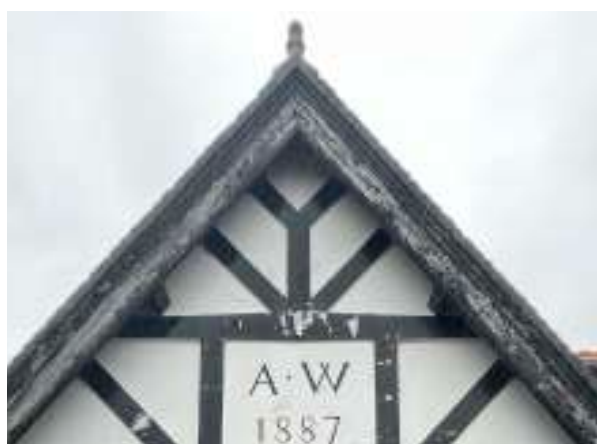
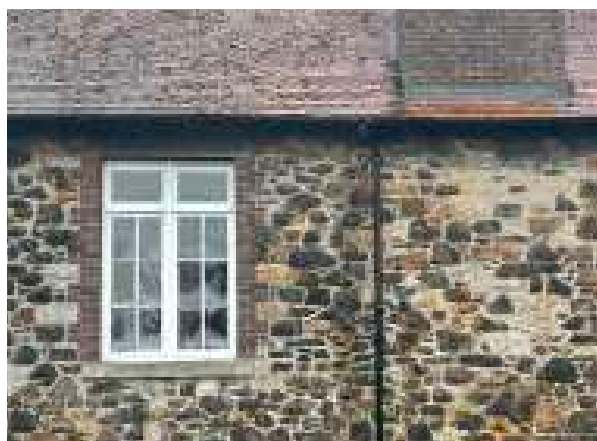
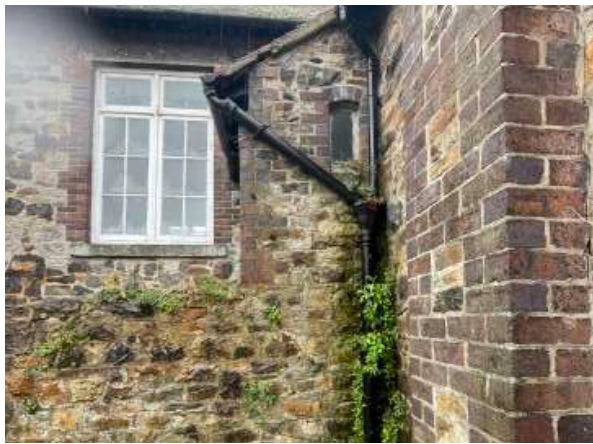
The clay tiled roof is in fair condition. They are generally well aligned with only isolated locations where areas have risen or fallen out of alignment. There are a number of slipped and broken tiles. The north roof slope has more moss growing between the tiles.

The ventilators are in very poor condition and may be allowing water into the loft space above the church hall. The lead flashings appear to be in poor condition and there are a number of broken and missing tiles.

A number of the ball finials are missing.

Undertake isolated repairs to the roof to replace broken tiles and repair slipped tiles. **B**

Ventilators to tiles be reroofed allowing to replace lead flashings with new and redecorate timber louvers. **C**

Reinstate ball finials. **C**

Strip down all fascia boards and repaint with exterior timber Weathershield paint. **D**

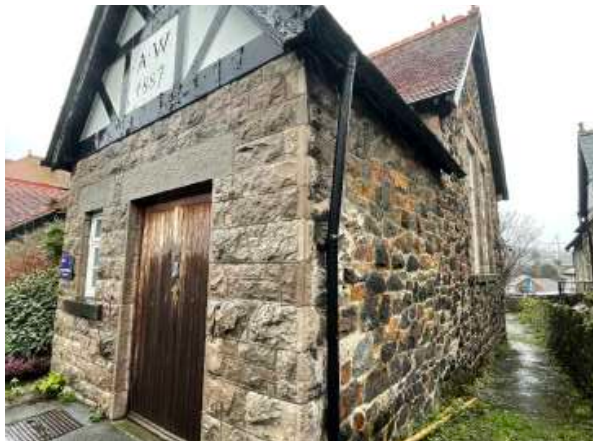
The cast iron rainwater goods appear to be in fair condition however a number of downpipes have fallen out of alignment and are partly blocked. A large number of the gutters are blocked causing water to spill over onto the face of the masonry and the ground below.

Clear vegetation from gutters. Unblock downpipes and correct alignment. D

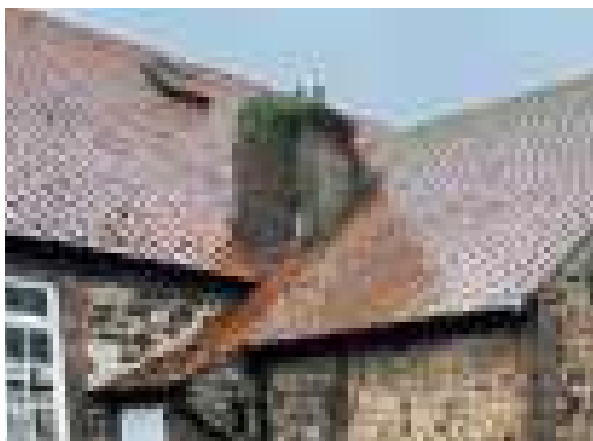
The chimneys appear structurally sound however there is missing pointing mortar and vegetation growing over the face of the masonry. The lead flashings also appear to be failing as there is evidence of water ingress on the internal ceiling beneath the chimneys.

Remove vegetation. Point brickwork. Replace capping with new. Repair lead flashing. B

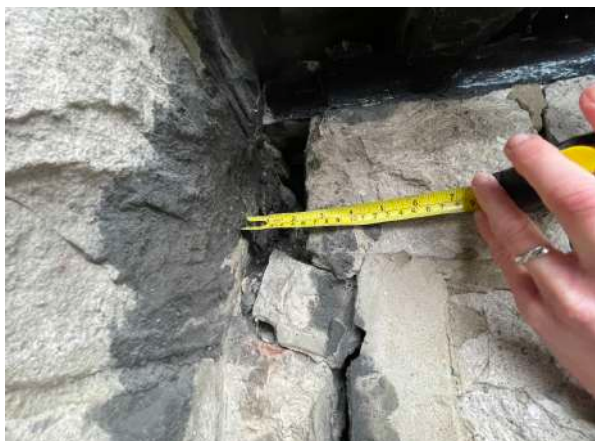
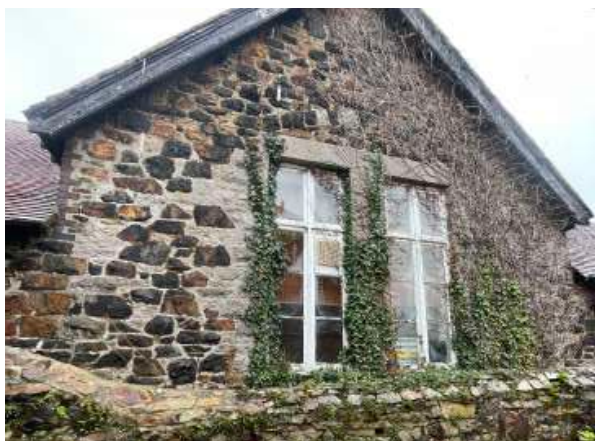
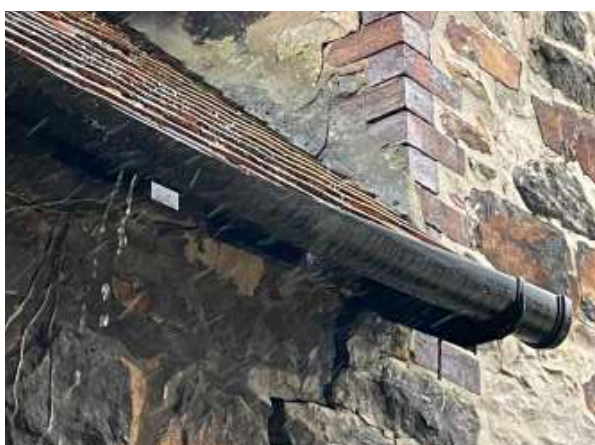
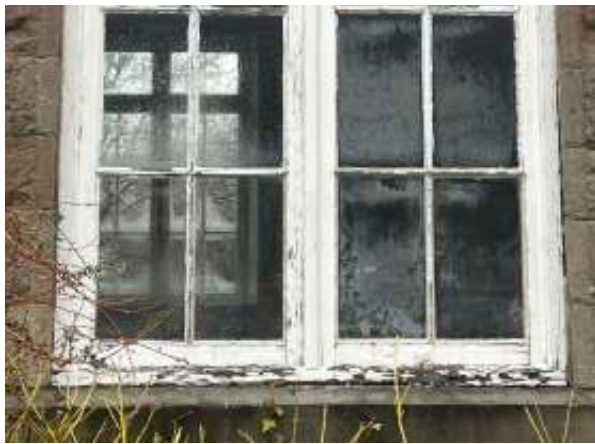
There are two noticeable subsidence cracks in the building. One on west wall in conjunction between G07 and G08 and the other between G06 and G04.

The stonework itself is in good condition however the north, east and west walls appear damp. This is likely to be a combination of the cementitious mortar and condition of the rainwater goods above.

Undertake isolated repairs to mortar. Repoint loose, friable or missing mortar. B

Localised replacement of cementitious mortar with an appropriate lime-based mortar. B

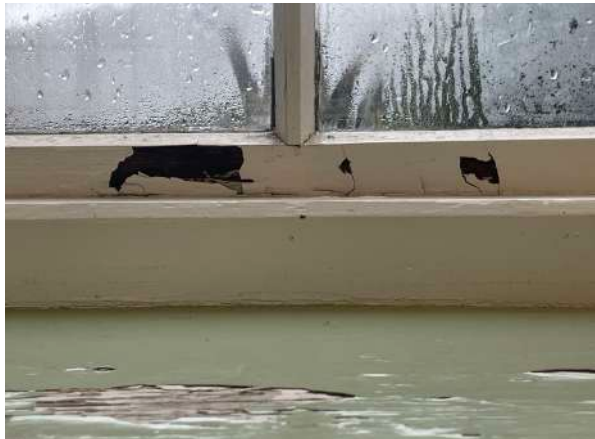
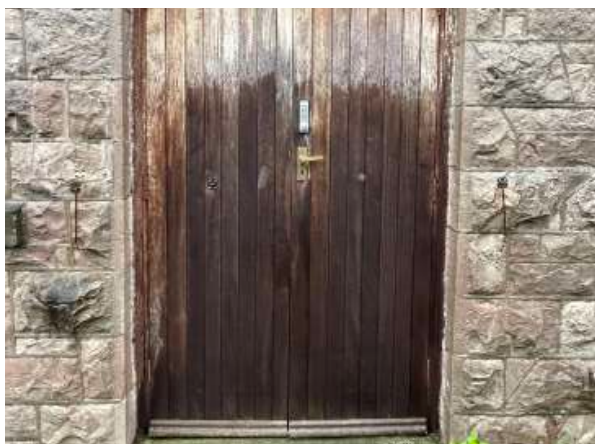
The windows are in poor condition. These do not appear to have been regularly maintained or redecorated resulting in the decay of the timber frames and cracked panes of glass. The majority of decay appears to be to the sill and transoms. The windows on the north gable are in a particularly poor condition with large section of glass pane missing / broken to G08.

Undertake timber repair to windows to replace sections of decayed timber with new. Ensure all windows can be easily opened and locked. Redecorate following repairs.

In order to improve the thermal efficiency of the windows, consider the use of secondary glazing. This can be located internally within the window reveals. This will also provide additional security to the building.

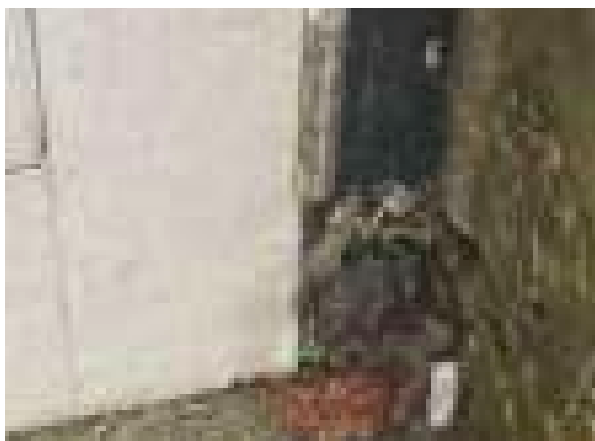
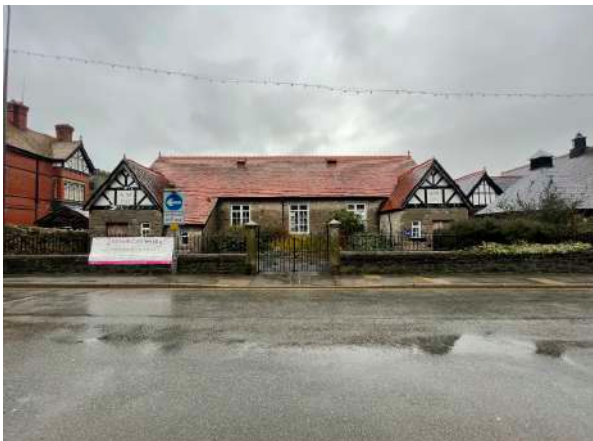
The doors are in fair condition, the staining has worn away and should be renewed to provide suitable protection to the timber.

The timber doors and decoration are in fair condition. A small section to the bottom of the frame to door G09 has decayed, (bottom right).

Redecorate / stain 2no. timber boarded doors.

Undertake splice timber repair to the frame before redecorating frame and door in its entirety.

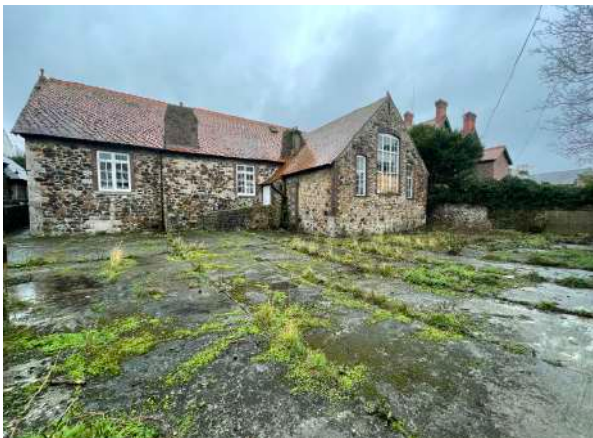
The covered timber section of the ramp directly adjacent to the timber door was very slippery and also had wet leaves collected adjacent to the wall.

Vegetation growing through open cracks and in general very slippery.

A length of coping of the stone wall adjacent to the ramp was missing.

The concrete yard to the rear is in a very poor state with vegetation growing everywhere and open cracks making whole area and health and safety issue.

Replace coping with new to match existing. C

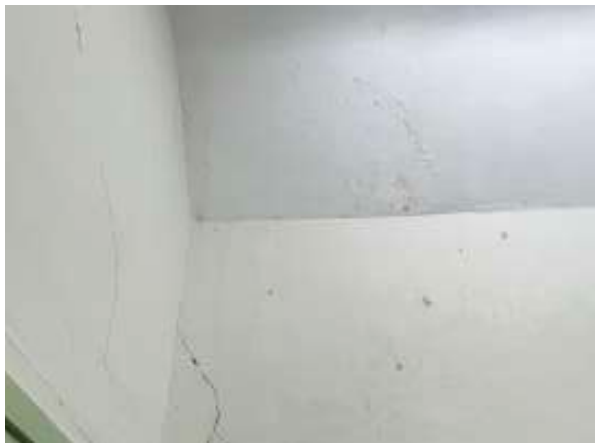
The plaster appeared to be in good condition albeit water stain to east corner of G01.

Redecorate plaster. C

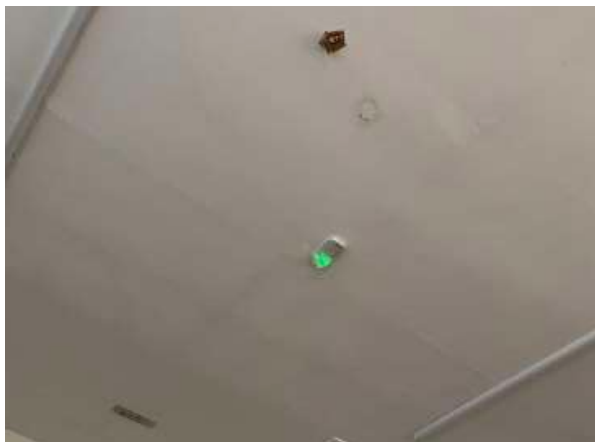
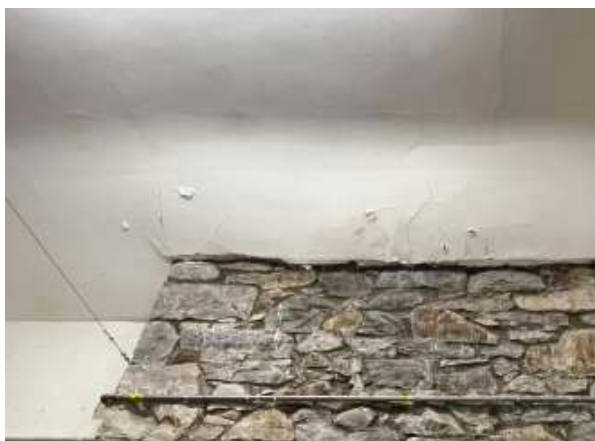
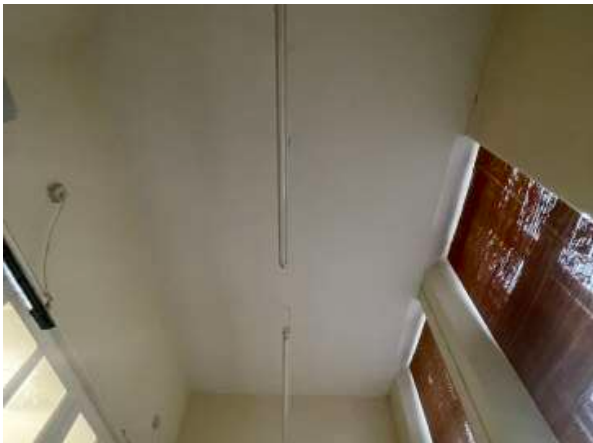
Ceiling joists visible through plaster. The ceiling above the chimney breast (west) has two cracks and has water stains highlighting there are water ingress issues to chimney. There is also water damage to ceiling centrally.

Once external recommendations to the roof and chimney are conducted. Redecorate ceilings and paint with breathable paint.

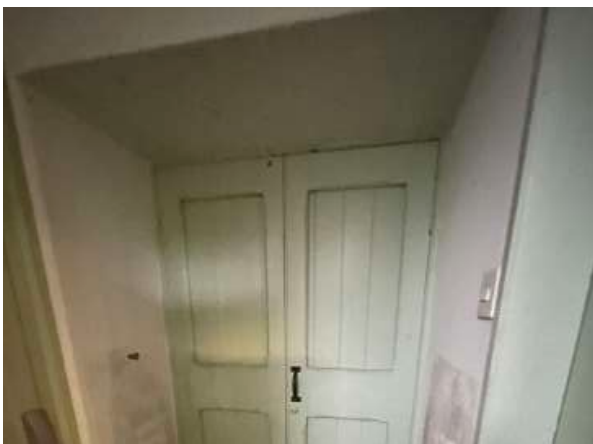
The plaster is generally in good condition. There are isolated areas which have hairline cracking particularly around the trusses. Condensation is visible on all walls.

Redecorate ceilings with breathable paint.

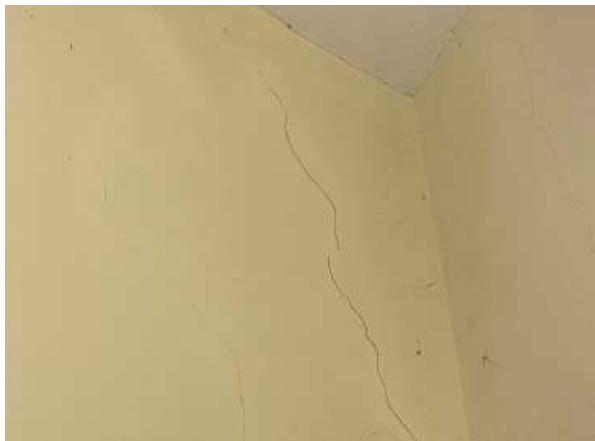
The plaster is generally in good condition. There are isolated areas which appear damp, condensation marks and hairline cracking around chimney breast. The masonry of the chimney breast appears damp. Bare plaster (previous removal of radiator) on south wall.

Note. Rectification of the moisture ingress to the chimney breast covered in external work.

Redecorate walls with breathable paint. C

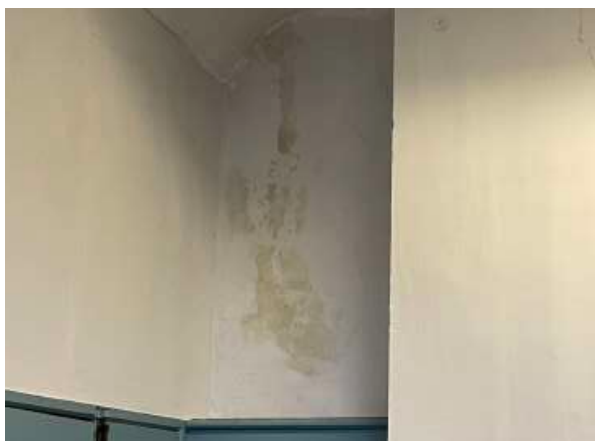
Vertical crack to west wall, top right of window.

Note - structural work covered in external walls section.

Once exterior works done, redecorate walls with breathable paint. C

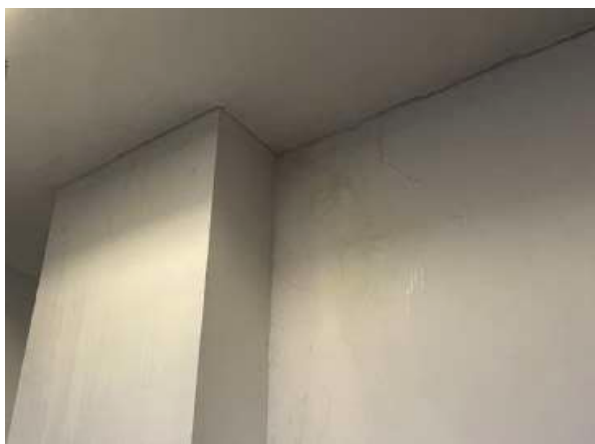
The plaster is generally in good condition. There are isolated areas which have hairline cracking particularly around the truss on the west wall. There is also dampness and condensation marks to majority of the walls and around the chimney breast.

Once exterior works done, redecorate walls with breathable paint. C

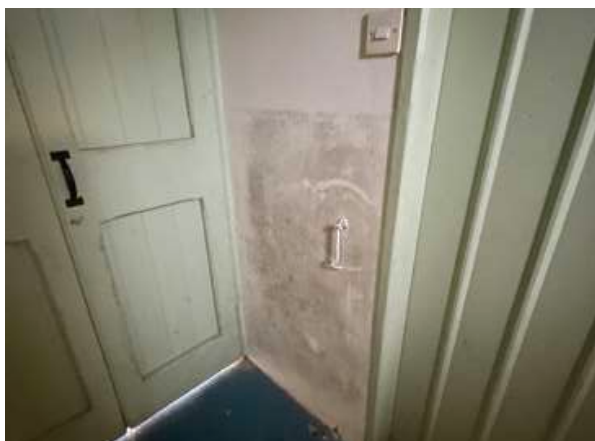
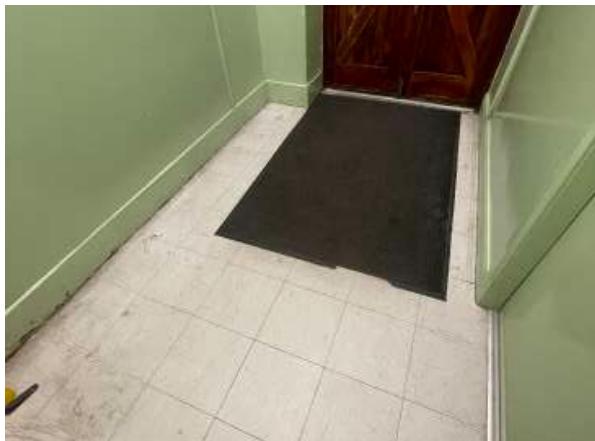
The plaster and paintwork around the window have blistered. Damp stains from ground to mid-level of walls.

Brush off loose and flaking paintwork and redecorate using breathable paint. C
