CHURCH OF ST TEGAI, LLANDEGAI SUPPLEMENTARY REPORT AND QUOTATION

SPECIFICATION AND QUOTATION No. 6.0 (Revision A) TO PROVIDE AND FIT WEATHER PROTECTION TO THE BELL CHAMBER LOUVRED OPENINGS

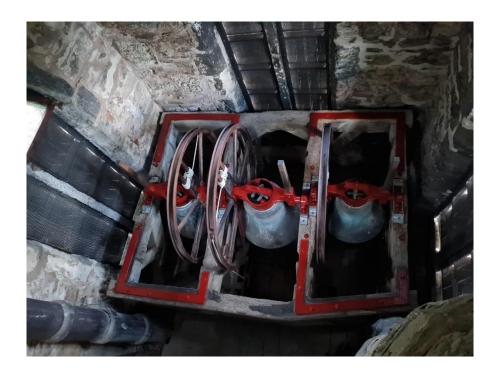
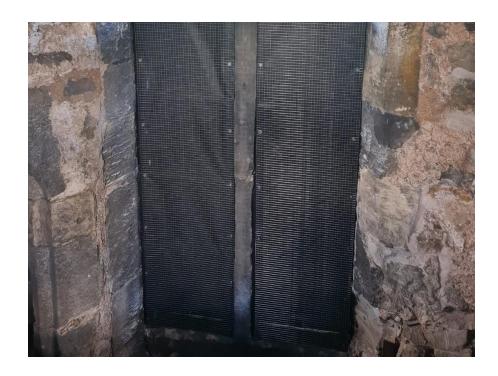
We have recently carried out similar work at St Martin's Church, Bole, Notts, in the Diocese of Southwell and Nottingham. As part of a major renovation of the ring of three bells, we also manufactured and installed new louvres for the bell chamber openings and fitted weather mesh and stainless-steel rigid mesh internally, shown in the photographs below.

The bell chamber openings at Bole are of a completely different design, however I hope these photographs will give some idea of the internal appearance of the weather protection. There are possibly other examples that might more closely match the situation at Llandegai, however I have used this example that was known to me, to get something to you as soon as possible.

Fix across the framework of each opening a layer of 6% permeable Black Galebreaker weather proofing mesh. The mesh to be secured into position with the lower edge run onto the leading edge of the lowest louvre blade to allow water to run off outside. Fix across the inside of the Galebreaker welded stainless steel 12x12mm rigid mesh.
